Investigation of a Failed Circuit Breaker

Root Cause: Inappropriate Contact-tip Material

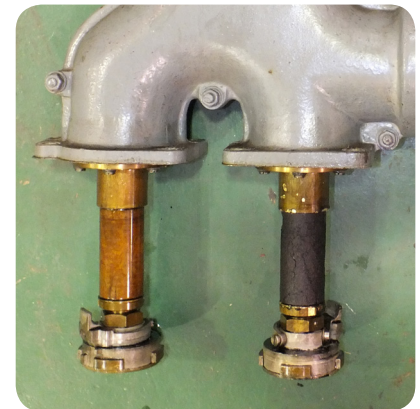
The examination showed that a flashover had occurred between bushings in the breaker tank. The damage to the contacts was severe and of a similar nature on all six contacts. Various potential causes were considered: the cause of the poor performance of the contacts could have been due to breaking current beyond rated capacity or slow operation, but analysis of background information showed that these were unlikely and some other cause may have existed. Further investigation included microscopic examination, using visual and electron microscopes: an unexpected metal was found as spatter on some contacts during elemental analysis in the electron microscope. Metallurgical examination of the material of the arc contact tips showed they were made of the same material as the spatter: the material is not commonly used where arc resistance is required. Analysis of the contacts from the failed circuit breaker and contacts known to be to the original manufacturer's specification showed that the failed contacts were made of material that was more prone to arcing damage than the material specified.

Intact and arced bushings

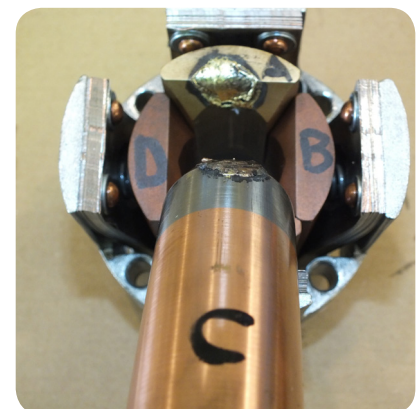
Arc contact and poker contact

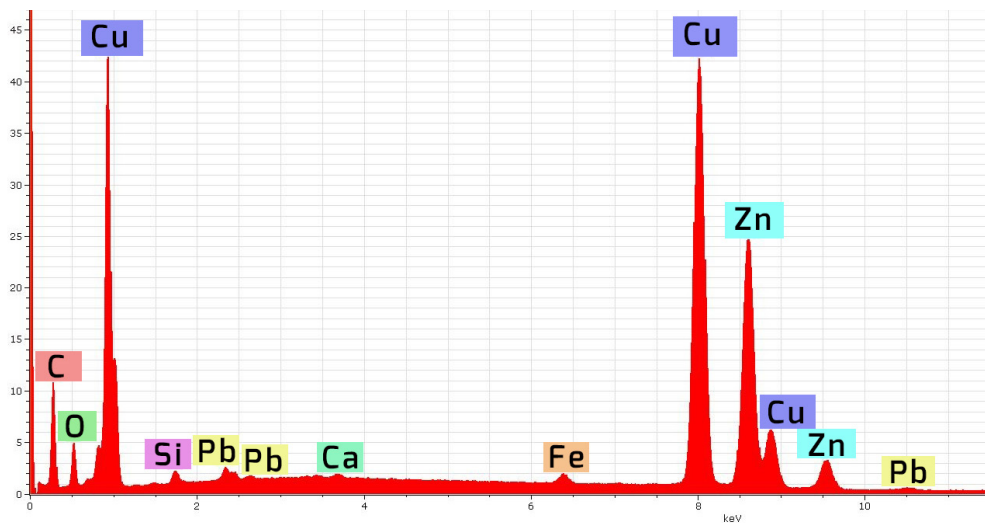
Elemental analysis of the contact tip material

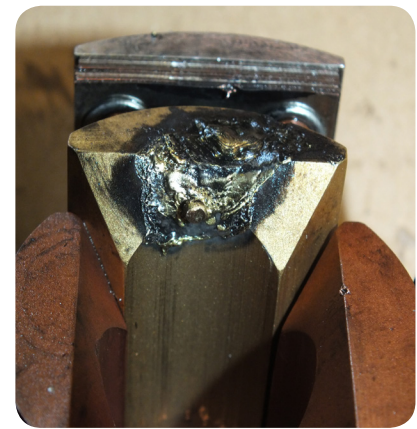
Damaged arc contact

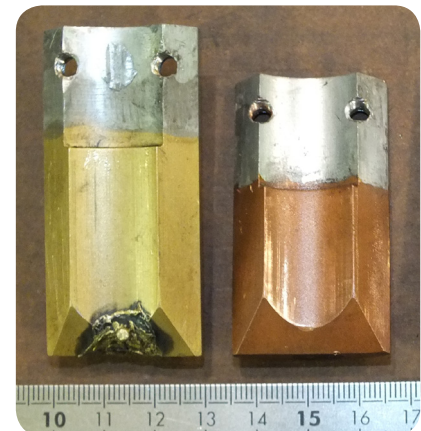
The failure sequence started with the trip and reclose, which caused arc products from the contact tips to be deposited on the main current contact areas, leading to high resistance when the breaker was reclosed. This caused overheating, rapidly degrading the oil. The flashover was caused by the electrical weakness of the degraded carbon-bearing oil, probably exacerbated by arcing products generated as the contacts degraded further. The initial flashover was followed by full current power arcs, finally extinguished by the opening of other breakers.

Arc and main contacts

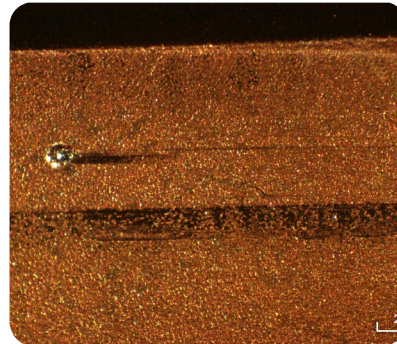
Globule of spatter
(optical microscopy)

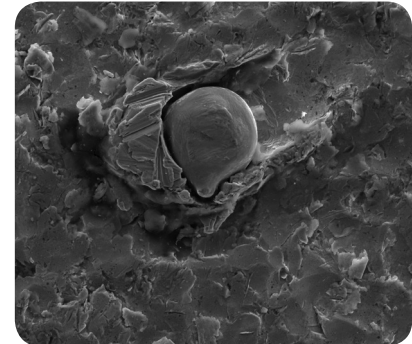
Globule of spatter
(electron microscopy)
