*Prepared for  
Area 51*

## ***Investigation of a Failed 11kV Cable Termination from Location X***

*Job No: 07055 Issue 2*

*20 April 2012*

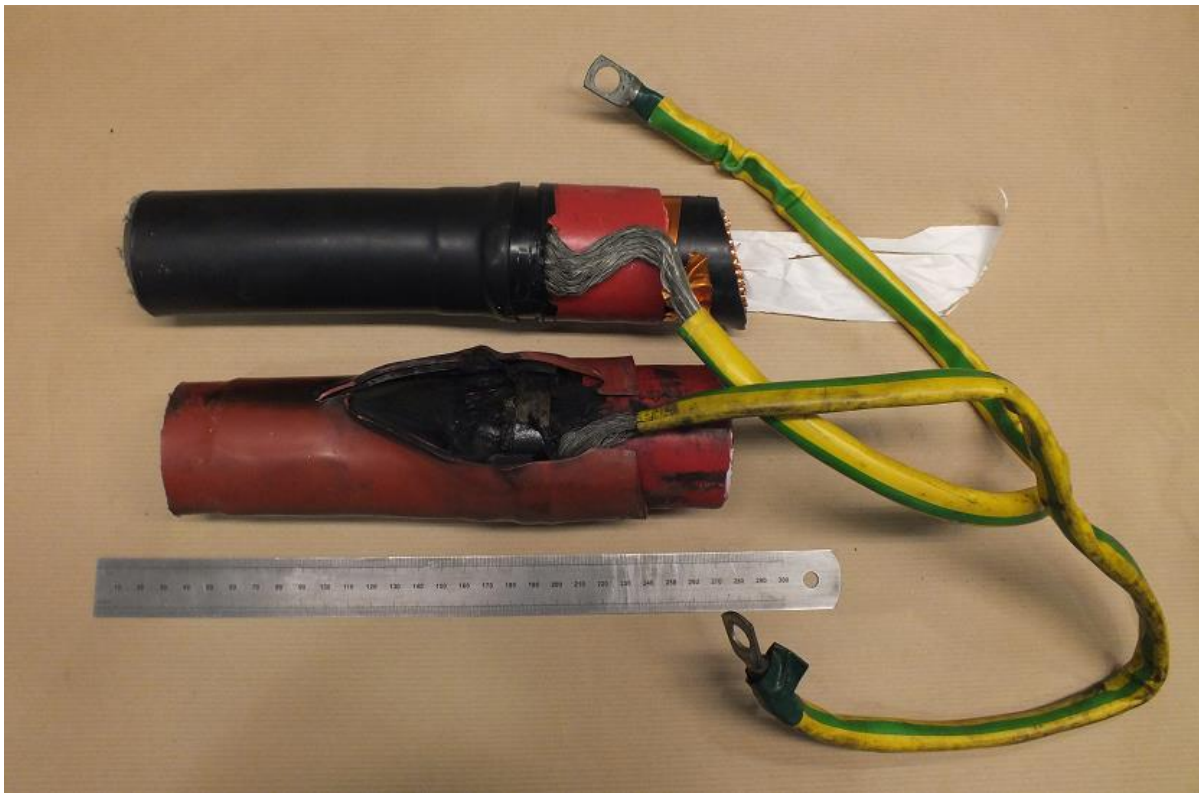
Parts of two terminations were supplied (Figure 1):

**Figure 1. Samples supplied to EA Technology for examination.  
Non-failed termination is upper in the picture, failed termination is lower.**

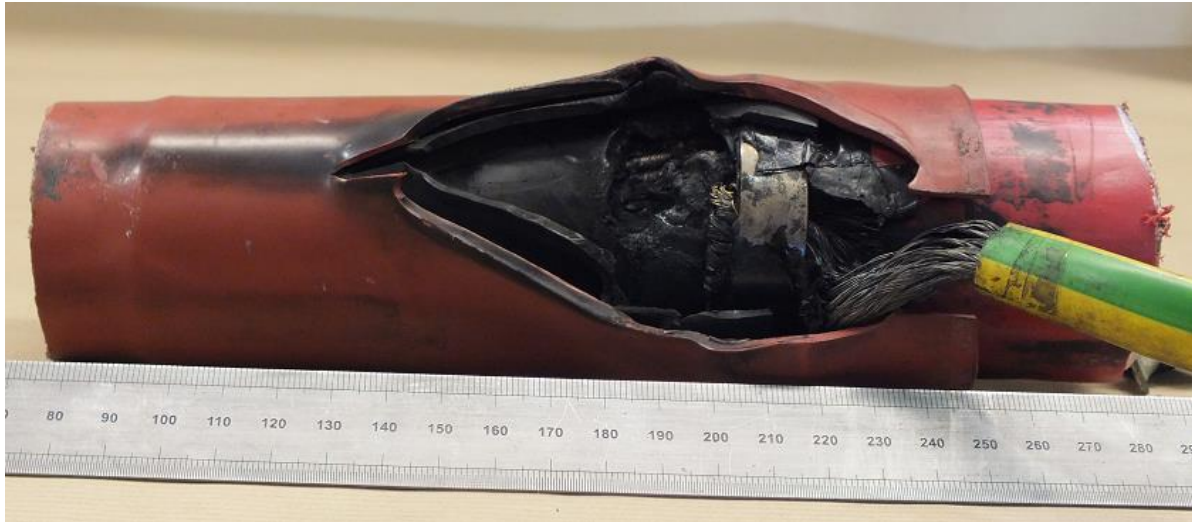
On the failed termination, arcing damage on the conductor was visible in the fault hole. The area in and around the fault hole showed no evidence of contamination or mechanical damage that pre-dated the fault damage. The fault appeared to be near the screen cut (where the extruded insulation screen of the cable is cut, effectively the end of the earth plane around the cable) and was next to the point where the earth bond lead was fitted onto the copper tape screen of the cable (Figure 2). None of the yellow mastic tape that is part of the Company Z termination design and should be fitted around the screen cut was seen in the termination: for reference, a view of a similar termination equipped with yellow mastic tape is given in Figure 3.

**Figure 2. View of the fault hole in the failed termination**

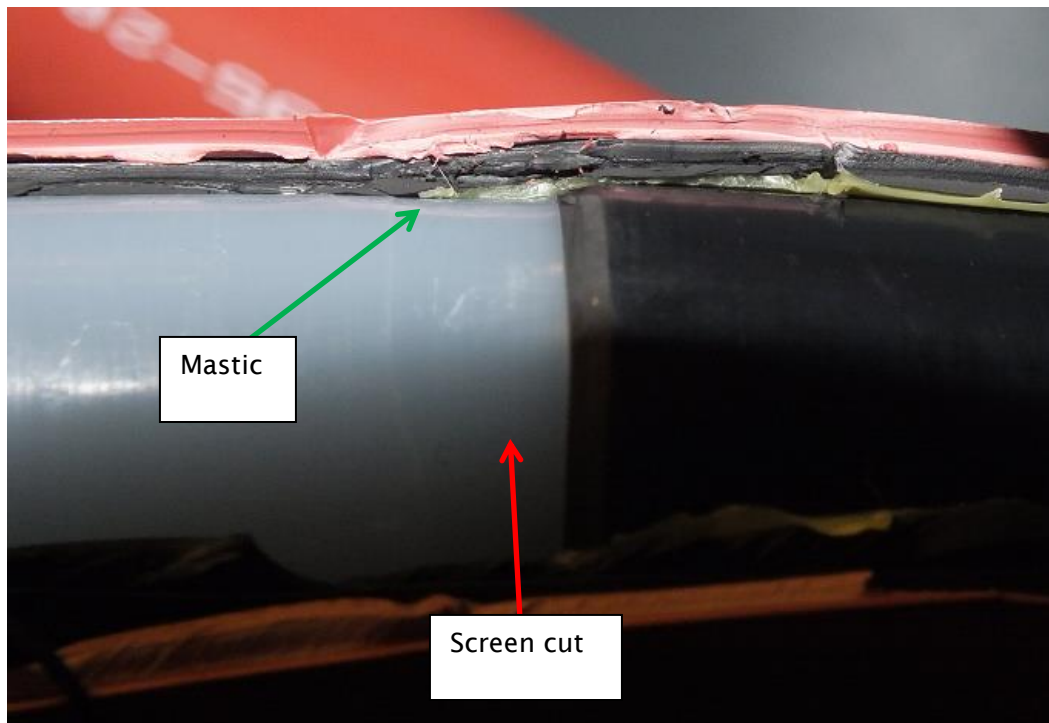
**Figure 3. Yellow stress relieving mastic around a screen cut in a cut away view of a correctly assembled termination**

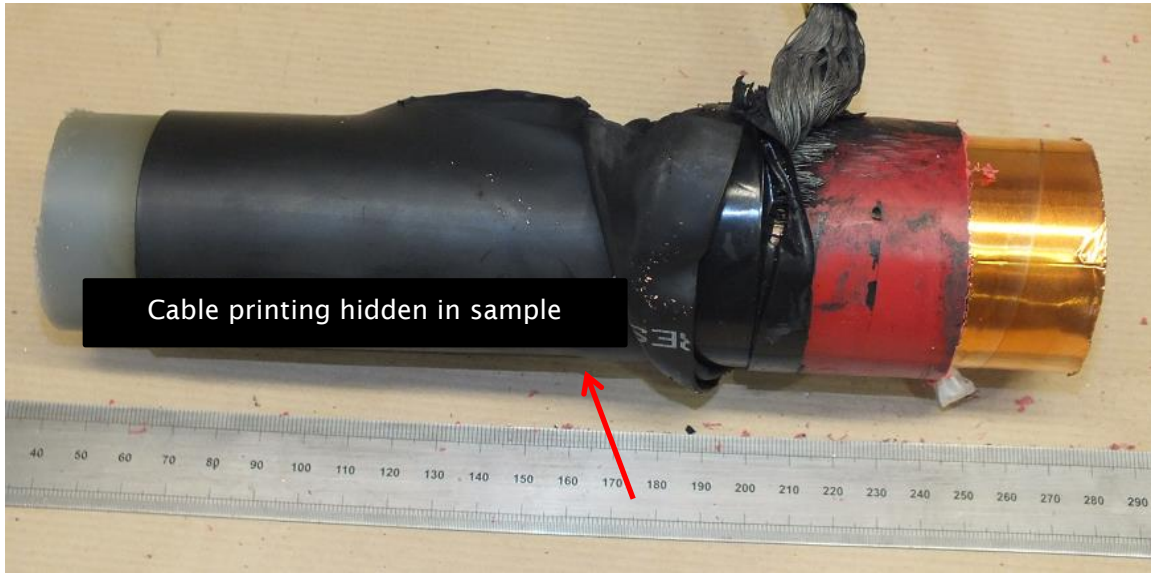
The stress control tube showed a crease aligned with the fault damage: this may have been a result of the fault rather than an assembly defect (Figure 4). The remainder of the tube appeared to have been shrunk into place evenly with no other defects on the stress control tube noted.

**Figure 4. Failed termination: stress control tube creased next to fault damage**

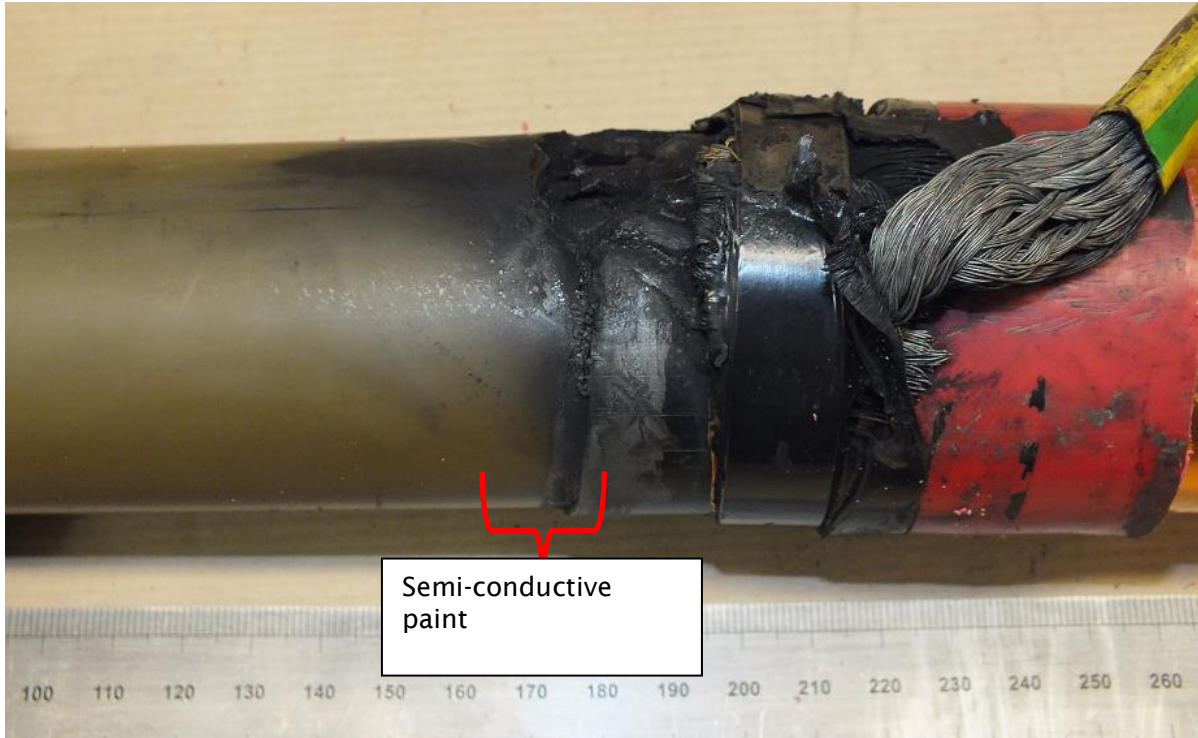
With the screen cut now exposed, it was seen that there was no yellow stress relieving mastic around the screen cut, but instead there was a ring of paint instead (Figure 5). An area of paint that had not suffered fault damage was tested with a multimeter in resistance mode. The electrodes were pressed into the paint with a 5mm gap between them and a resistance of 4.4k $\Omega$  was measured: a similar measurement on the cable extruded semiconducting screen gave a resistance of 3.5k $\Omega$ . These measurements indicated that the paint was probably semi-conductive. Such paint would not relieve stress, but would instead concentrate electrical stress at the upper end of the paint. The fault hole was coincident with this painted layer.

**Figure 5. Semi-conductive paint applied around the screen cut**

The terminations had been assembled using a semi-conductive paint rather than stress relieving mastic around the screen cut. This would have concentrated electrical stress at the end of the paint, making that area susceptible to electrical breakdown of the surrounding materials. On the non-failed termination, some material erosion consistent with electrical erosion was noted, and white powders typical of such partial discharge activity were also noted. The XLPE was also discoloured, which may have been caused by heating from the partial discharge activity.

The cause of failure is therefore identified as the use of a semi-conductive paint rather than stress relieving mastic around the screen cut.

- R1. Similar terminations installed at a similar time should be considered to be at risk of similar failure.
- R2. A programme of partial discharge monitoring using TEV measurement should be implemented as a short-term measure to allow the cables to continue in use until critical levels of discharge are found.
- R3. A programme of termination replacement should be drawn up and implemented as a longer-term solution to preventing similar failures.

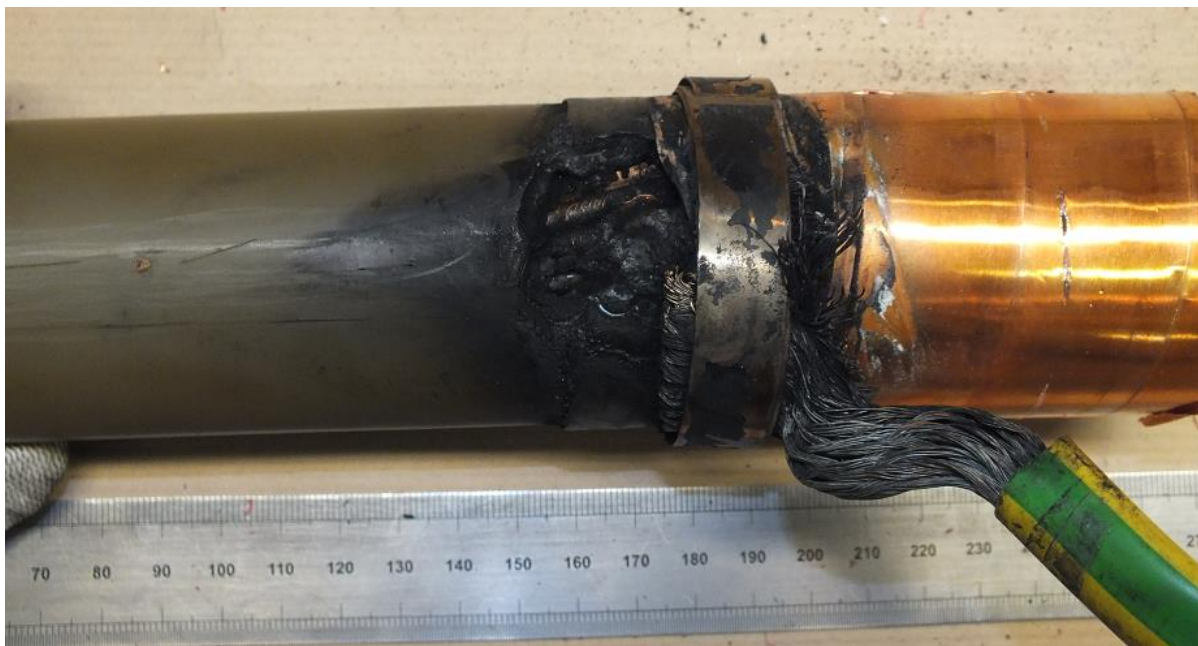
The cable overshath was cut along its length and removed. The exposed copper tape screen on the cable appeared to be relatively undamaged and no further features were seen on the roll spring earth bond (Figure 6).

### Figure 6. Exposed copper tape screen undamaged

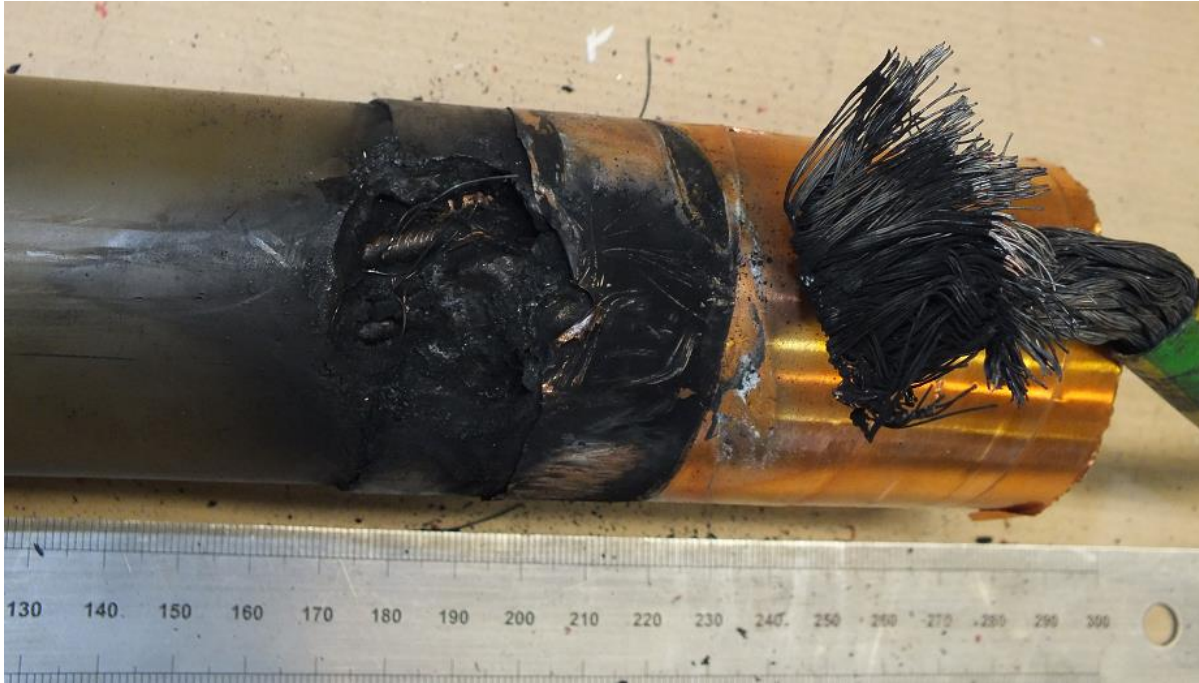
The roll spring and earth lead were removed. Some blackening of the contact area between the copper tape and earth lead was noted, but all arcing was in a position next to the roll spring, not directly inside it (Figure 7). This indicated that the fault was not directly related to the earth lead to copper tape bond.

**Figure 7. Contact area between copper tape and earth lead blackened, but not arc damaged.  
Arcing damage on the tape is above the roll spring position.**

It was noted that the failure occurred next to the earth current bond. There is no indication from the available evidence that the bond was a contributor to the cause of failure, but the proximity of the fault to the bond has been considered. In a solidly bonded circuit formed of single core cables, a circulating current is induced in the screens by the electromagnetic field that is set up when load current flows through the cable conductors. That circulating current will flow through the copper tape screen and earth bonds: as with any current flow, when that circulating current flows through a resistance, heat will be generated. In this case, the relatively high resistance of the copper tape screen will limit the magnitude of the circulating current to a relatively low level, so there would be no excessive heating

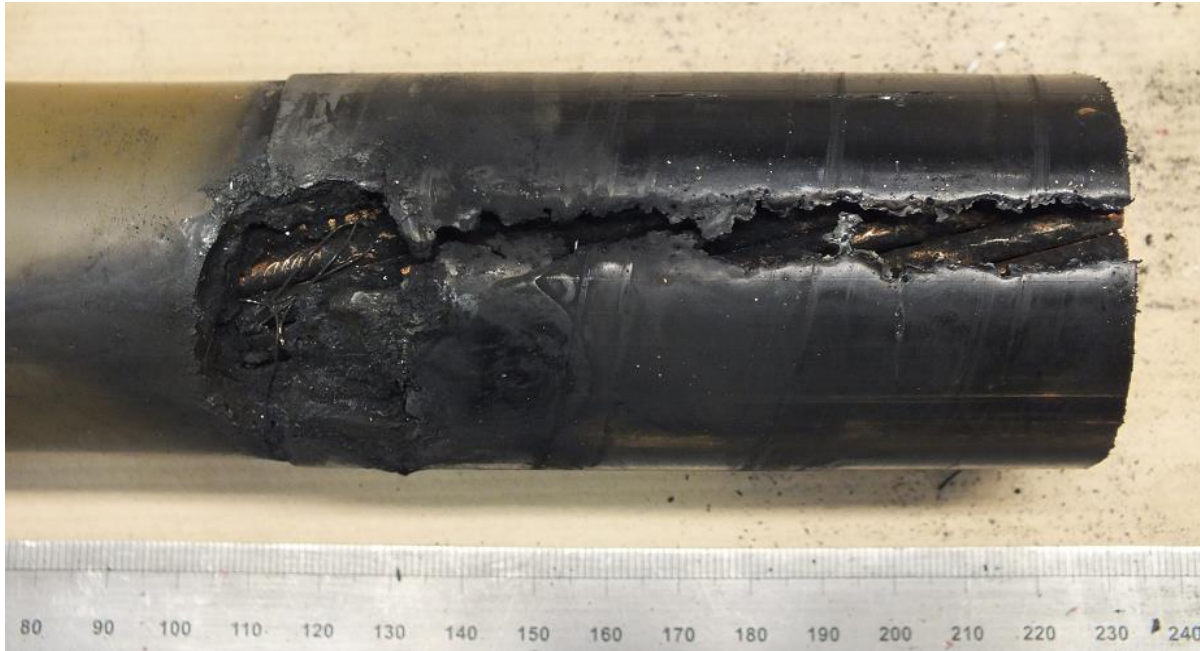
The copper tape screen was removed from the cable. A line of arc erosion was seen in the cable insulation (Figure 8). The alignment of that feature was marked along the full length of the sample for future reference during cross sectioning and microscopic examination of the cable.

**Figure 8. Linear arcing damage in the cable**

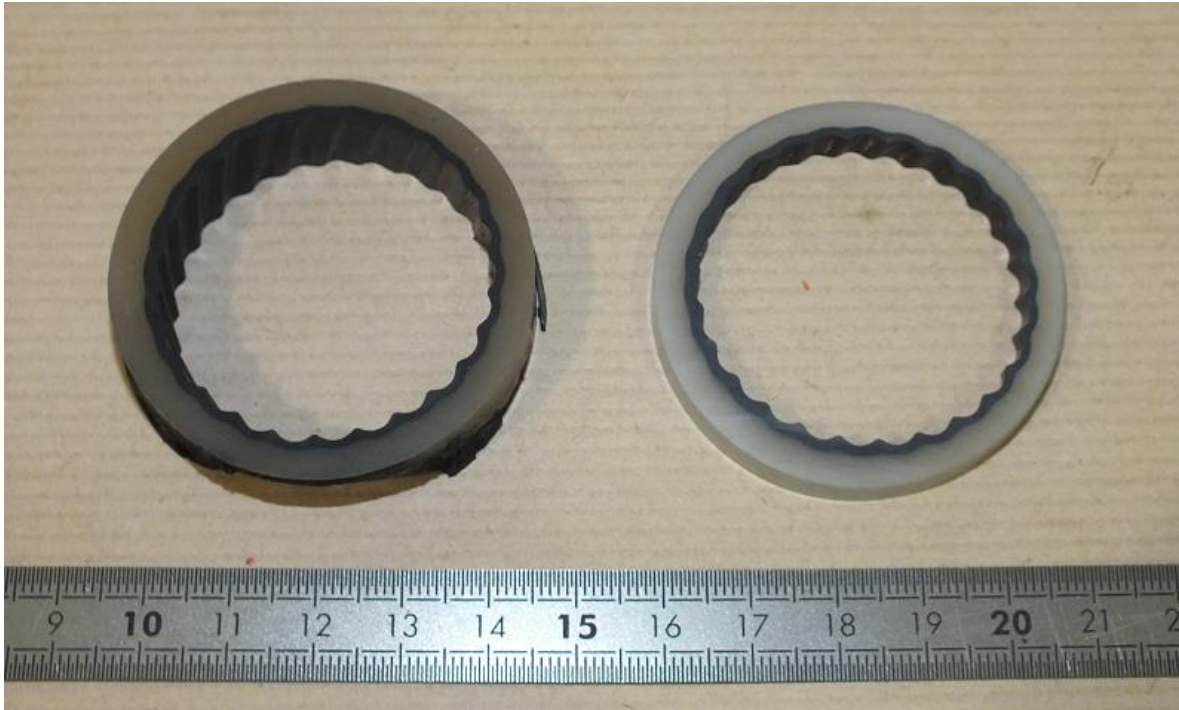
**Figure 9. Slices prepared for microscopic examination**

Examination of the slice that contained the screen cut showed no evidence of widespread treeing in the insulation, although much of it was heat damaged which may have obscured such damage in the insulation.

Examination of the slice that was remote from the fault showed no electrical damage (as would be expected from a slice taken from this low stress area of the termination). No specific features were found that coincided with the line of the linear damage found below the fault damage. A faint extrusion seam was found approximately 120° around the cable from the linear damage alignment: both the faint nature and position of the seam suggested that it had played no part in the creation of the linear arcing damage.

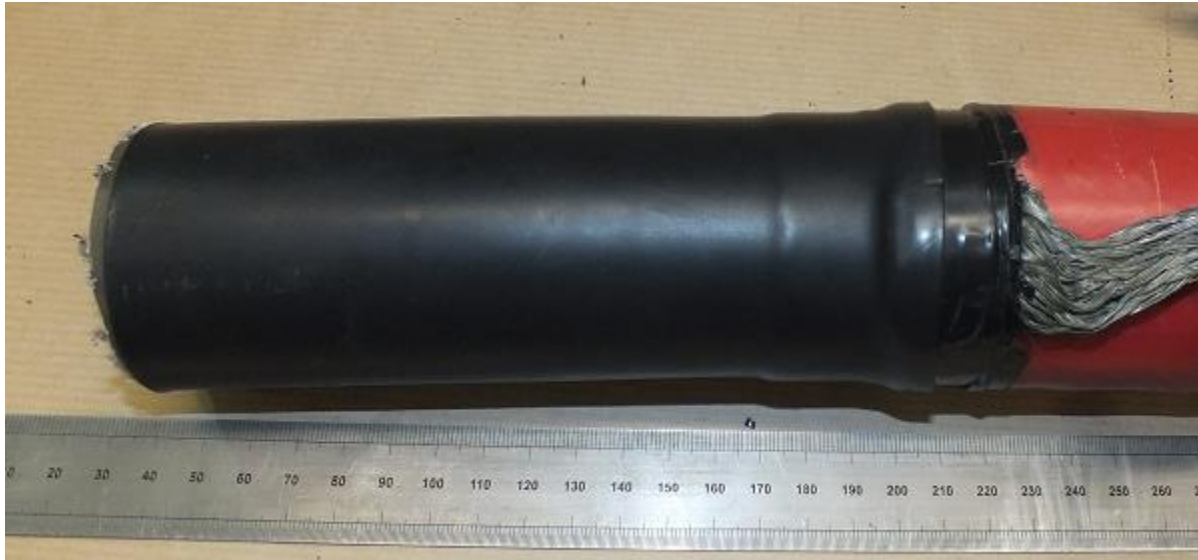
The heatshrink sleeve was not present on the termination as received by EA Technology, so no comment can be made on its condition. The stress control tube had been evenly shrunk into place with no defects noted (Figure 10). The stress control tube was cut along its length and removed: no features of interest were found on its inner surface.

**Figure 10. Non-failed sample, stress control tube in good condition**

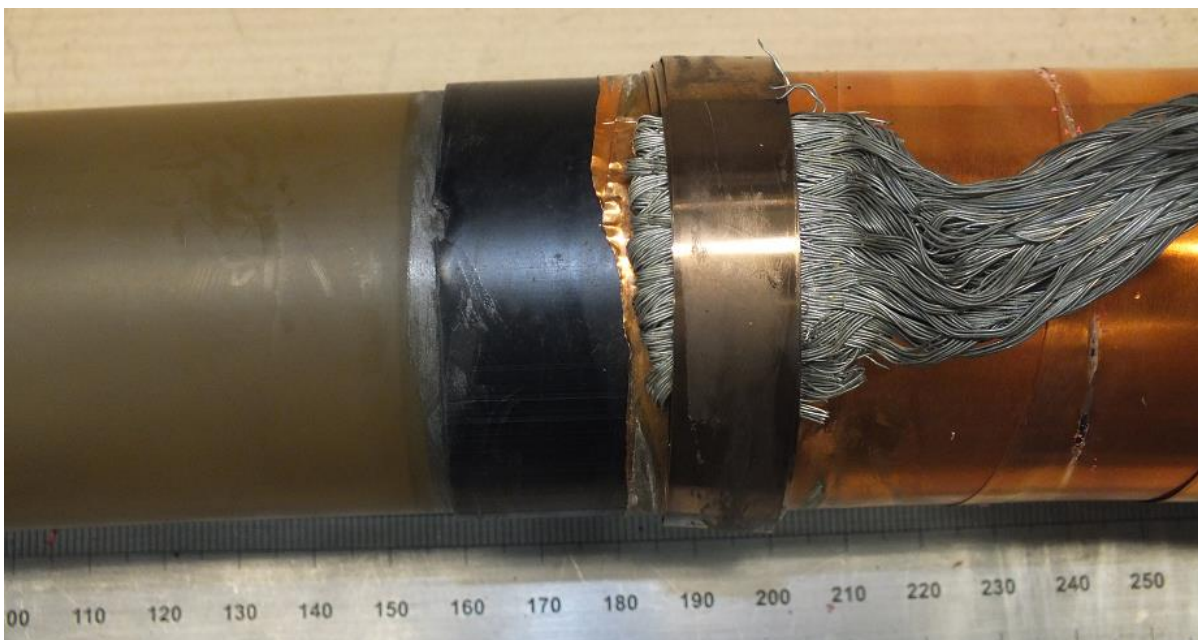
The insulation appeared to have been discoloured and the screen cut was also surrounded by paint, similar to the failed termination (Figure 11). A 15mm long line of material erosion was found next to the screen cut (possibly the result of arc erosion by partial discharge) (Figure 12), and some white deposits, typical by-products of partial discharge activity, were found next to the screen cut (Figures 13 and 14).

**Figure 11. Non-failed termination: paint around the screen cut and discoloured insulation**

The non-failed sample showed discolouration symptomatic of excessive heating and white powders symptomatic of partial discharge, indicating that it was deteriorating due to the presence of semi-conductive paint at the screen cut. This is clear evidence that other cables that have been terminated with semi-conductive paint rather than mastic are at risk of failure, and that partial discharge occurs during the failure mechanism.

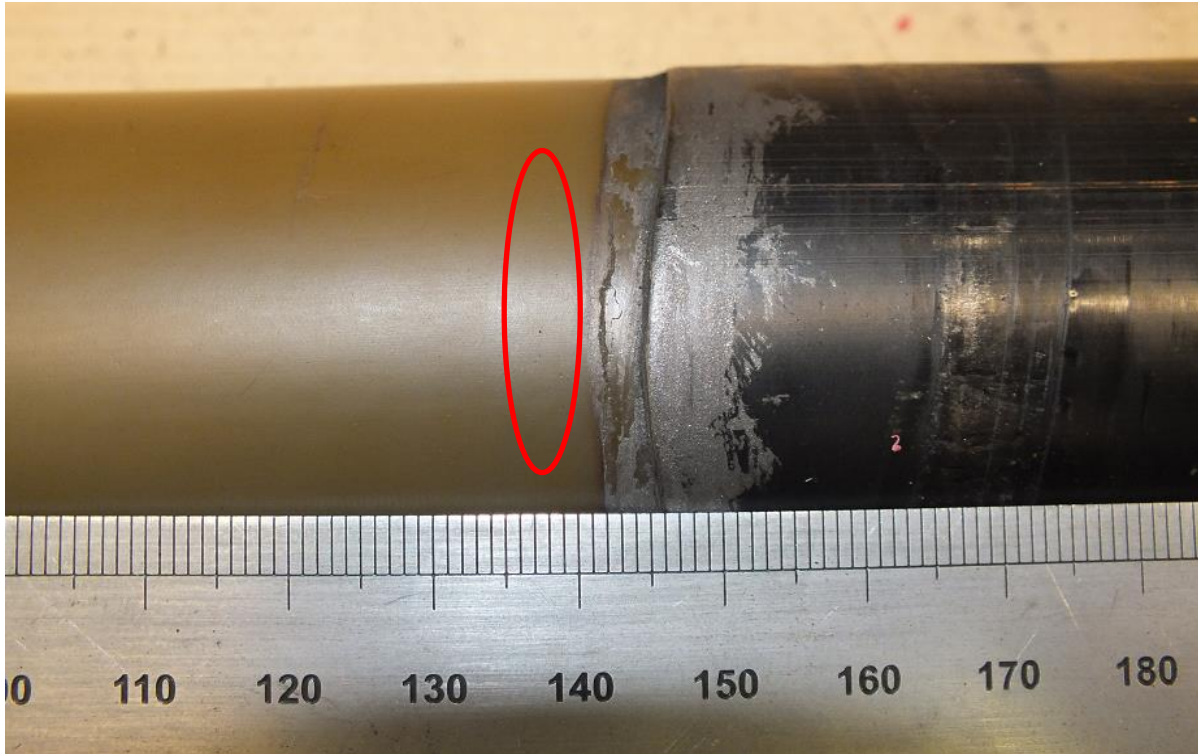
**Figure 12. Line of material erosion possibly caused by partial discharge damage**

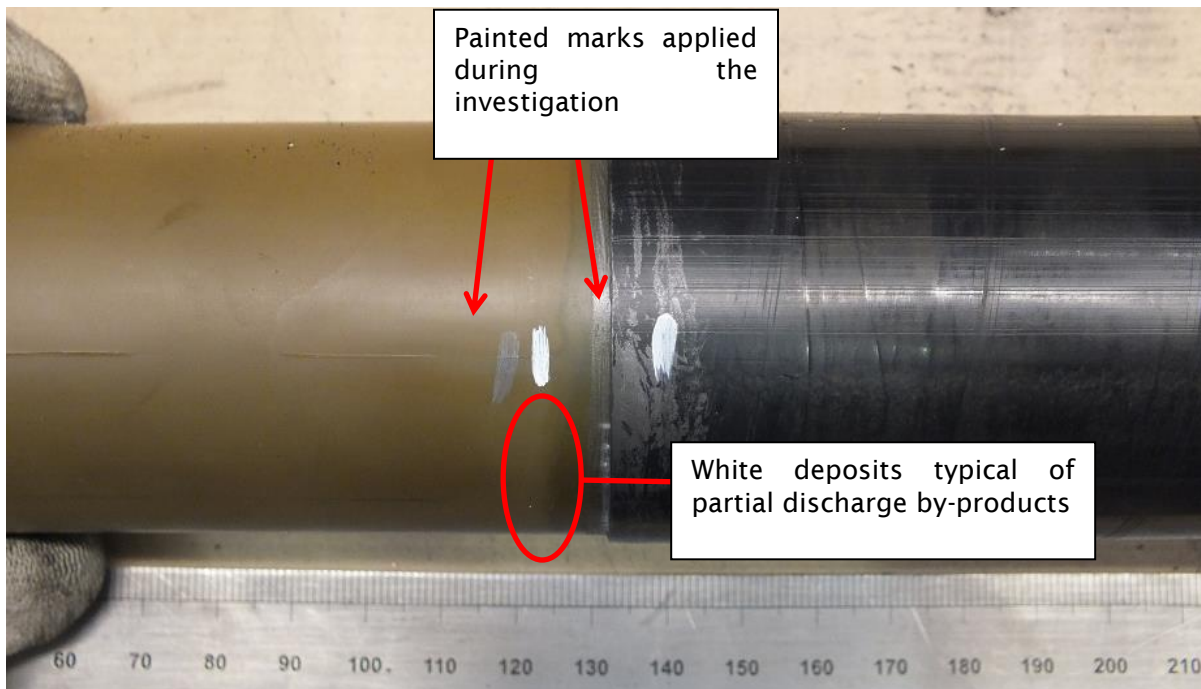
**Figure 13. White deposits next to the screen cut**

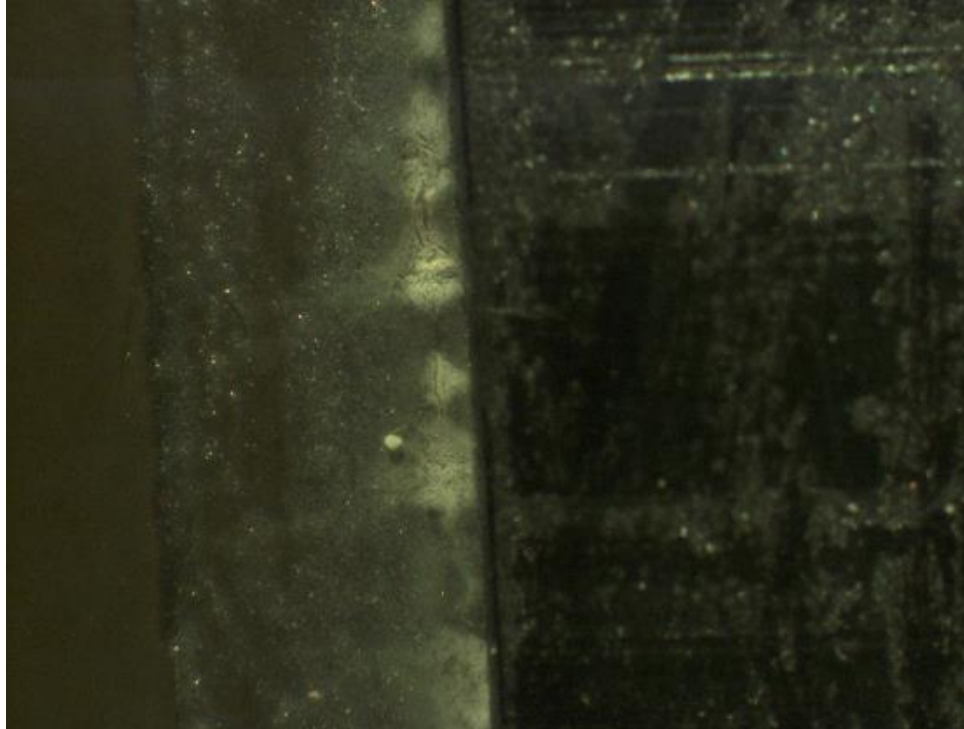
**Figure 14. Microscopic view of the white deposits**

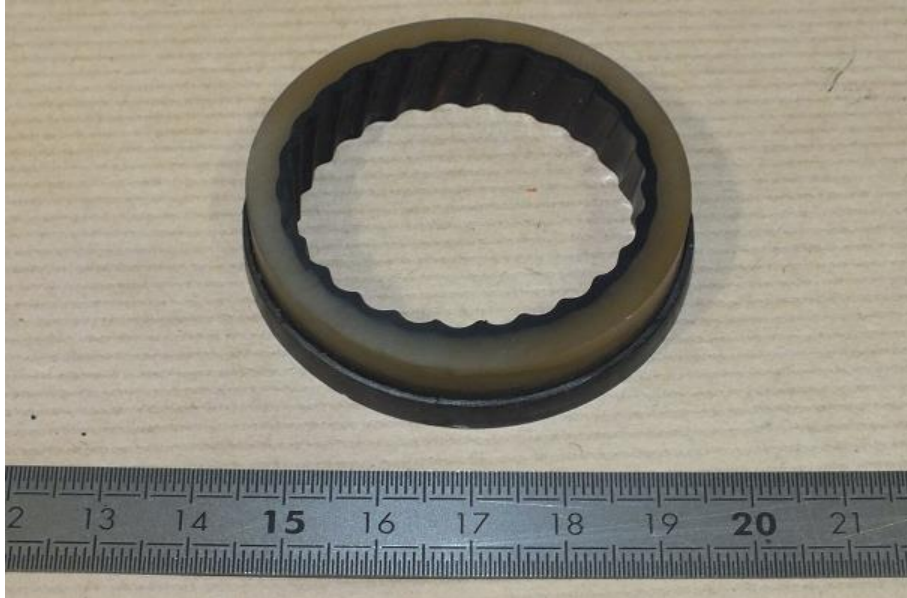
A slice was taken through the cable including the screen cut position. The conductor strands were removed and the insulation surface was polished to allow microscopic examination (Figure 15).

**Figure 15. Cable slice prepared for microscopic examination**

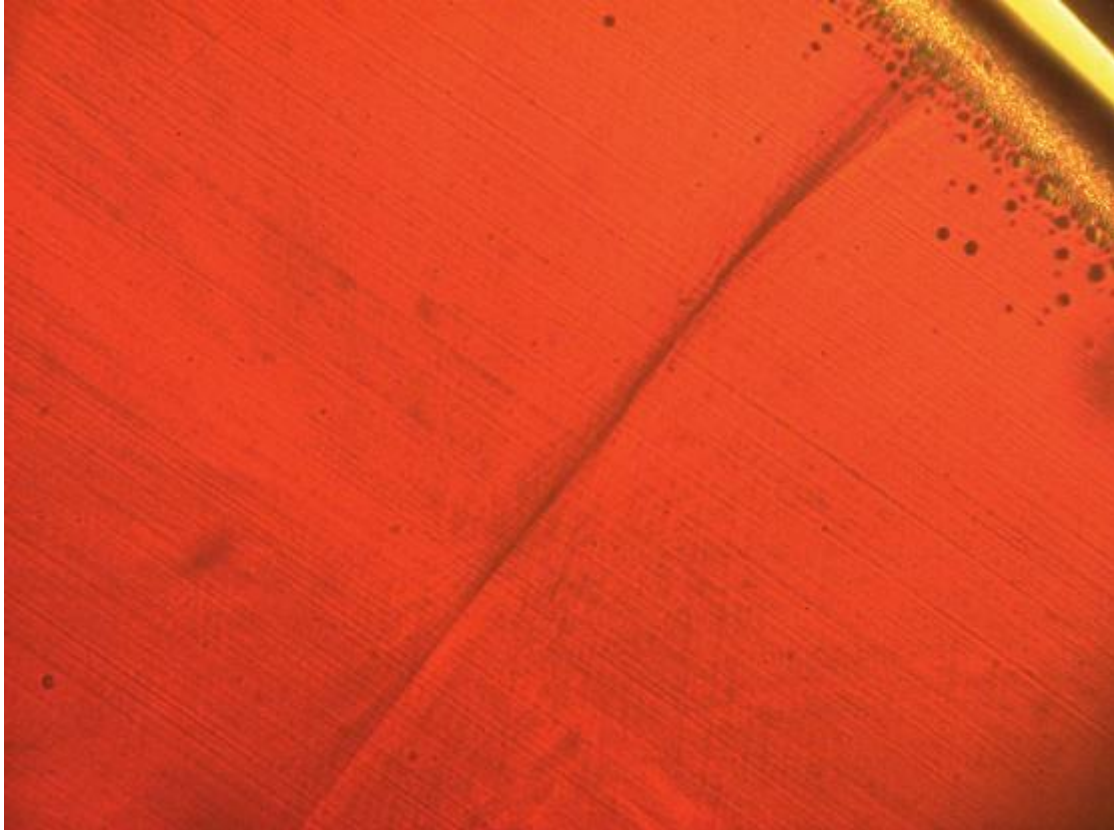
Examination of the slice showed no evidence of any trees or other electrical damage in the insulation material. However, a very prominent extrusion seam was noted (Figure 16). The seam was more pronounced than would be found in high quality modern cable, but the absence of any electrical damage at the seam showed that the seam had not caused any electrical damage.

**Figure 16. Non-failed sample: prominent extrusion seam in the XLPE**

It was observed that the non-failed sample showed a distinct extrusion seam in the cable insulation. On the failed sample, the fault damage was not aligned with the extrusion seam, so the seam was not a cause of failure. However, the very distinct nature of the extrusion seam on the non-failed sample was considered to be unusual and is an indication that the quality of cable manufacture was not as high as can be achieved in a modern good quality cable.

The analysis undertaken did not show any electrical deterioration at the seam, so on the basis of the evidence examined within this investigation there is no evidence to suggest that the seam is a risk to cable integrity in this case. Therefore, there is no evidence to suggest that any action should be taken at present in reaction to this observation. However, poor extrusion seams have been implicated in other failure investigations undertaken by EA Technology, so if future cable failures occur in this circuit, the possibility of a seam defect being the cause of failure should be considered.
