Investigation of a Failed Circuit Breaker

Root Cause: Inappropriate Contact-tip Material

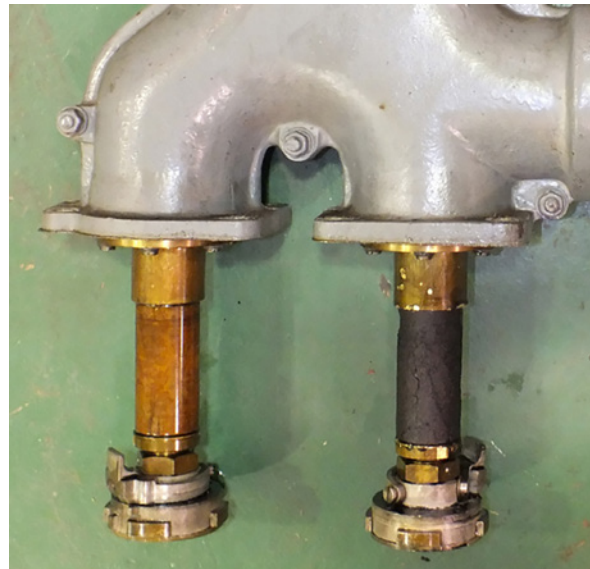
The examination showed that a flashover had occurred between bushings in the breaker tank. The damage to the contacts was severe and of a similar nature on all six contacts. Various potential causes were considered: the cause of the poor performance of the contacts could have been due to breaking current beyond rated capacity or slow operation, but analysis of background information showed that these were unlikely and some other cause may have existed. Further investigation included microscopic examination, using visual and electron microscopes: an unexpected metal was found as spatter on some contacts during elemental analysis in the electron microscope.

Intact and arced bushings

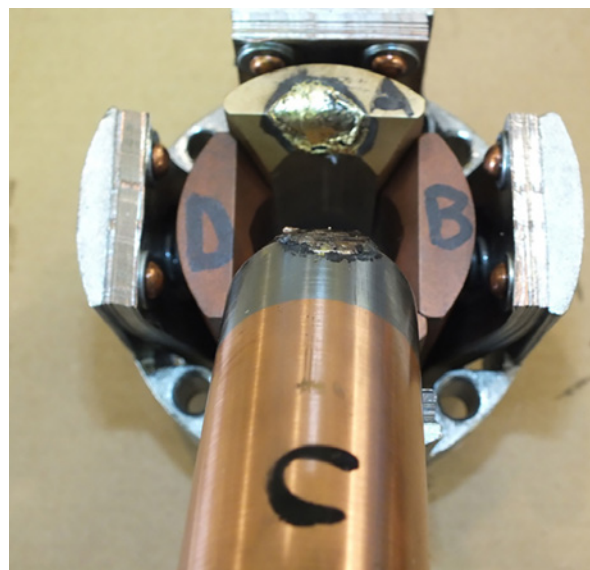
Arc contact and poker contact

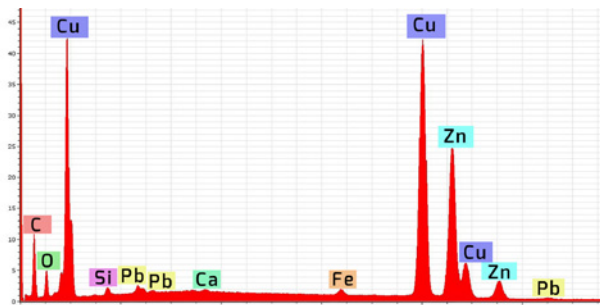
Metallurgical examination of the material of the arc contact tips showed they were made of the same material as the spatter: the material is not commonly used where arc resistance is required. Analysis of the contacts from the failed circuit breaker and contacts known to be to the original manufacturer's specification showed that the failed contacts were made of material that was more prone to arcing damage than the material specified.

Elemental analysis of the contact tip material

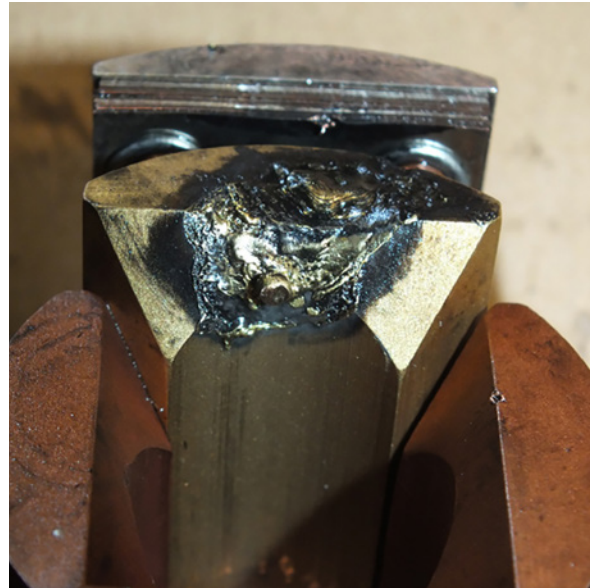
Damaged arc contact

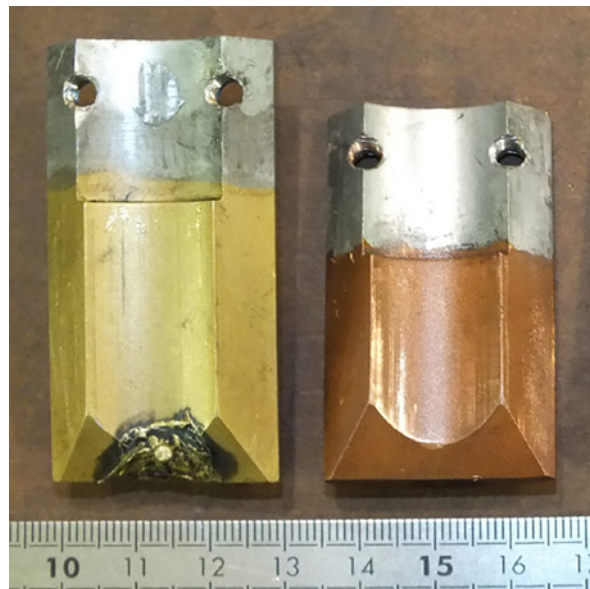
Arc and main contacts

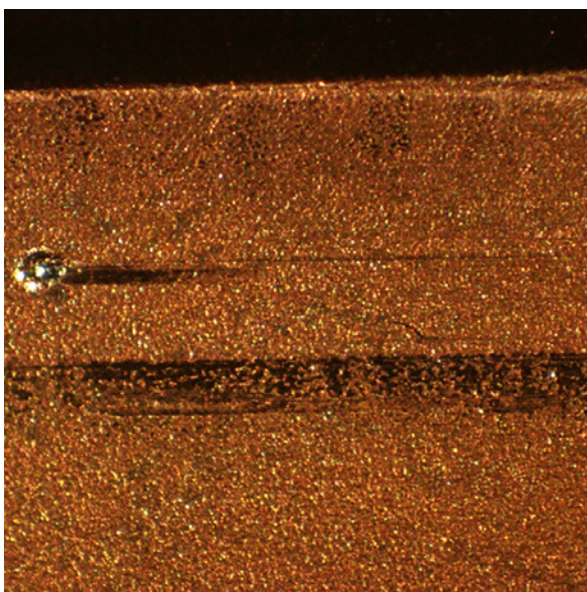
Globule of spatter (optical microscopy)

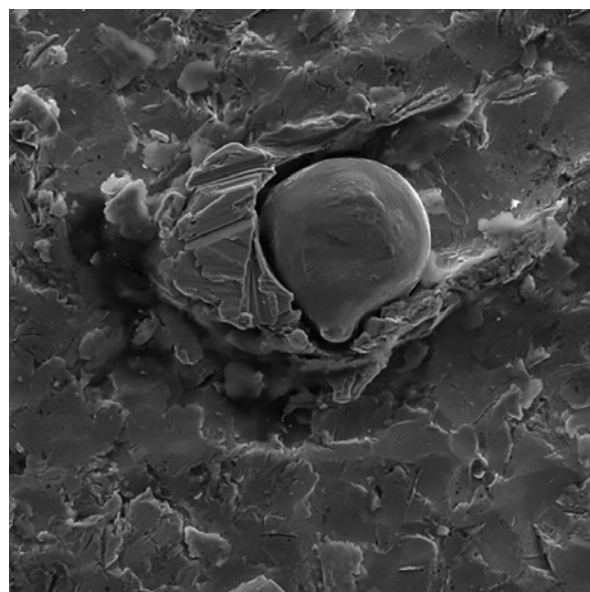
Globule of spatter (electron microscopy)
