DEMYSTIFYING OFF-LINE **PD TESTING** FOR AN EFFECTIVE CBM STRATEGY

REAL-WORLD CAUSES OF PARTIAL DISCHARGE

BY WILLIAM HIGINBOTHAM, *EA Technology LLC*, and JAY PRIGMORE, PhD, *Google LLC*

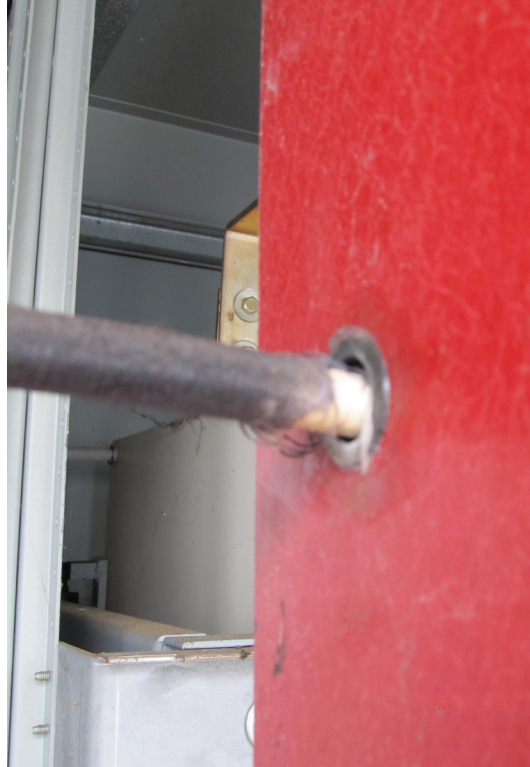
- An unshielded wire running through an oversized grommet or hole in fiberglass panel board (Figure 1)
- A busbar going through an oversized passthrough bushing or hole in an insulating panel (Figure 2)
- A busbar resting unevenly on an insulator
- A loosely fitting boot on exposed bus connections

Figure 1: *Air gap in Grommet Causing PD*

Use the correct grommets and bushings to ensure that small air gaps do not occur. Do not allow improperly fitting holes. A common solution is filling gaps with room-temperature vulcanizing silicone (RTV) of a similar or

higher permittivity. Higher permittivity will result in less voltage across the RTV and more across the insulation (where it belongs).

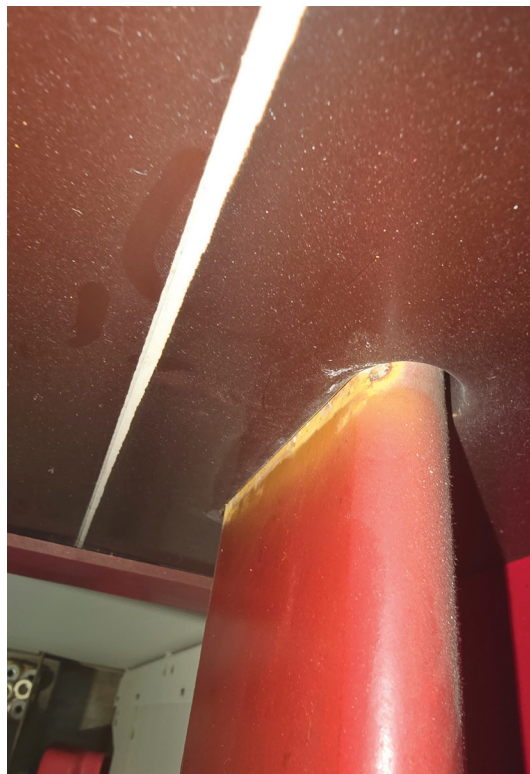
Figure 2: *Bus Bar Going through Oversized Hole in Panel*

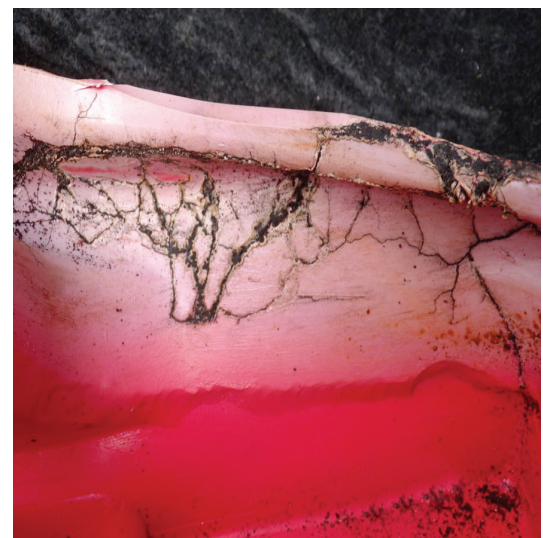
Situations with small air gaps are worse than no air gaps, but large air gaps are desirable. Air-insulated switchgear, by definition, uses large air gaps to provide adequate insulation between conductors. If those air gaps are insufficient for the voltage field — such as physically touching boots (Figure 3a) or MV cables from the transformer windings (Figure 3b) — discharge could occur over time.

Figure 3a: *Boot Installed with Insufficient Air Gap and Resulting PD Damage*

It is necessary to look at minimum spacing under all conditions. Keep in mind that the withstand capability of humid air is as little as one-third that of dry air. Wires droop over time, expand, and move with higher current. Moving switchgear parts can also violate air gaps minimum clearances.

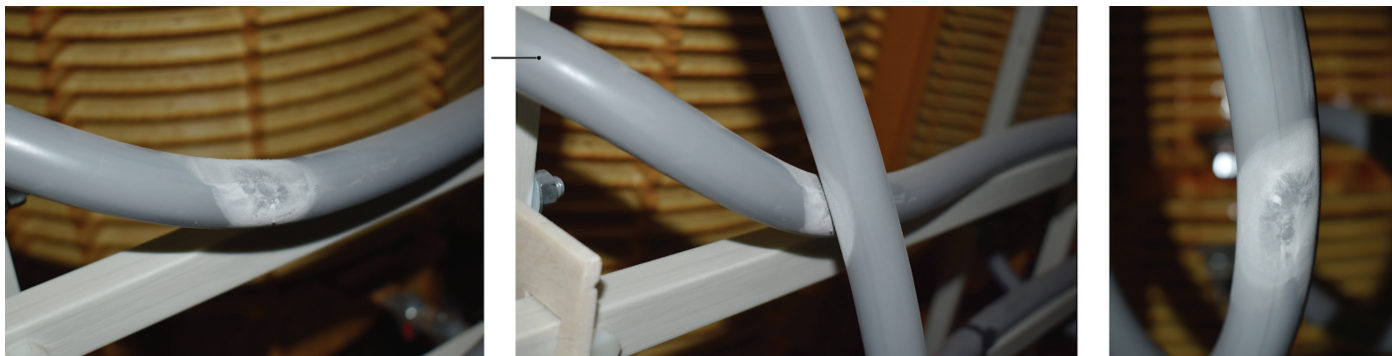
Note that the transformer in Figure 3b likely passed all manufacturer and third-party NETA testing. Fortunately, this premature failure was caught prior to failing and was quickly remediated. Other similar equipment onsite was inspected, and additional units also exhibiting PD were found and promptly remediated.

Figure 3b: *PD Due to Physically Touching Cables*

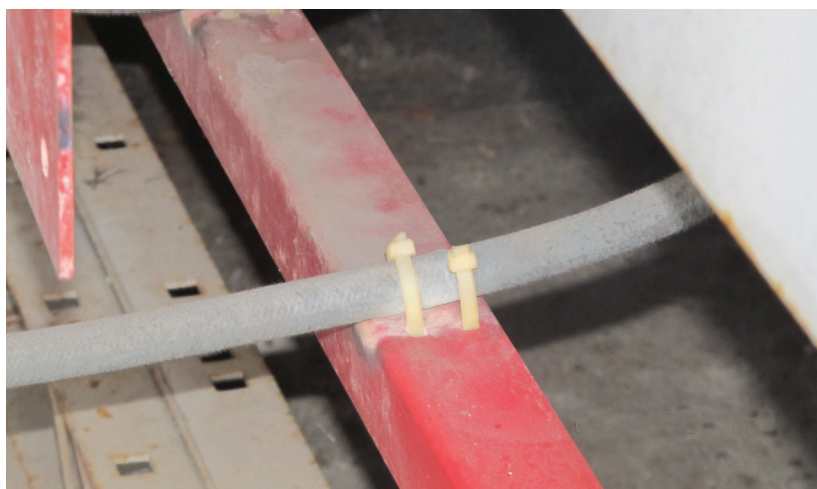
The natural reaction is to tie-wrap cables so they never move — but wait! We love tie wraps as much as any electrical guy, but they can cause big trouble in medium-voltage systems. A good insulation system has materials with known permittivity, good voltage withstand, high tracking and humidity rejection, and engineered geometry. Then someone goes in with a tie wrap they bought at Home Depot and cinches it nice and tight and there goes all that engineered goodness. Figure 4 shows tie wraps binding an unshielded cable to a fiberglass insulator. The resultant PD is evident. If the tie wrap itself isn't the issue, the fact that we've bundled this wire close to something it shouldn't be is another problem.

Figure 4: *Tie Wrap Causing PD*

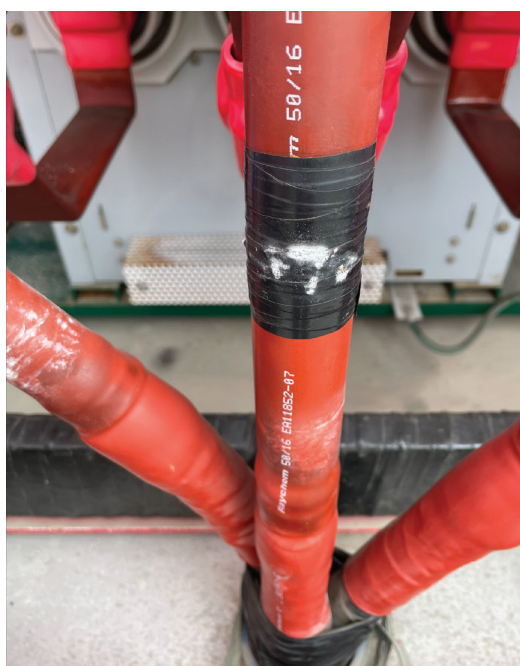
Another favorite is to add electrical tape to unshielded, insulated cables. Phase identification via colored tape has been around since Edison, and putting tape on the outside of a cable termination beyond where the shield is removed is a typical mistake. The outside of a termination is a high-field stress location, and tape will not offer the same permittivity as the outside of the termination. All tape, labels, paint, etc. on cables should go on the shielded portion. In Figure 5, black phase ID tape has caused PD.

Figure 5: *Phase ID Tape Causing PD*

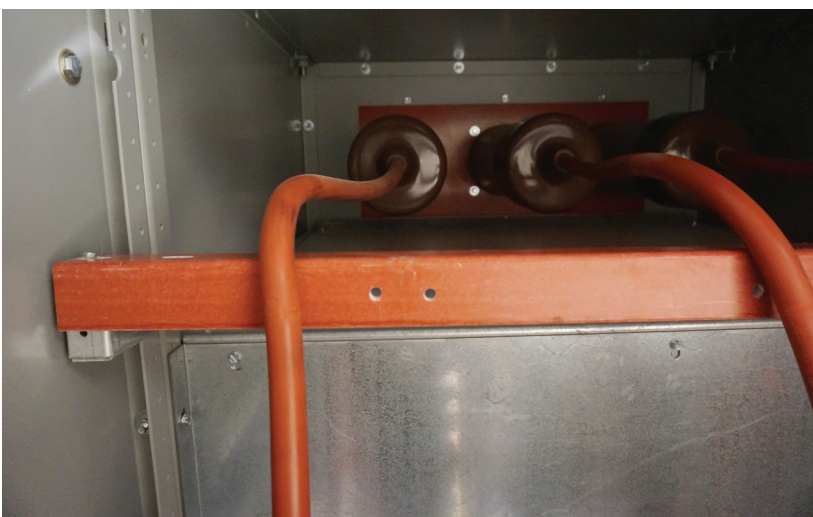
out for sharp edges on conductors or sharp interfaces on insulators. Two insulators touching at a small spot can concentrate the field and cause PD. Figure 6a shows a wire crossing a bracket with a sharp contact point. The PD was audible at initial energization and significant damage to the cable was visible after 4 months.

Figure 6a: *Geometrically Induced PD*

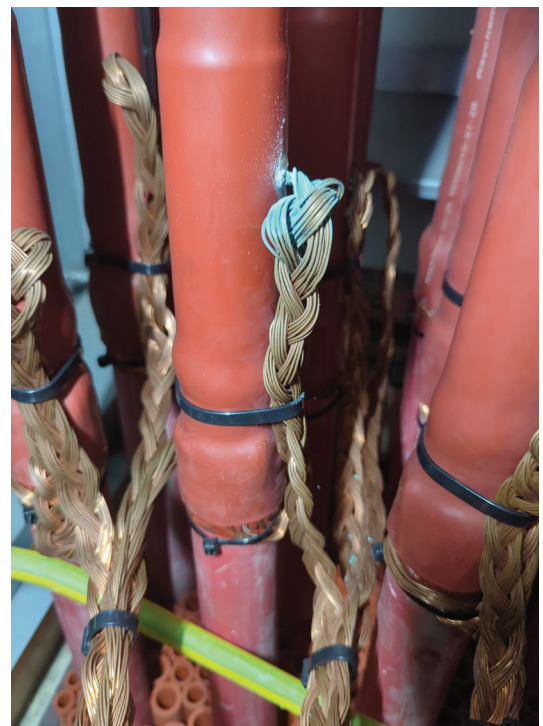
Another geometric effect is where corrosion appears on a smooth conductor. The pits and points of corrosion have sharp edges that can cause localized field concentrations. The corroded bus bar should be replaced whenever practical. Figure 6b shows an additional example of geometrically induced PD due to poorly installed ground braids that were zip-tied to the energized conductor.

These ground braids created a sharp angle and an easy path to ground for an electric field from the energized conductor. This switchgear had passed all factory testing (as expected since cables were not installed yet), NETA testing, and commissioning tests. Visual inspections

Figure 6b: *Geometrically Induced PD on Braided Grounds*

did not note, observe, or identify this potential partial discharge issue that was being created. Numerous other braided cables within the same section or the same switchgear lineup also showed identifiable partial discharge activity. Any affected cables were promptly repaired onsite to prevent this future short-circuit fault.

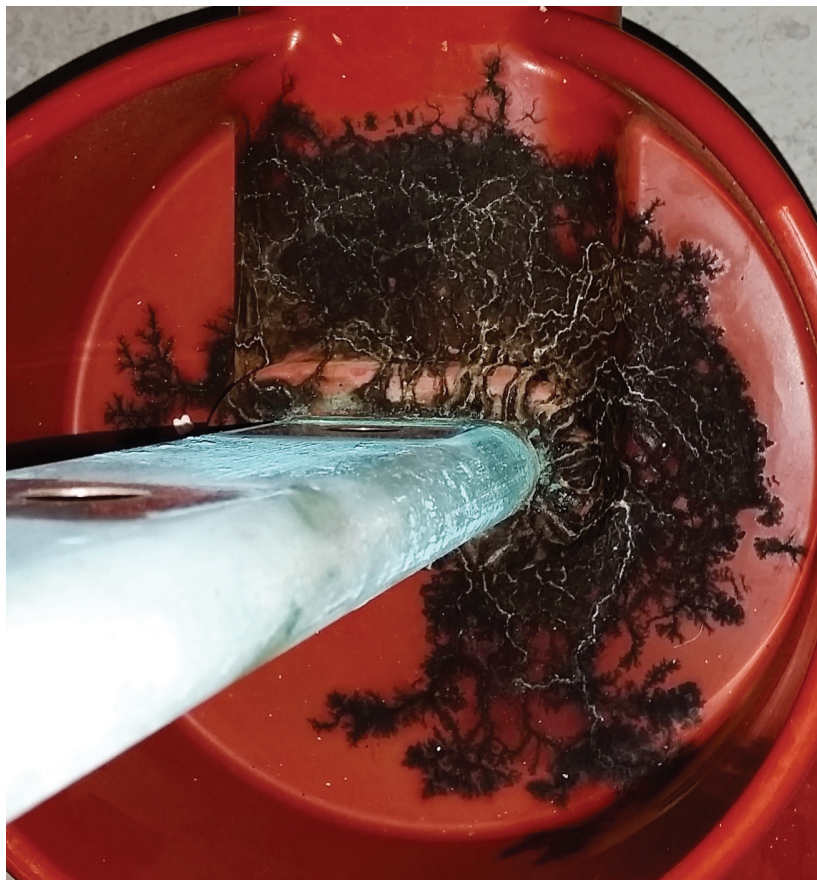
The worst example I've come across was an island substation with lots of PD induced by

Figure 7: *PD Caused by Excessive Saltwater Humidity*

salty, humid air. I asked where the humidity was coming from, and the owner lifted a piece of plywood covering a hole leading to the substation sump. The hole was not only full of salt water but also had tiny fish swimming around. A good rule of thumb: If there are fish in your substation, the humidity is probably too high. Figure 7 shows the 10-year-old switchgear from that substation.

Indoor substations should be designed to limit exposure to high humidity levels. Rapid changes in outdoor temperature can cause the air inside the substation to have high humidity and even condense. Condensation is best eliminated by using space heaters. One surprisingly common problem is that heaters are installed but often not turned on. Dehumidifiers can also be used to keep humidity low.

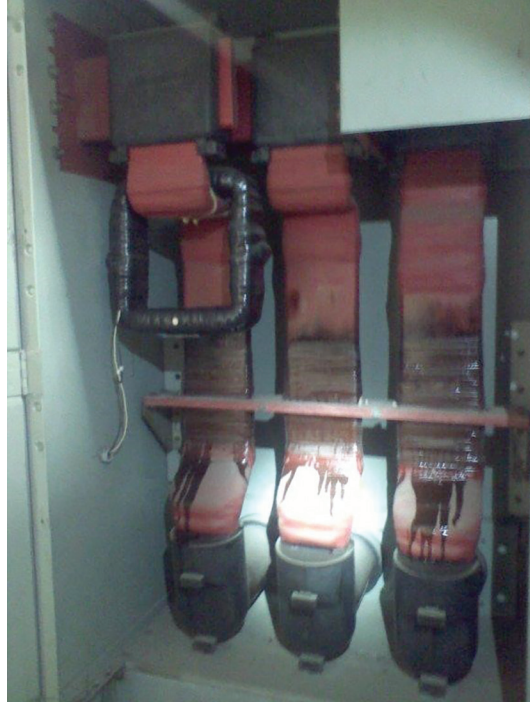
Figure 8a: *Busbar Bracket with PD Damage*

brace between phases is initially pretty even, but as dust accumulates and humidity collects, sections become conductive, totally disrupting the voltage fields. Figure 8a shows the result on the edges of the busbar where the brace was mounted. Figure 8b shows the bracket and the resulting damage. Partial discharge and flashover are concerns where the dust may be conductive (coal-burning plants, steel mills).

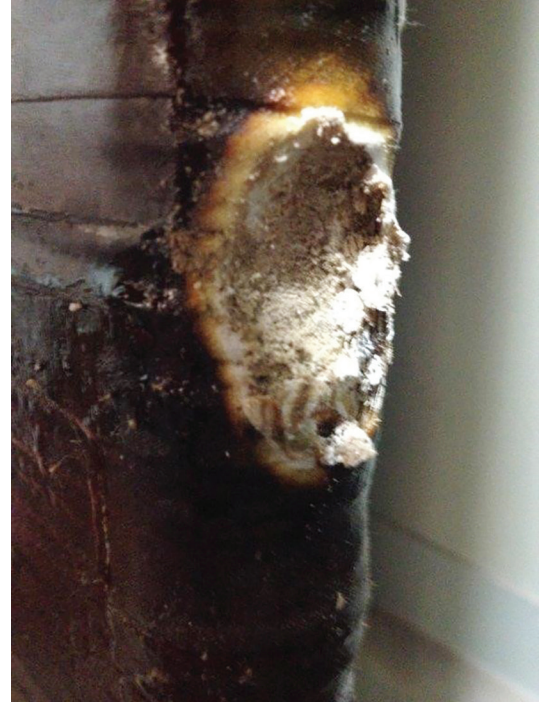
Figure 8b: *Closeup of PD Damage*
