How EA Technology predicted PD cable failure four years in advance

An Australian natural gas-fired power station

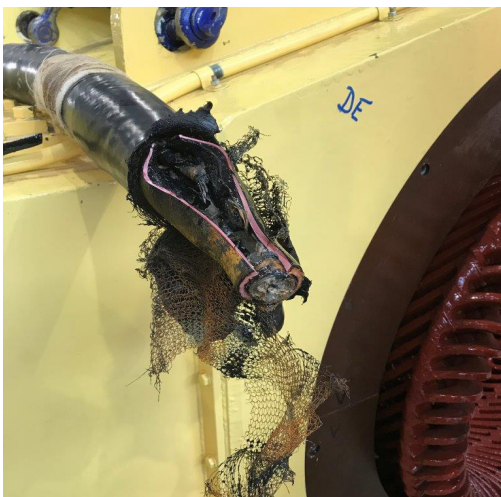
Around four years later in July 2020, the HV cable XLPE/PILC transition joint failed at the location determined within the test report: approximately 440m along the 640m long cable run.

Failed 6.6kV Transition joint, XLPE to PILC

Conclusion: A source of partial discharge was detected on the 6.6kV Cable at around 68-70% of the length of the circuit. There is an XLPE/PILC transition joint at the 65% position and this is therefore the likely source of the PD activity.

Recommendation: It is recommended to replace the HV cable joint if this asset runs a high risk to the plant. Prepare for a failure of the joint.

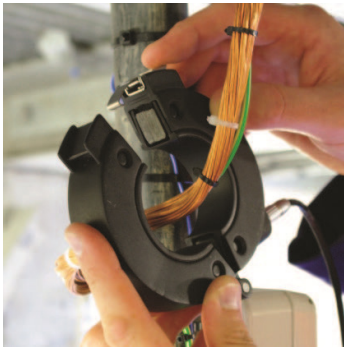
Split core HFCT applied to HV cable earthed screen wires

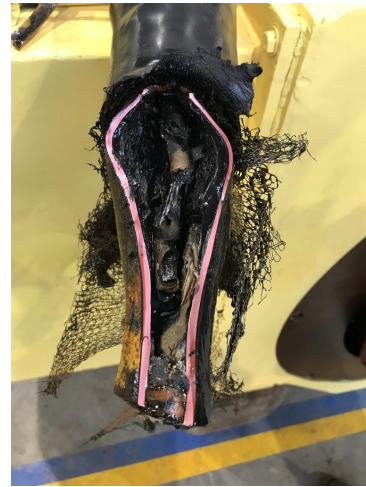
The failed transition joint

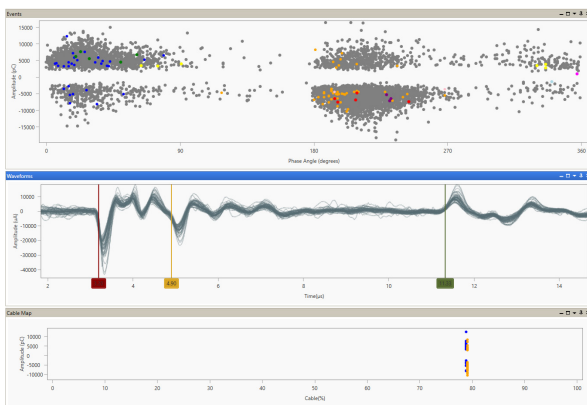
Below is the cable PD data captured from the 6.6kV cable which failed in the pre-determined location four years later.
