Turbine Bearing Failure Case Study

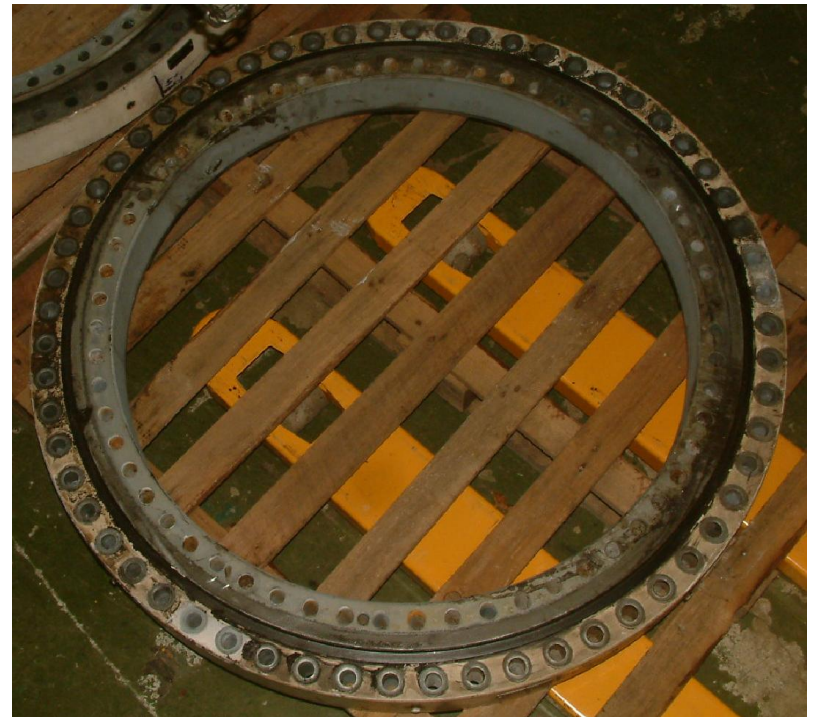
- Blade bearings
- In service for 10 years
- Protective coverings – off for unknown period
- 4-point contact ball bearing system
- Induction hardened raceway – leave a ‘soft’ spot
- Maintenance period – every 6 months
- Actual maintenance - unknown

- Multiple pitch errors across one site
- Vibration of the turbines
- Seizing of 2 of the blades on 1 turbine
- Possible more seizing across site

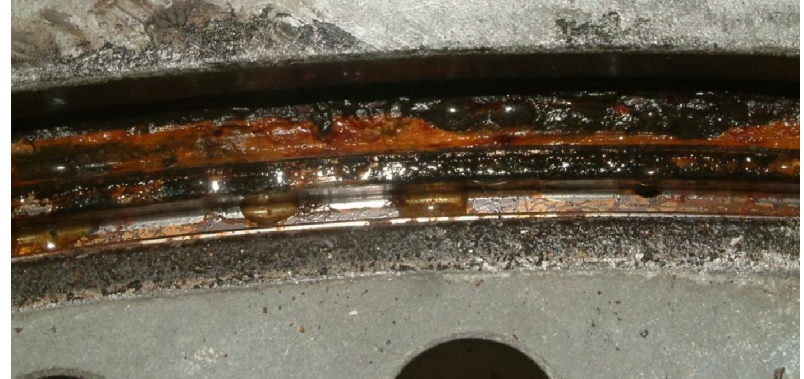
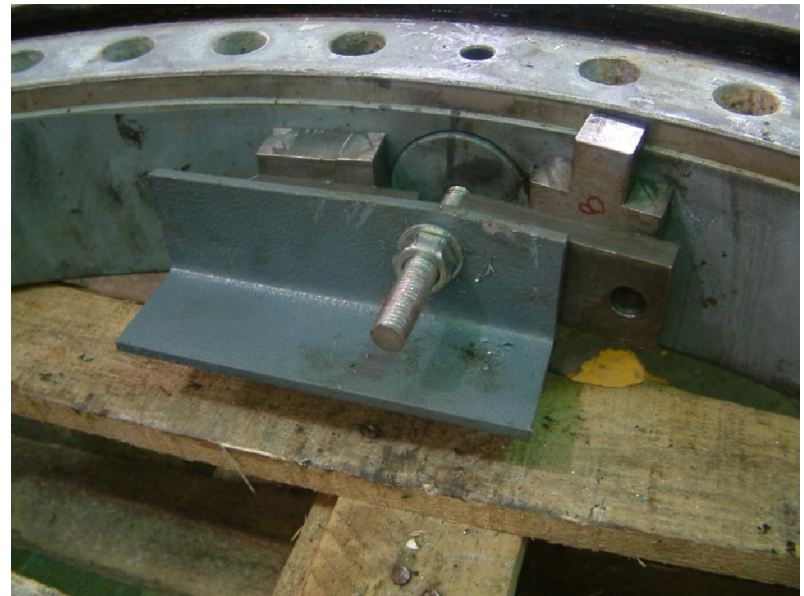
Dismantling & Inspection

- General external condition
- Gasket assessment & removal
- Water ingress assessment
- Filler plug removal
- Ball bearing removal & conditioning
- Sectioning
- Raceway and cage assessment
 - Outer and inner ring
- Grease assessment
 - General condition
 - Elemental analysis

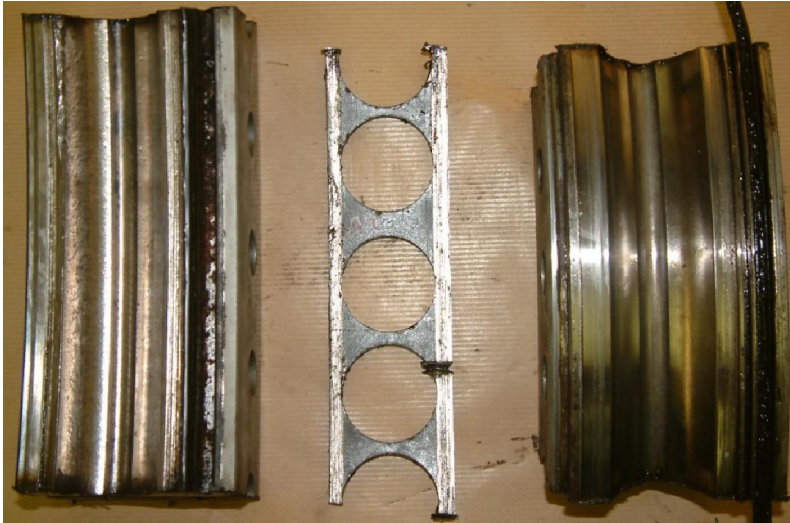
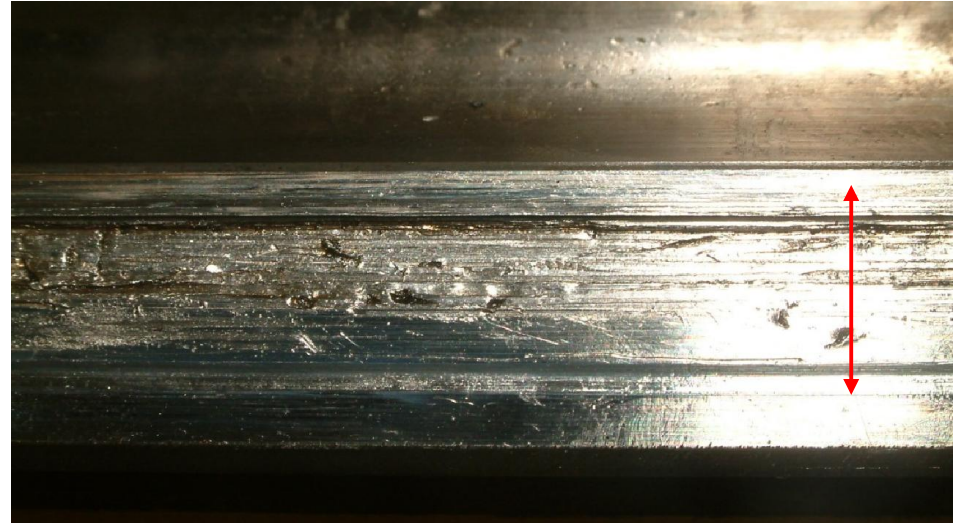
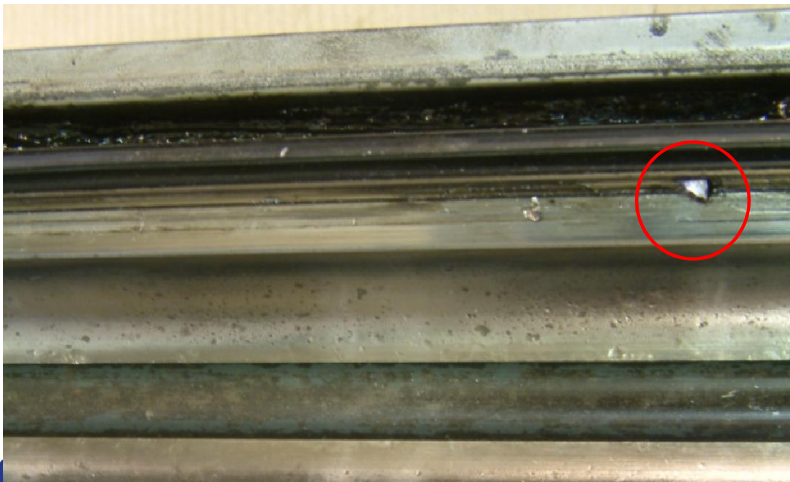
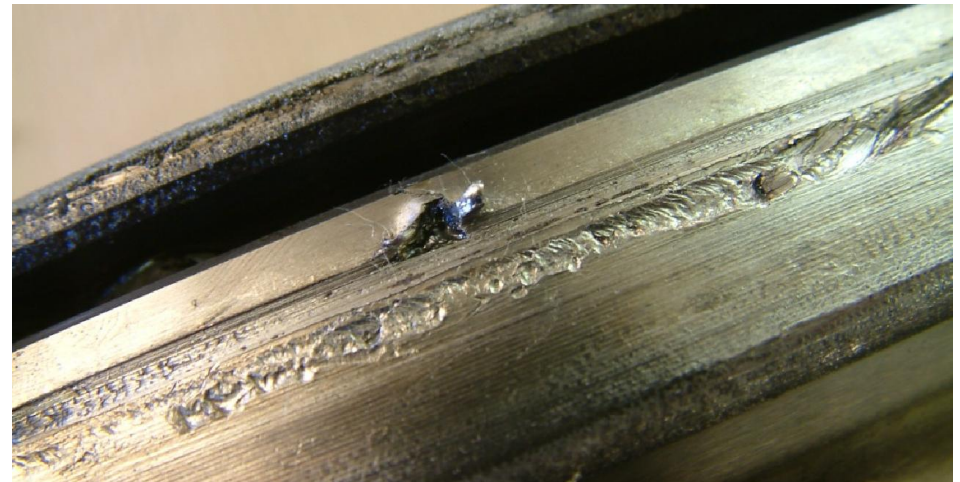
Cage running surface

- Good external and gasket condition
- Evidence of water ingress – rusting
 - Weather protection not in place
- Reasonable grease condition – small amounts of metal particulate
 - Suggests grease has been changes recently
- Cage and running edge wear – severe scoring and material loss
 - Caused by sliding friction and material debris – inadequate lubrication and radical clearance
- Severe raceway degradation & breakup
 - Indentation damage caused by material debris/inadequate lubrication
 - No significant degradation around ‘soft’ spot region 0 indicating failure was not due to the surface hardening or installation processes
 - Evidence of false brinelling – bearing vibration has occurred, could be secondary due to spawling and raceway breakup
- Route cause
 - Poor/inadequate lubrication or inadequate maintenance policy

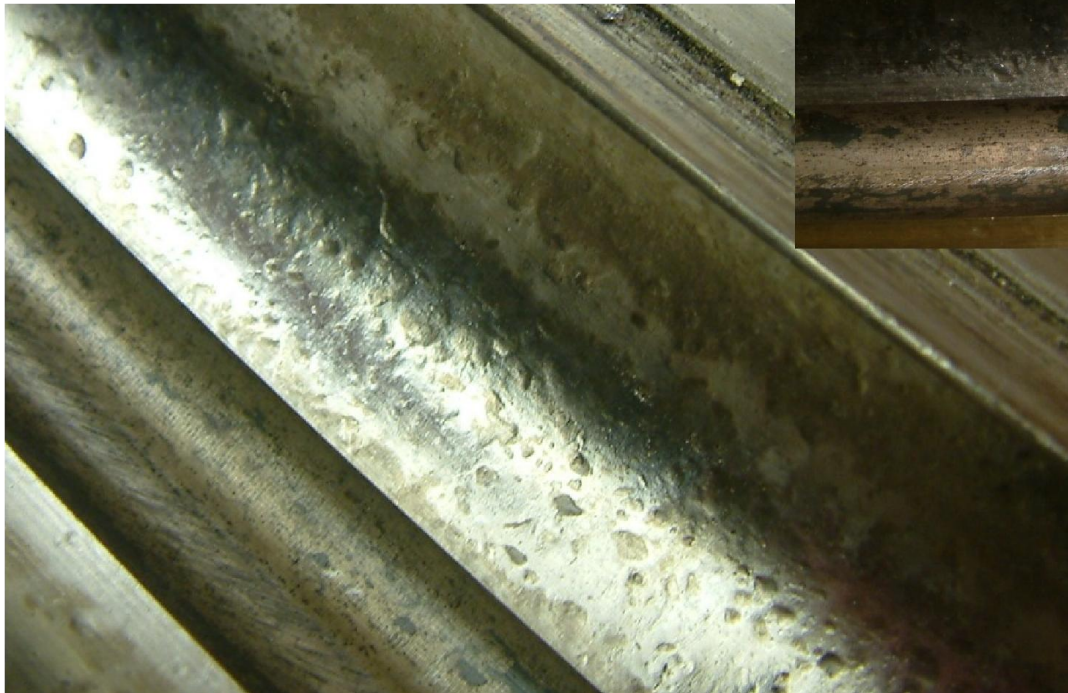
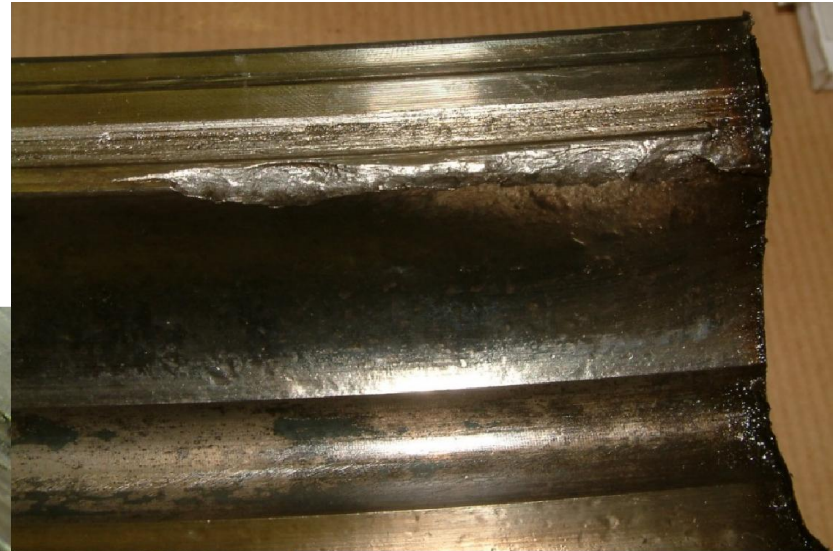
Dismantling & Inspection

- Indentations – Material debris from cage/running surface
- Spawling of the raceway and raceway breakup

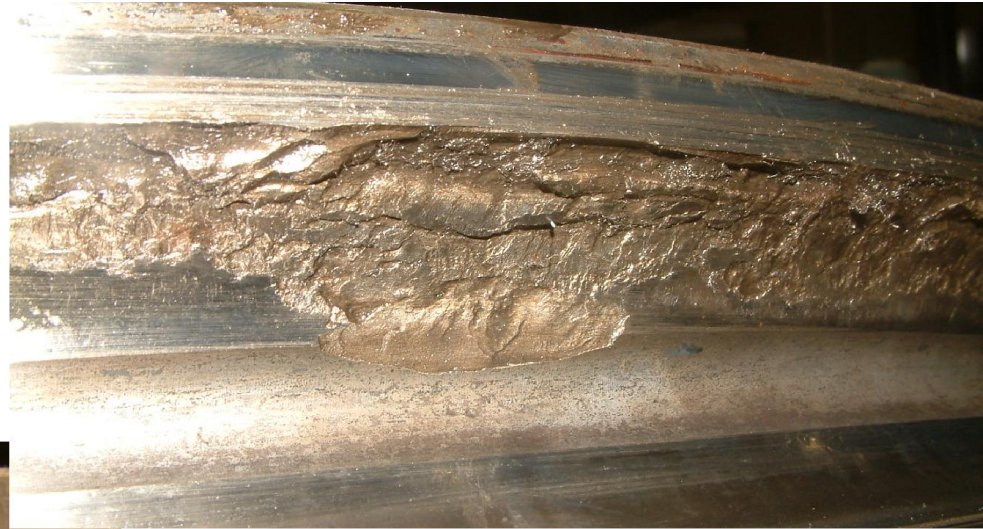
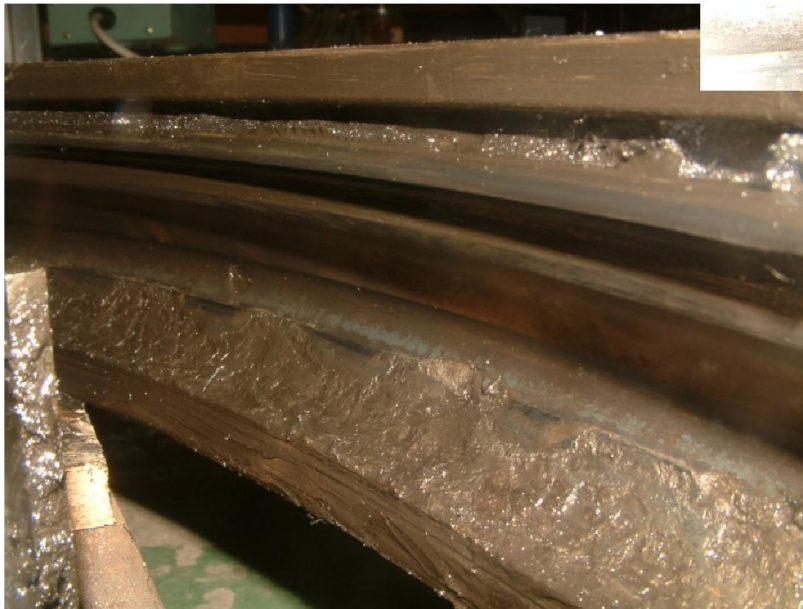
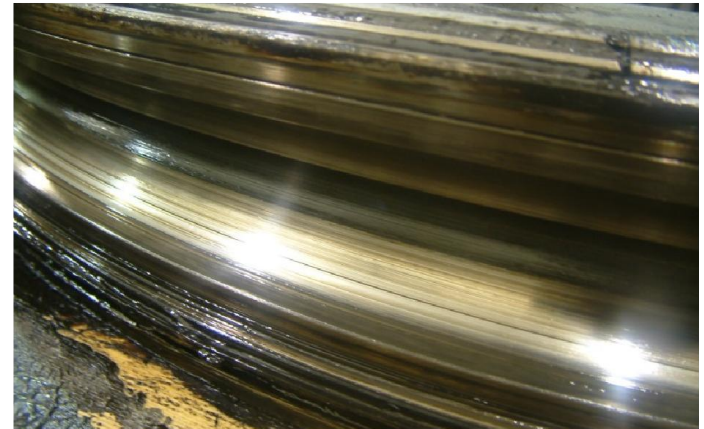
Raceway degradation

- Rolling contact fatigue
 - Material indentations
 - Lack of/poor lubrication
 - Sliding motion of ball bearings

- Maintenance – grease sample, metallic particulate analysis
- Permanent online monitoring
- Vibration detection
- Torque, lubrication quality & temperature detection
- Automatic grease systems

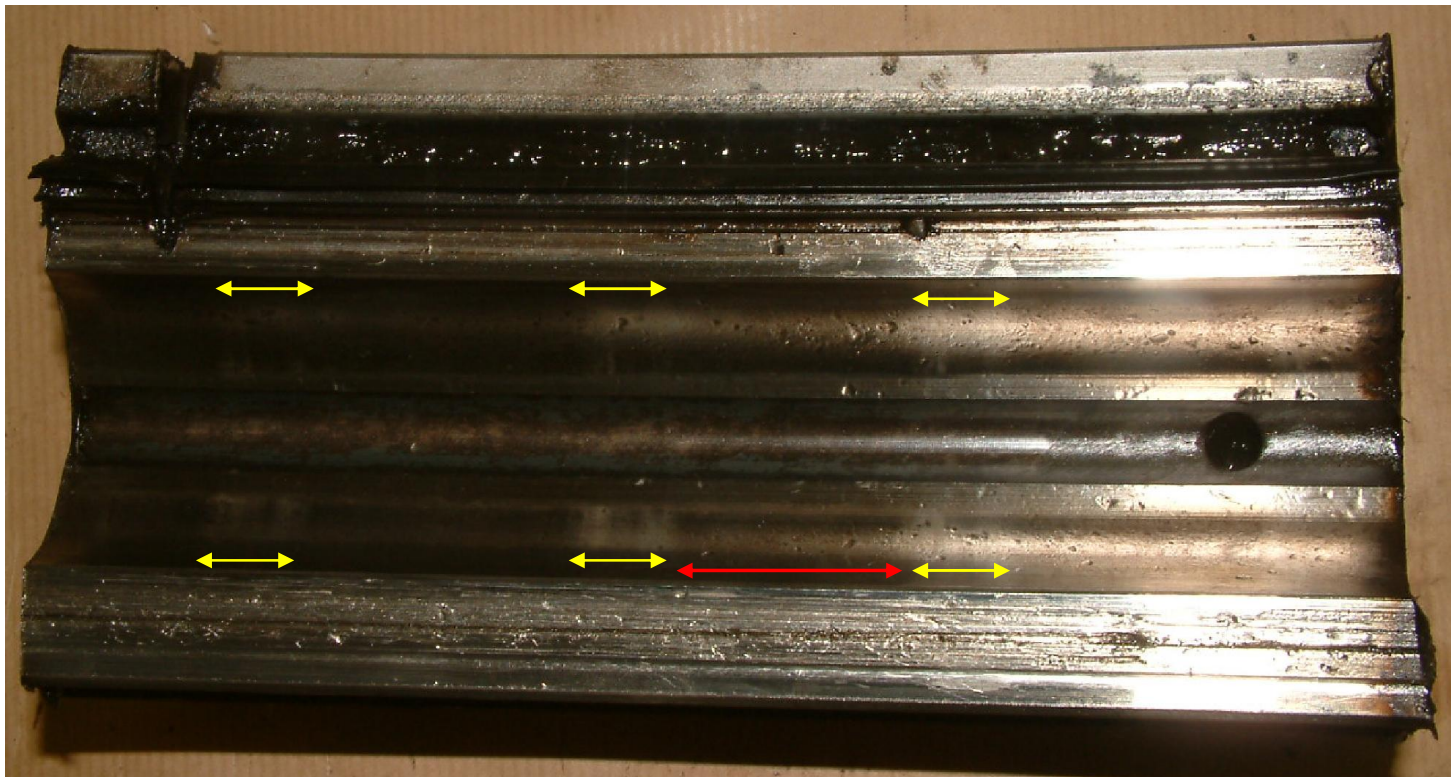
Raceway degradation

- Low level vibration corrosion – False brinelling
 - Caused by micro movements under cyclic vibration
 - No significant wear or corrosion present

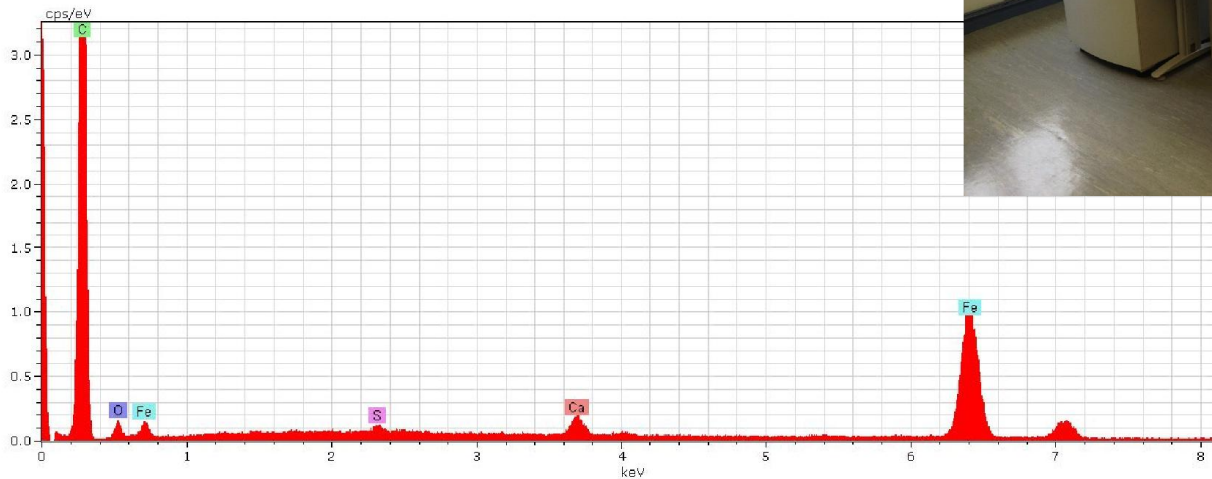
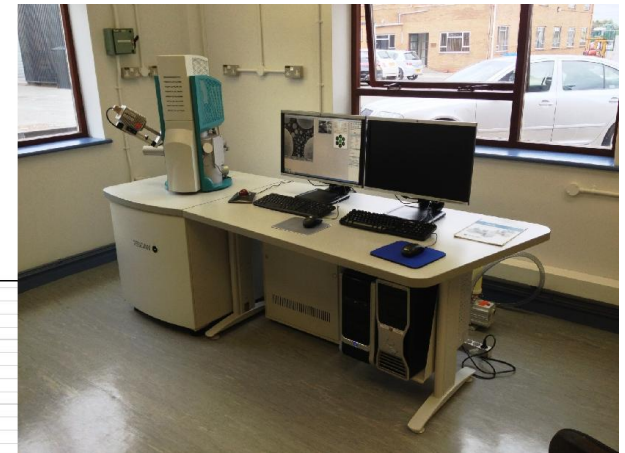
Grease assessment

- Reasonable condition
 - Dark, fluid, slightly thickened suggesting aging
 - Some but not significant levels of material debris
- Elemental analysis
 - Iron (Fe) present
