So, You Have Found PD -What Next?

So, you have carried out an annual partial discharge (PD) survey of your HV plant and the readings suggest you have a problem, what next? That quickly becomes a matter of potential consequence and risk; but if you decide it is time to act, have you got all the available information on the actual location of the defect?

By Neil Davies of EA Technology Australia and Greg Linton of HV Diagnostic Services in New Zealand.

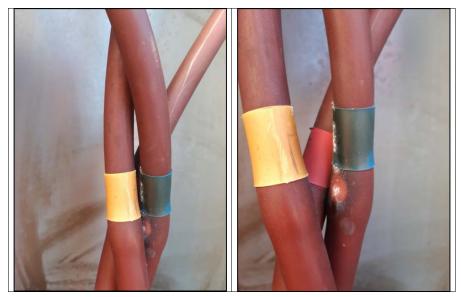
Figure 1 PD Detected on the cable box / cable of an RMU

One recent example found in New Zealand is shown in Figure 1 where a defect was found on an air insulated cable box of an aged Long & Crawford T4GF3 RMU using both TEV and ultrasonic techniques. The TEV measurement taken on the cable just below the cable box showed a high level of activity. The fact that this was coupled with high ultrasonic activity (although intermittent in nature) points to the source being inside that cable box.

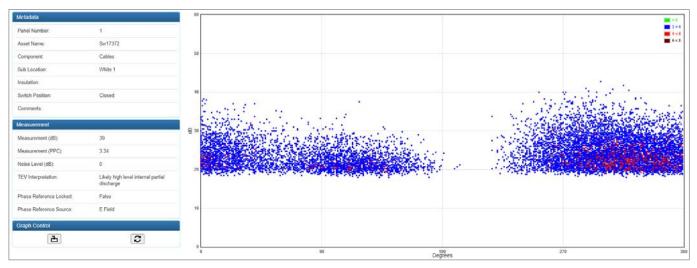
Figure 2 PD Activity caused by incorrect installation of cable termination

of opening the chamber and undertaking a thorough visual examination. Ultrasonic activity will always be occurring on the surface of insulation and unless it is at the very early stage of evolution will have left some visible evidence. In many cases the underlying cause, such as inadequate spacing is also obvious to trained and experienced personnel. It certainly was in this case (Figure 2).

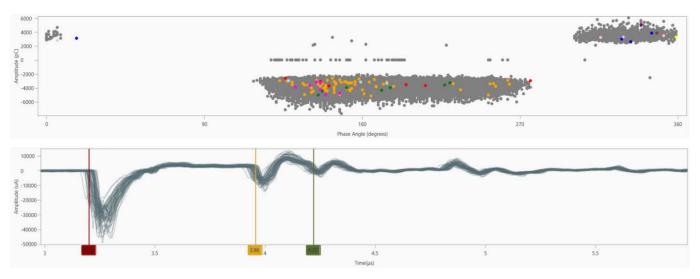
Figure 4 Cable PD activity captured using the CableData Collector

Therefore, the next technique we used was to capture signals on the earth sheath of the cable using an HFCT. This can also be done using an UltraTEV Plus² accessory, however in this instance we had the more sophisticated CableData Collector available at site. The captured PRPD and waveform plots are shown in Figure 4 and they indicated that the PD source was at a position of approximately 20m from the kiosk, which looking at cable records tied in with a joint position.

So, in this instance focussing on the termination, or indeed the switchgear, would have been the wrong call. However, proactive replacement of the nearby joint in a planned manner will prevent a future unexpected outage, improve the performance of the network and save money.
