SF₆ in Tank Failure

ESR Recloser case study

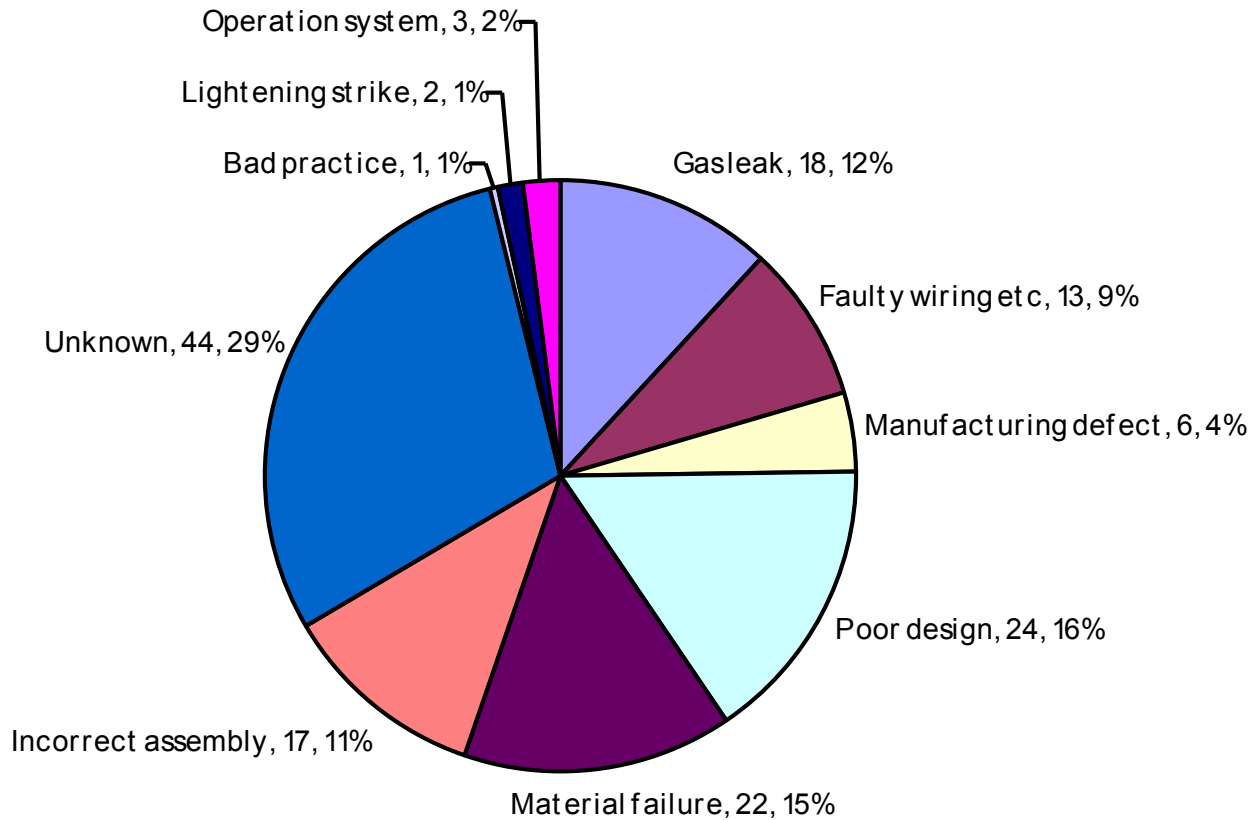
**Failure and Defects of SF6 Equipment upto July 2006
(150 incidents in total)**

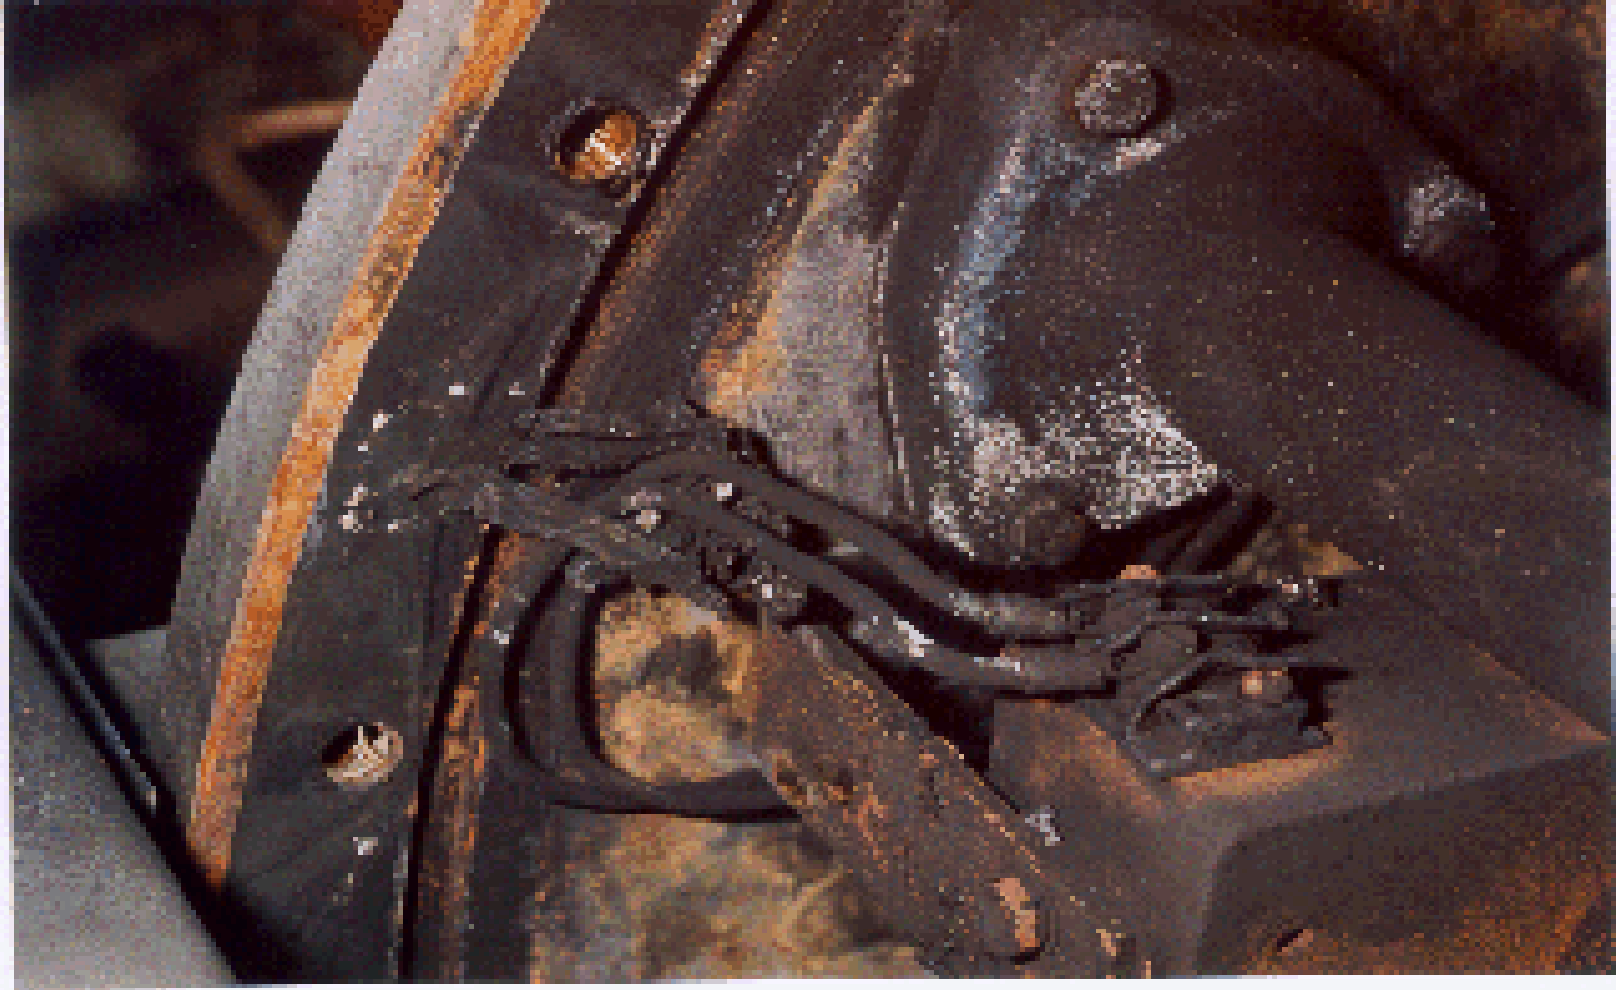
'O' Ring seal of ESR

- Cloth across gas seal (present since manufacture)
- In correct seating of the 'O' ring
- Long term degradation of the rubber 'O' ring
- Reduction of SF6 gas and breathing in of air and moisture reduced the dielectric properties of the gas
- Arcing initiated from the bottom of the fixed contacts (phase voltage) to the bottom of the tank (earth)
- Further secondary arcing was initiated until the protection acted

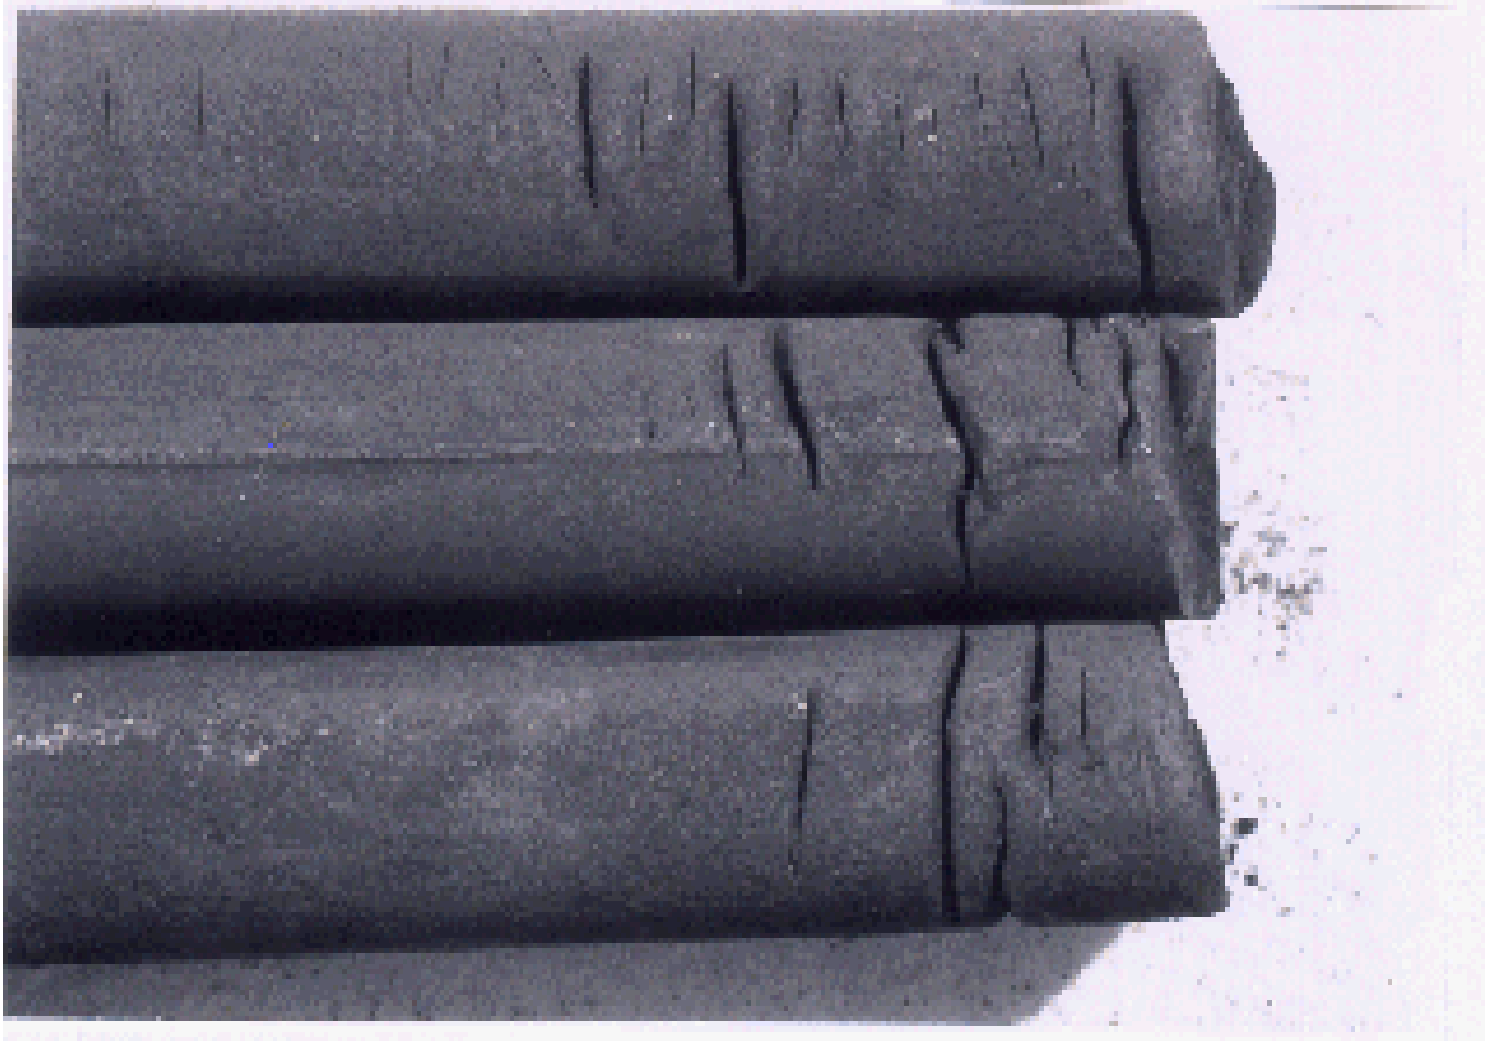
Perished 'O' Ring

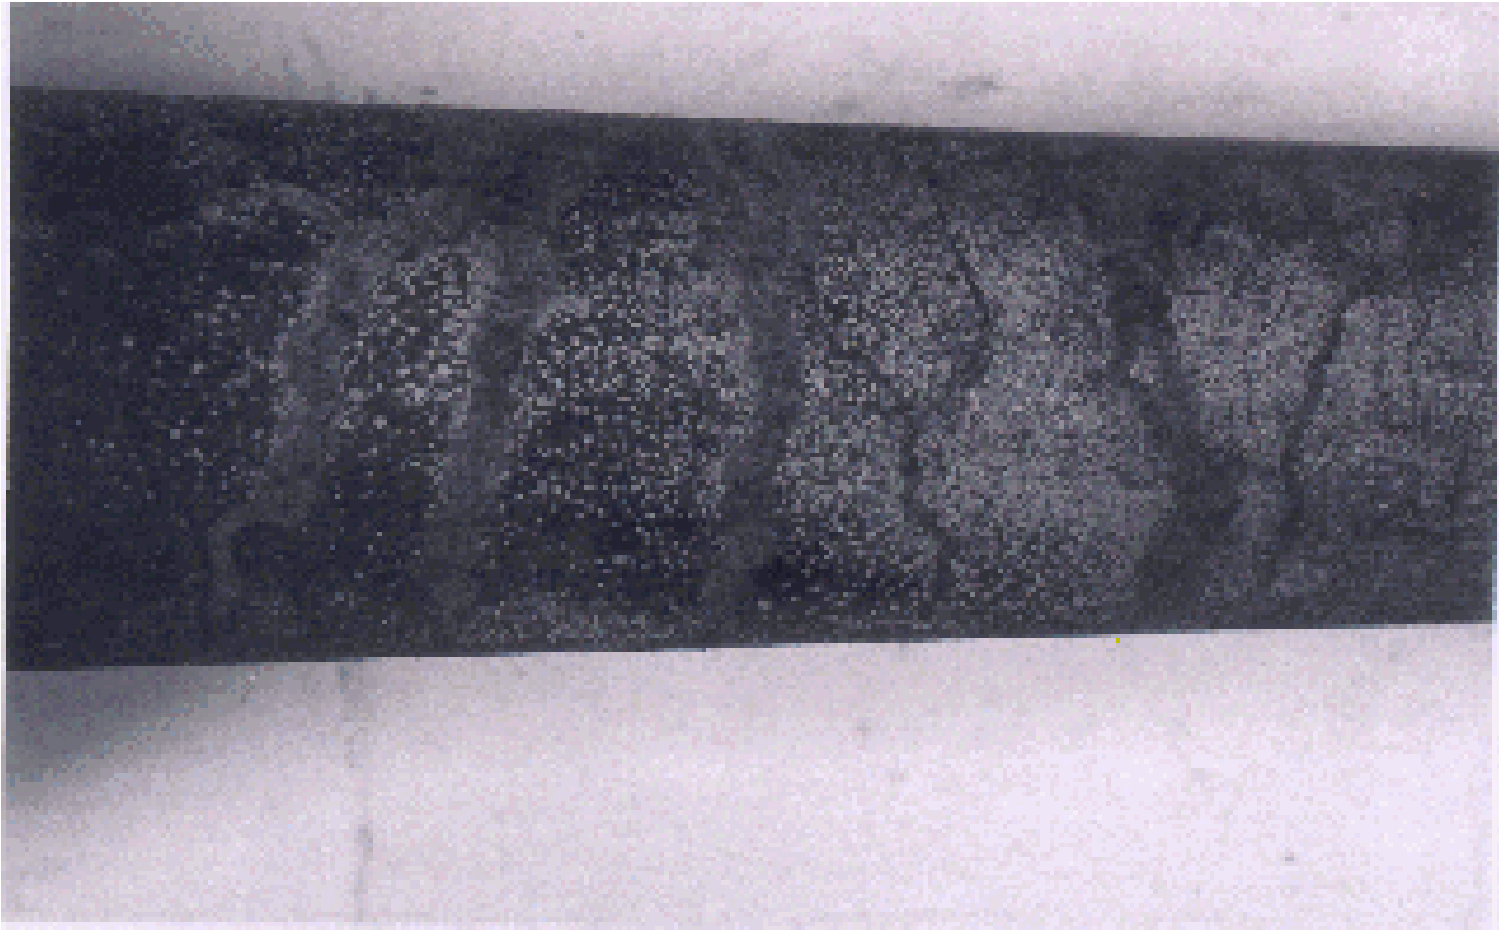
Tracking of Epoxy Bushing

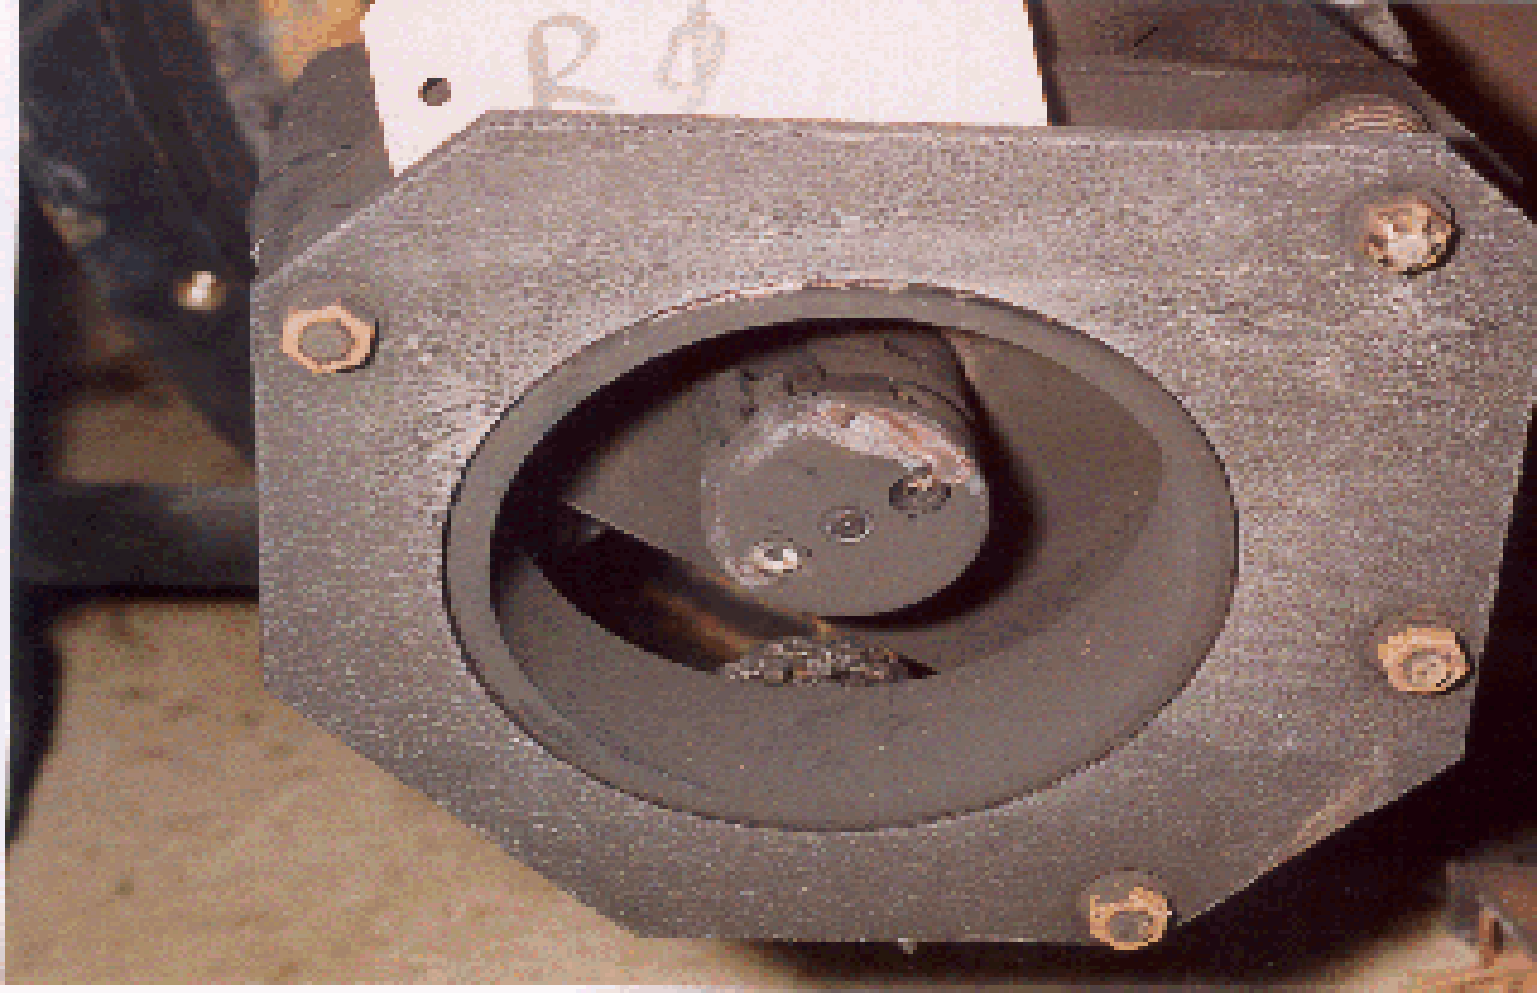
Arcing of Components
