## PARTIAL DISCHARGE ASSESSMENT WITH ULTRASOUND AND TEV (TRANSIENT EARTH VOLTAGE) IN MEDIUM VOLTAGE SUBSTATION FOR POWER DISTRIBUTION SYSTEMS RELIABILITY OF 18<sup>TH</sup> ASIAN GAMES 2018

### ABSTRACT

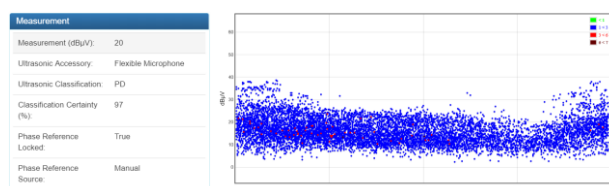
Fig.2. Ultrasound PD in Kasti Feeder

In Fig. 2, there were partial discharge findings using the ultrasound method in Kasti Feeder, Ketapang Substation. An indication of partial discharge was found on the cable box. The sound was identified as a crackling sound in the headphones. As shown in the instrument, partial discharge was measured on 20 dB $\mu$ V, which indicates that the equipment lies behind was critically severed by partial discharge. Thus, it needs immediate investigation (open access panel is required).

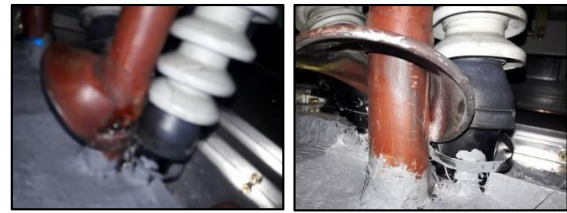
Fig.3. Investigation in Kasti Feeder, main-spare jumper cable conditions

In Fig. 3, after further investigation, partial discharge findings were localized in the wounds on the main-spare jumper cable. The cable was repaired in accordance with proper maintenance standard and indication partial discharge was decreased.

Specific in the case of assessment using the ultrasonic wave method (Kasti Feeder and Canda Feeder cases), the source of partial discharge was derived from chaffing in the cable terminations. Having examined works performed at the cubicle, it was concluded that these defects can be traced back in commissioning phase. Limited by a commissioning deadline, the maintenance team was decided to install the cable without proper maintenance standard. Thus, making the deterioration process faster. Lesson learned from the failure and indication of partial discharge is the initial installation stage of the cubicles is a stage that requires good planning and execution so that the installed material can be in accordance with applicable standards and does not cause potential harm in the future.

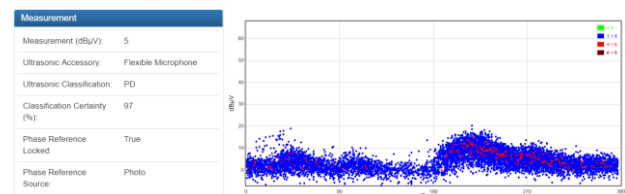
Fig.4. Ultrasound PD in Canda Feeder

Another partial discharge case was detected with ultrasound detection method in the cable box of Canda Feeder, Kemayoran Substation. Figure 4 shows that the classification shown on the measuring instrument has indicated partial discharge with a measurement value of 5 dB $\mu$ V. Even though the value is still relatively small, it is necessary to check further on the cable box.

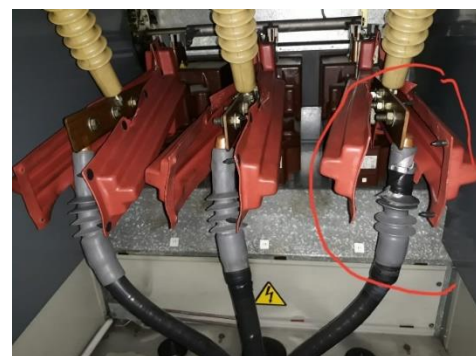
Fig.5. Crack in Indoor Cable Terminations Canda Feeder

After inspection, a crack was found in the indoor cable terminations, as shown in figure 5. A replacement was then deemed necessary.

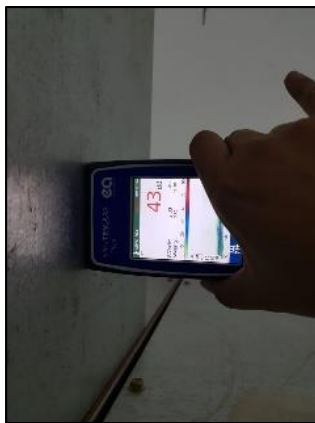
Fig.7. PD Assessment with TEV

As for internal discharge activity, it is characterized by the propagation of electromagnetic waves from internal discharge. When this electromagnetic wave hit the outer surface of equipment (such as cubicle case, or any other equipment enclosure), it will produce a substantial amount of Transient Earth Voltage (TEV). In Fig. 7, in the method of using TEV in SN38 which supplies electricity to Gelora Bung Karno Stadium.

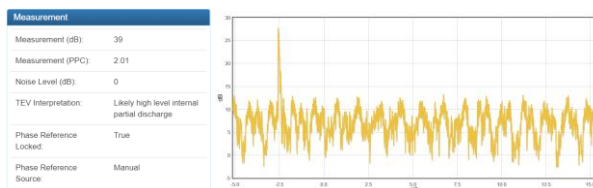
Fig.8. TEV in SN38

The causes of partial discharge with TEV is difficult to be determined because it is often regarded as “hidden failure”. In Fig. 8, the waveforms indicates that there is an indication of TEV on the cubicle. This method only gives suggestions for parts that have a high measurement of TEV but it cannot determine the details of damage caused by the internal discharge. Nevertheless, the TEV method can provide early warning for the next step.

As for assessment using the TEV method, our concerns are on the selection of equipment used in the cubicle, such as the quality of the current transformer, voltage transformer, busbar, and circuit breaker. It must be ensured that it is always in accordance with the engineering standard.

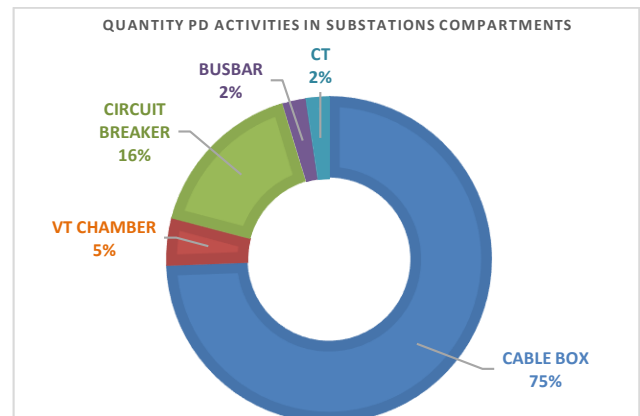
Fig.9. Quantity PD Activities in Substations Compartments

Figure 9 shows that partial discharge activity most occurs in the cable box. The main cause of the partial discharge at the cable box is due to improper procedure during the cable installation process. In addition, it is also suspected that postponed scheduled maintenance can further deteriorate.
