Understanding failures with Power ForensicsTM

By Anne McIntosh, Director of HV5-9s at EA Technology

Power Forensics™ Case Studies

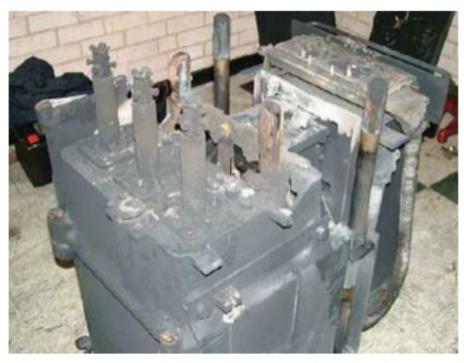
A failed oil filled circuit breaker, shipped to our laboratories for investigation

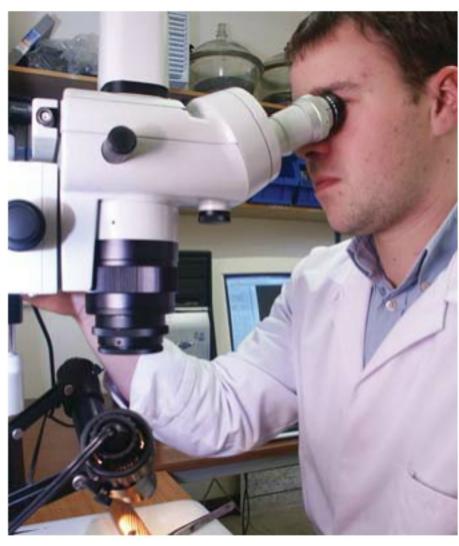
Optical microscopy

Low-powered optical microscopes are used to examine the condition of samples, while higher-powered microscopy with magnification up to x1250 is used in conjunction with image analysers to identify such things as the presence of material defects, impurities, degradation, inappropriate selection of materials, poor quality control and errors in the manufacturing processes used.

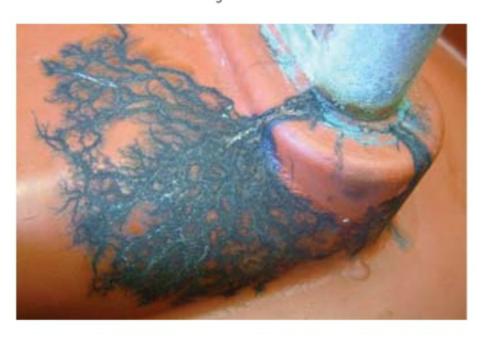
PD activity on a cast resin monobloc, caused by a poor substation environment

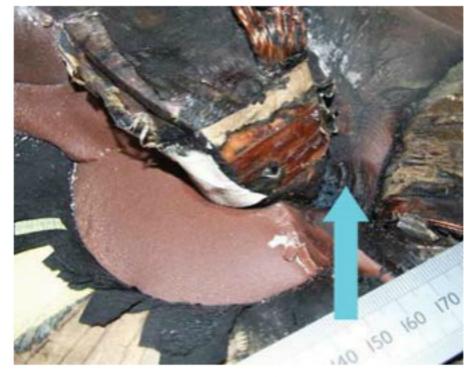
Foreign body in failed CT winding

After carefully removing sections of the remaining resin from the CT, a foreign body was seen on the outside of the winding (see arrow below).

The foreign body was removed and examined under a microscope. It was wrapped in layers of the binding tape, apparently trapped there while the tape was being applied during manufacture. The foreign body was enclosed in an air pocket forming a void in the insulation, resulting in partial discharge causing erosion of the surrounding insulation and a build up of heat, leading to catastrophic failure of the insulation.

Three other intact CTs from the same location were also destructively examined: one showed early onset of corrosion in a similar location, also putting it at high risk of partial discharge failure. It was therefore recommended that partial discharge monitoring be implemented to provide early warning of impending failure. It was also recommended that CT replacement should be actively considered to reduce risk of failure in the longer term.
