WINTER 2019

NETA WORLD™

MEDIUM-VOLTAGE ASSET FAILURE INVESTIGATIONS

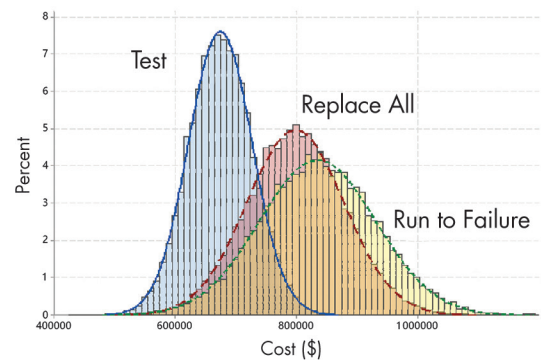
Figure 1: Cost Option Comparison

Since cables are often sealed systems, continual assessment is difficult, and failures often occur without warning or preparation. Figure 1, provided by the National Electric Energy Testing Research, and Applications Center (NEETRAC), compares the costs of testing equipment, replacing all equipment regularly, and running equipment to failure. Each cost is shown as a standard distribution to represent the uncertainty associated with failure costs. It is evident that the costs of testing are significantly lower and have less uncertainty than the costs associated with running equipment to failure or wholesale replacement prior to failure.

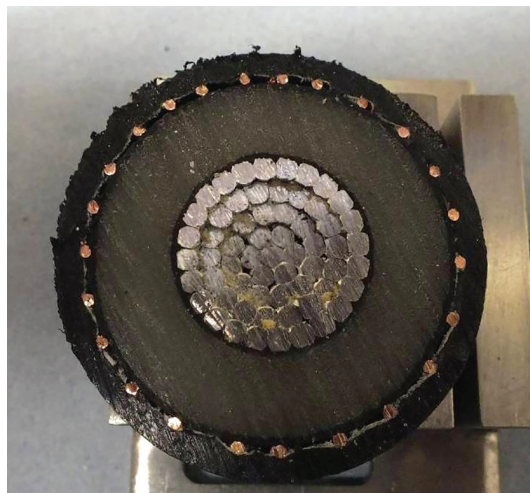
Figure 2: *XLPE Insulation*

The next step is the analytical investigation. The details vary based on insulation type, but in general the analytical investigation dives deeply into suspected issues and determines the severity of underlying issues. For XLPE (Figure 2), the sample is boiled in oil of cloves

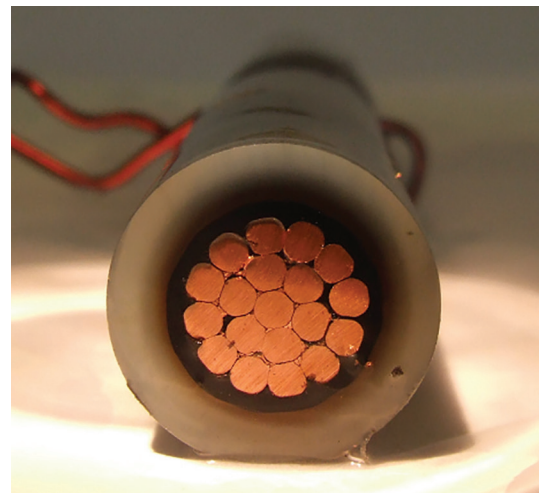
Figure 3: *XLPE Insulation Made Transparent*

to make it transparent (Figure 3). This allows the researchers to microscopically examine thin sections of insulation to visualize any inclusion and ambers from the manufacturing process. Inclusions come from foreign matter lodged in the insulation during the extrusion process. Ambers are bits of insulation that weren't fully converted to the final material. Both can affect the dielectric constant of the insulation, but foreign materials have a more negative effect on insulation quality. Having the insulation transparent also makes it possible to see developing water trees in the insulation. These could have contributed to the fault or could indicate underlying issues based on size and location. For paper oil-insulated cables, the analytical investigation looks into the many mechanical factors that can lead to cable failure. This is done by unraveling the paper and looking for two major things:

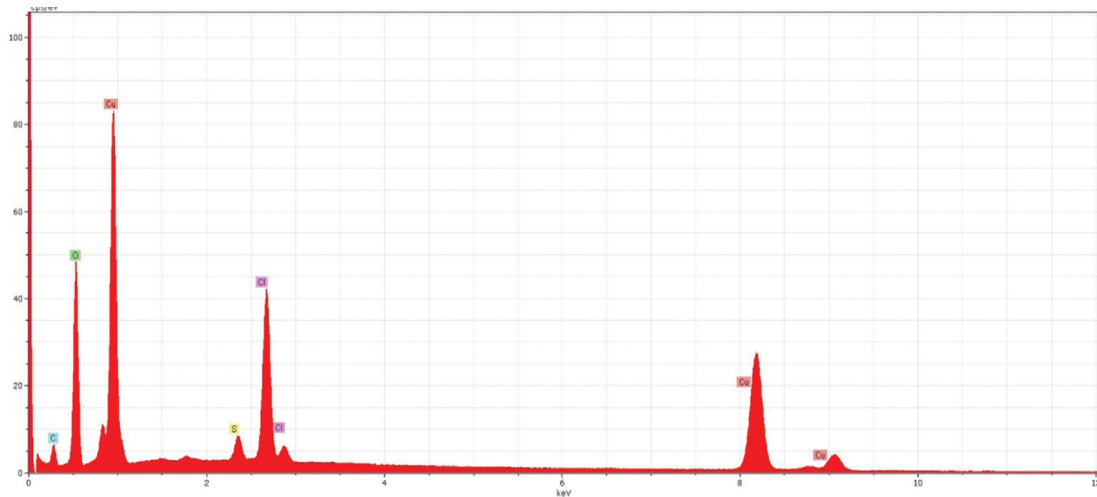
Figure 4: *Scanning Electron Microscope-Based Elemental Spectroscopy*

- Scanning electron microscopy (Figure 4) performs elemental analysis on inclusions to identify foreign compounds. This can be used to compare the materials in the inclusion to the bulk insulation and possibly determine the impacts the inclusion would have on dielectric constants.
- Scanning differential calorimetry can determine the maximum temperature reached by the component prior to failure. This is important information to determine whether the component was used in the wrong application and whether overheating contributed to fault.
- Mechanical tests of cable components can determine material characteristics that indicate whether a component was appropriate for the application it was used in. This is commonly done for components expected to perform

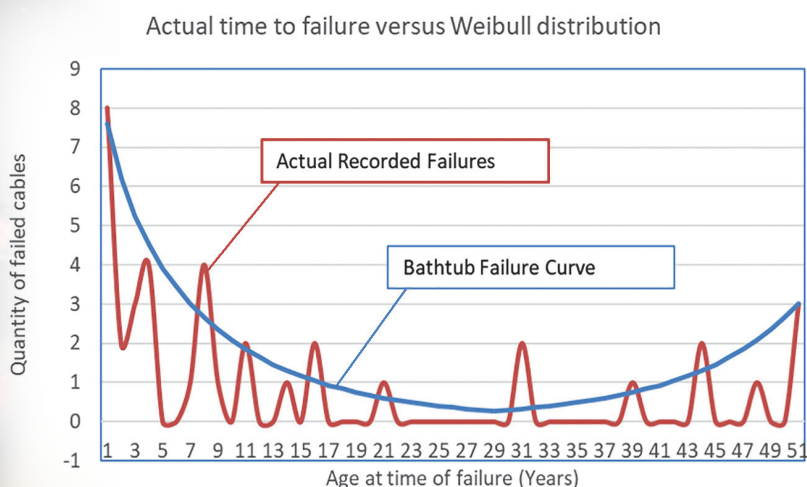
Figure 5: Time to Failure

The first metric analyzed was the age of the cable when the failure occurred. It was found that failure occurrence matched the Weibull distribution — the bathtub curve pattern shown in Figure 5. Failures can be classified into three main categories:

- Infant mortality failures make up the largest segment of the graph and last for approximately 10 years after installation.
- Random failures occur for the next 30 years or so. These are intermittent and generally uncorrelated.
- At around 40 years after installation, end of life failures begin to occur.

End of life failures are generally only prevented by replacement, while infant mortality and random failures can be prevented by looking deeply into the causes and responding appropriately.

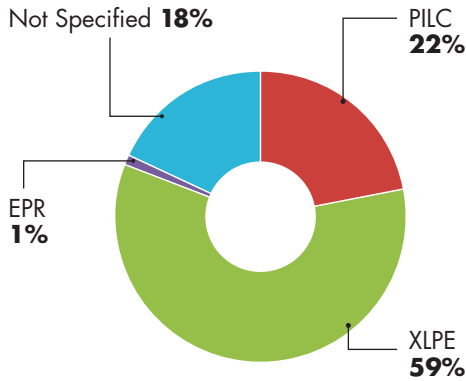
Figure 6: Failure Rate by Insulation Type

Next, the report samplings were analyzed across insulation type and fault type (Figure 6). Based on “Historical Overview of Medium- and High-Voltage Cables,” written by the Georgia Tech NEETRAC group, XLPE and PILC cables show a similar ratio of failures per mile of installed cable. The ratio of failures per mile was developed using the data about EPR usage compared to XLPE usage provided by NEETRAC. Comparing NEETRAC’s

average percentages per insulation type versus this study’s average percentages of failures per insulation type takes into account that EPR is less commonly used than XLPE. This factor may have swayed the data to make EPR look dramatically more reliable than XLPE. While the numbers presented are backed by the various reports referenced, the difference in field failure rates for insulation types is unlikely to be as great as this specific study implies due to external factors not accounted for in this analysis.

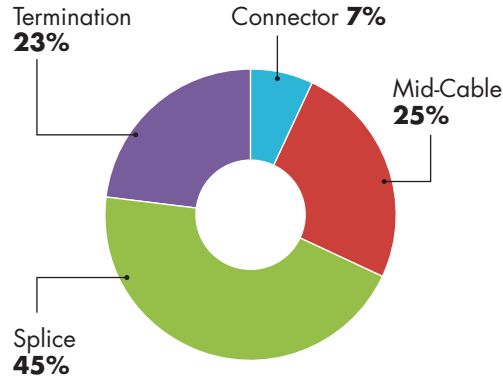
Figure 7: Fault Location

Next, we analyzed where the failures occurred (Figure 7). Based on the fault locations seen in the report sampling, 68% of failures occur in places where technicians are working on cables in the field versus 25% of failures mid-cable where technicians likely have had little interaction with the cable. Clearly, the act of working on the cable in the field can introduce failures. Explanations for the mid-span failures include mechanical damage before or during installation, incorrect application, manufacturing defects, or simply random failures without a clear reason.

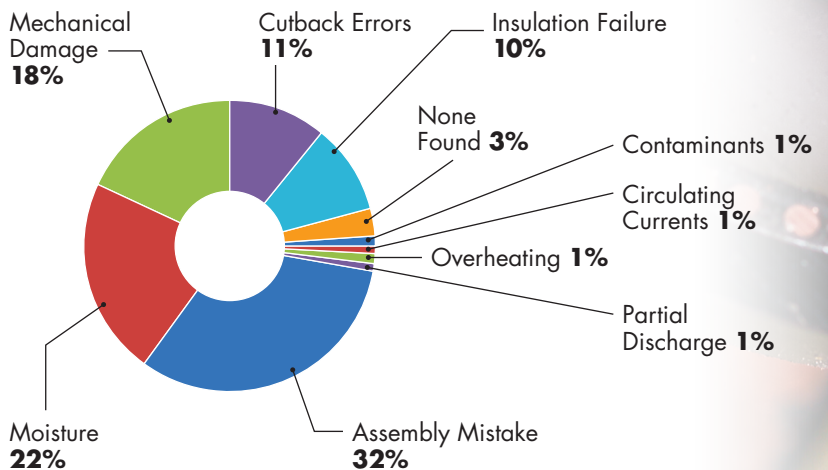
Figure 8: Proximate Causes of Failure

We next characterized and plotted the proximate causes of failure (Figure 8). Reviewing the proximate causes of failure revealed several interesting trends. Assembly mistakes cause 43% of failures commonly found. This indicates a lack of effective communication between manufacturers and

installers or in training of jointers. Another 40 percent is due to preventable damage to the cable, either from moisture or mechanical damage. Small percentages can be attributed to contaminants, circulating currents, and overheating.

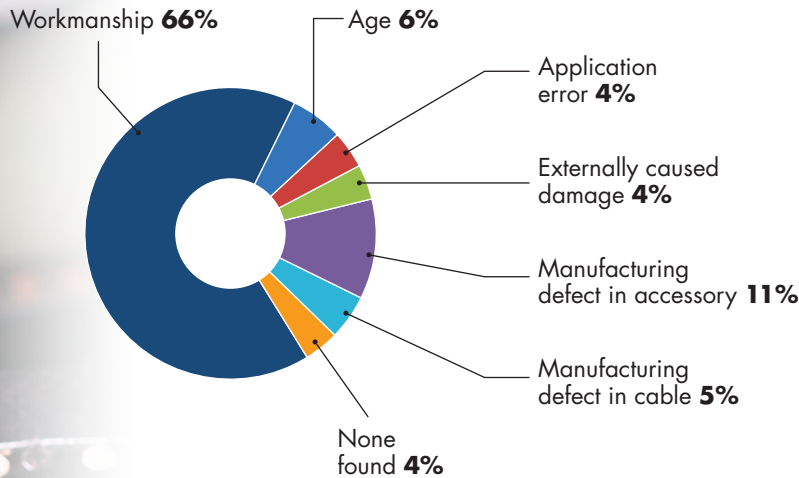
Figure 9: *Ultimate Causes of Failure*

What is missing from this picture is the detail of what is causing these failures. Proximate cause provides insight into what happened, but often lacks the complexity of the full reasoning behind a fault. Looking at the ultimate causes of the sampling (Figure 9), we see that the vast majority of faults can be attributed to workmanship errors. These include errors in jointing due to negligence or inexperience, as well as sloppy work and lack of care. Six percent of failures were due

to age, which is lower than expected based on the correlation to the Weibull distribution discussed earlier. Manufacturing defects presented about 11% of all ultimate causes, which is higher than expected. These range from contaminants in the insulation to violation of conductor spacing requirements in the brand new cables. In just 4% of cases, no ultimate cause was found, which suggests steps can be taken to address the vast majority of cable failures.

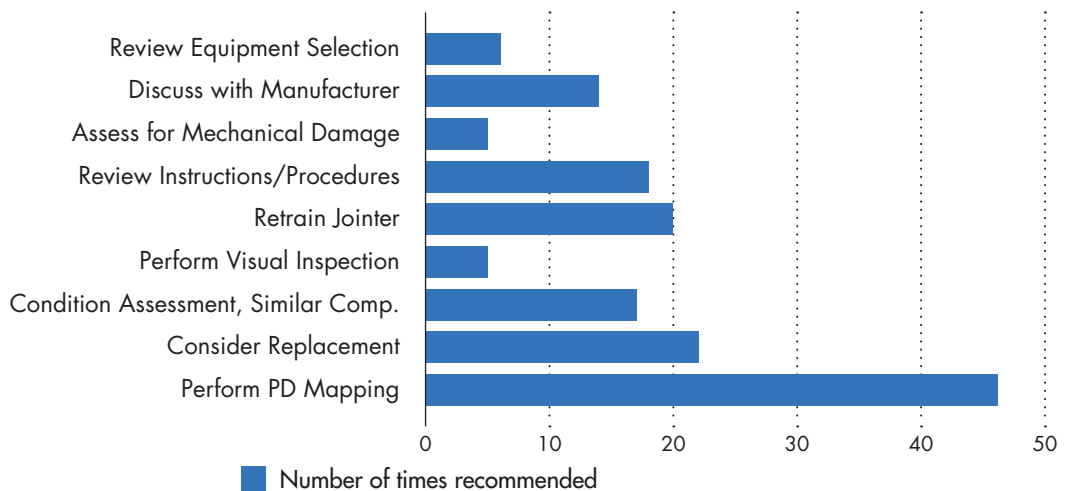
Figure 10: *Recommended Actions for Existing Equipment*

Based on the ultimate and proximal causes of failure, several standard recommendations would help prevent future failures (Figure 10). The most commonly recommended

action was to perform partial discharge mapping regularly. Partial discharge is cyclic breakdown of part of the insulation system due to a localized electric field greater than the dielectric withstand capability of that part, while the overall insulation system remains capable of withstanding the applied electric fields. Partial discharge, commonly found surrounding voids in the insulation, produces a variety of detectable byproducts such as heat, light, sound, scent, electromagnetic waves, and a high frequency electric current. Since the prevalence of partial discharge can indicate issues with insulation quality, routine partial discharge mapping can help clients plan for outages to address issues before they escalate. Cable partial discharge testing can provide data about how aging and conditions have affected installed cable and help prioritize replacement and repair.

Replacement is a commonly recommended action, yet it is regarded as only one of many options. The prevalence of partial discharge mapping and condition assessment recommendations suggests that proper asset management techniques can help prevent untimely replacement of working equipment by providing additional information about its operating condition. Discussing the fault with the manufacturer was also commonly recommended. By having clear and open

communication with the manufacturer, installation errors or application errors are less likely. Similarly, since 11% of faults occur because of manufacturing defects, it is important to have clear quality expectations for the manufacturer. Providing feedback on failed components can prevent future quality issues from costing the user so much long term. Visual inspection is relevant for some faults, but it is considered to be of a limited value since most problems are hidden. This reinforces the value of partial discharge mapping, which provides data about cable condition and longevity that cannot be gathered from visual inspection alone.

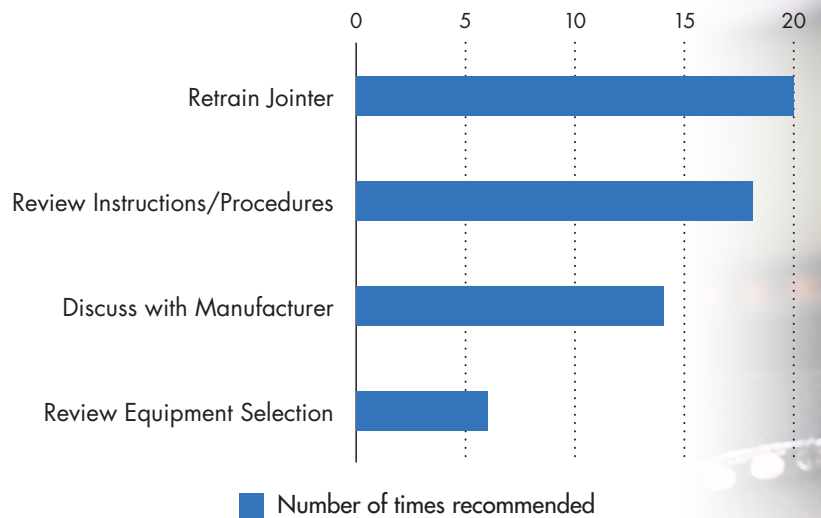
Figure 11: Recommended Actions for New Installations

Recommendations aimed at preventing failures in future installations (Figure 11) center around providing high-quality training for jointers and ensuring that instructions and procedures are clear and set the technician up for success. Well-trained jointers are key to having a reliable system because such a high percentage of faults can be traced to jointing issues. Talking to manufacturers throughout the process of a program upgrade can ensure instructions are being accurately followed. Finally, choosing the correct equipment for the application is frequently recommended since application errors caused about 4% of the failures from this sampling.

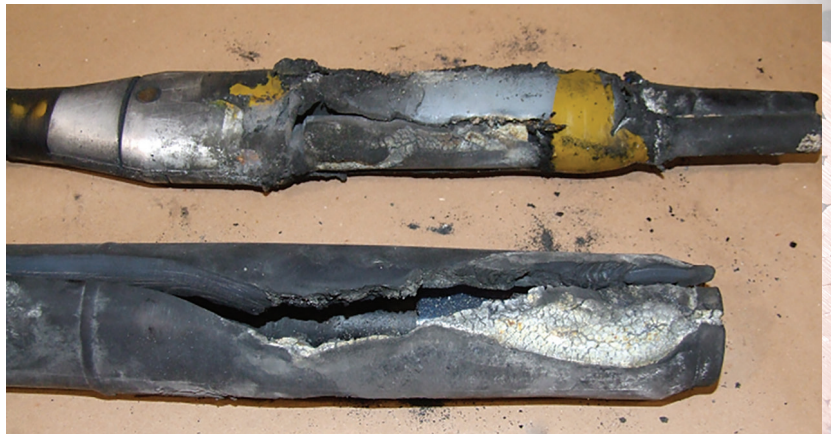
Figure 12: XLPE-PICAS Joint

The first example is an 11 KV PICAS to XLPE branch adapter that failed one hour after installation (Figure 12). The proximate cause was determined to be incorrect positioning of the adapter tubes. Therefore, workmanship errors were determined to be the ultimate cause of failure. Investigation found many quality issues: Shear bolts were misaligned, there was no putty in the shear bolts, the tubing was poorly cut, and there were gaps in the insulation throughout the sample. Common recommendations for these conclusions include retraining the jointers and assessing the components as a part of the project. This example highlights that finding and fixing the

proximate cause of the failure is not adequate. Several mistakes all could have led to failure had the first cause not been present. By addressing the ultimate cause of jointer training, all of the workmanship issues and potential failure points would be addressed.

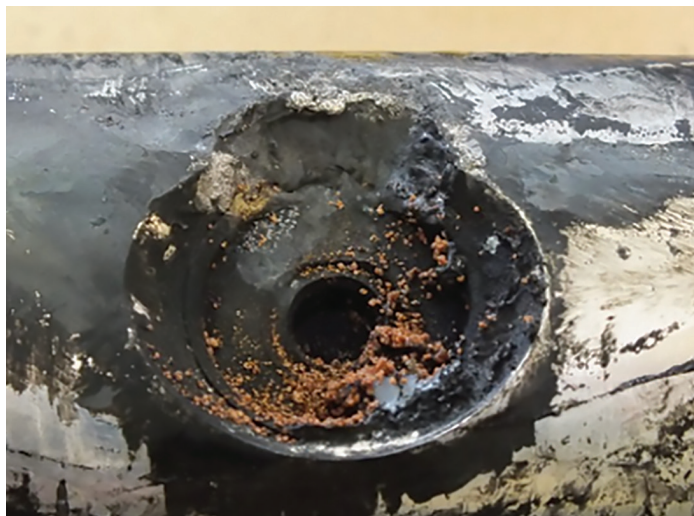
Figure 13: Failure Location on 33KV XLPE Joint

The next example explored a 33KV XLPE joint that failed after 18 months in service. The fault hole is visible through the insulation in Figure 13. The failure occurred because the jointer did not properly deburr a connector. The sharp edge caused mechanical damage and created a concentration of electric fields in the damaged insulation. The takeaway: Poor understanding of instructions, lack of attention to detail, and lack of training all contributed to the failure of this joint.

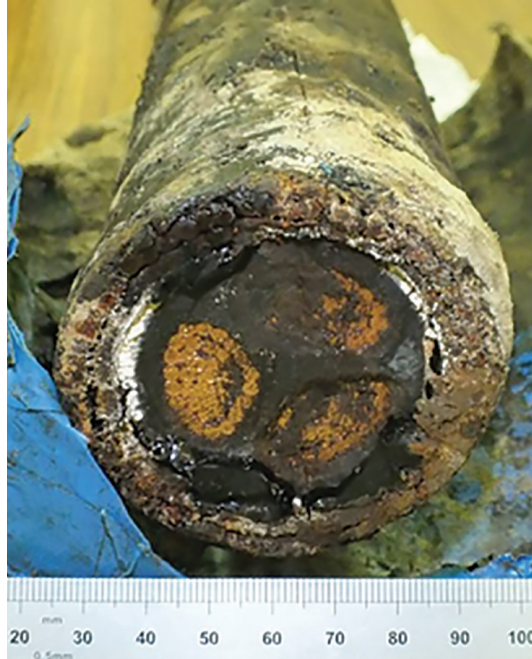
Figure 14: *Failed PILC Cable*

The final example explored an 11 KV PILC cable that experienced a mid-cable failure after 47 years of service (Figure 14). This failure is a result of age-related partial discharge. Although this cable was in service for an appropriate life span, it is an example of how partial discharge mapping could have prevented an unplanned failure. Catching the partial discharge earlier

would have allowed the client to plan an outage to address the issues.
