REPORT

PD Survey of 66kV Oil Circuit Breakers

Date: 8 March 2024

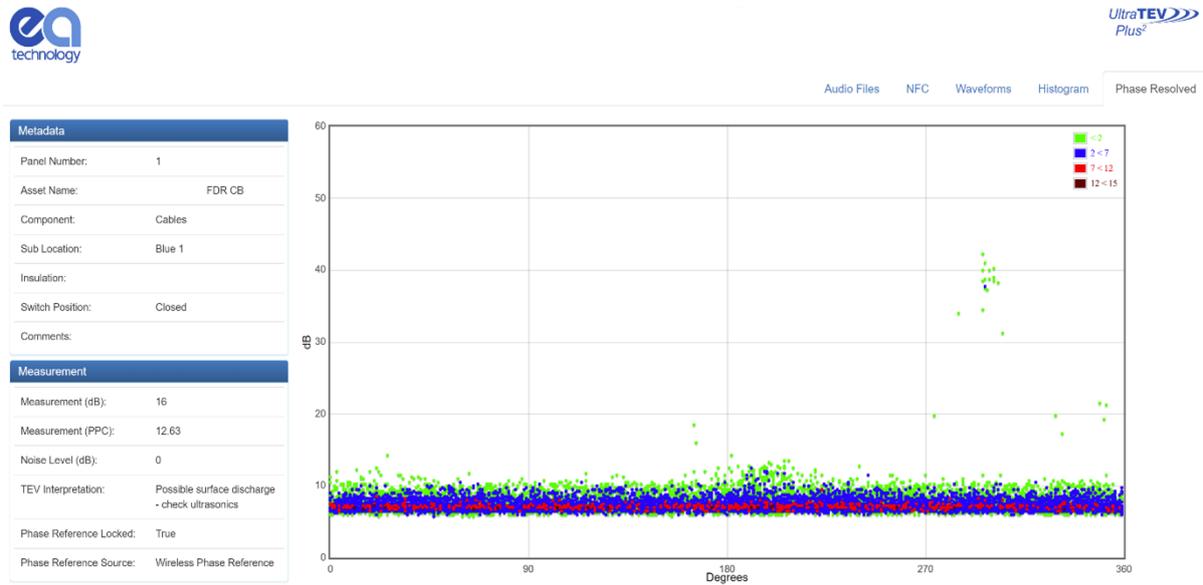
Figure 1 TEV PRPD Plot Blue phase of No. 1 FDR CB

TEV measurements were taken on the three individual phase tanks in turn (red, white and blue). A noise source that was not phase-resolved was seen on all tests and presented as a flat line at around the 10dB mark. This low level of interference provides comfort that any significant level of PD would be easily identifiable within the 66kV yard. A representative example of this is shown in Figure 1, taken on the Blue-phase tank of No. 1 FDR CB.

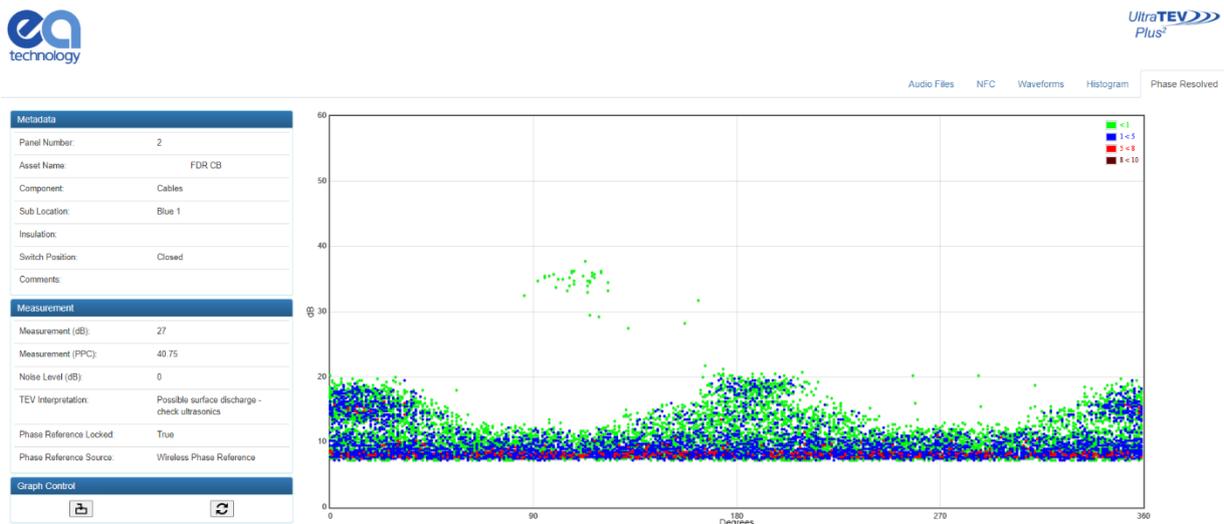
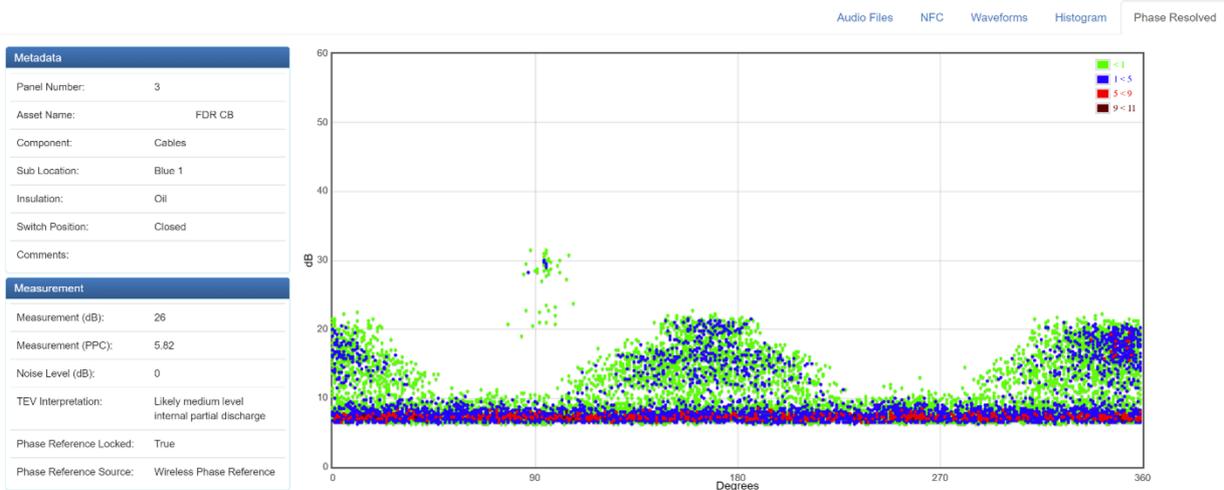
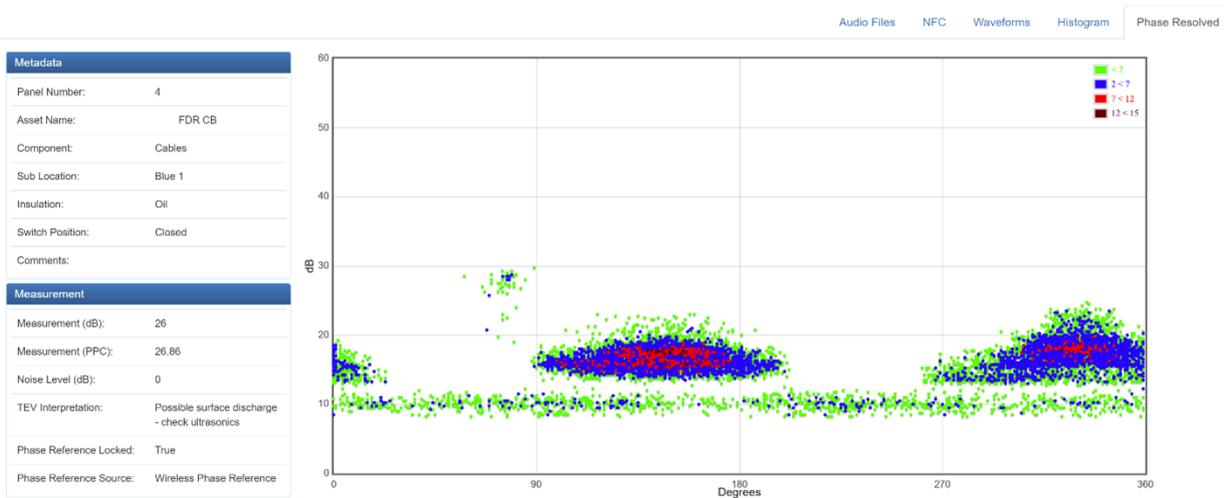
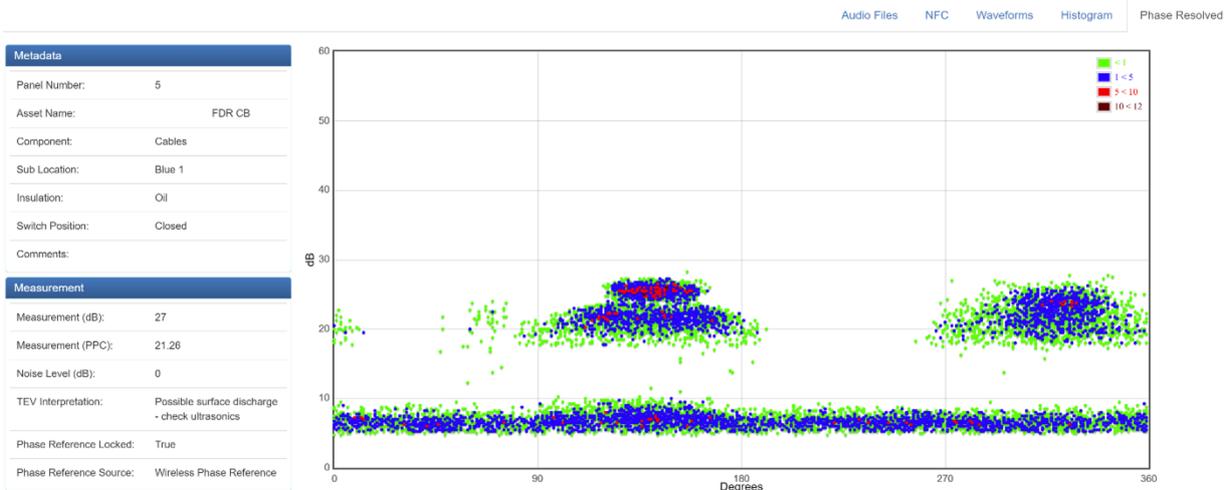
Moving progressively down the yard from OCB No. 1 FDR CB towards the second from end No. 6 FDR CB, TEV signals were seen to get progressively higher and were displaying a distinctive phase resolved pattern. Continuing to use the Blue-Phase as a representative sample, the plots in Figure 2 to Figure 6 show activity across the next 6 OCBs.

All the plots show single phase activity with similar characteristics and amplitudes getting progressively higher as it moves to DSH FDR CB.

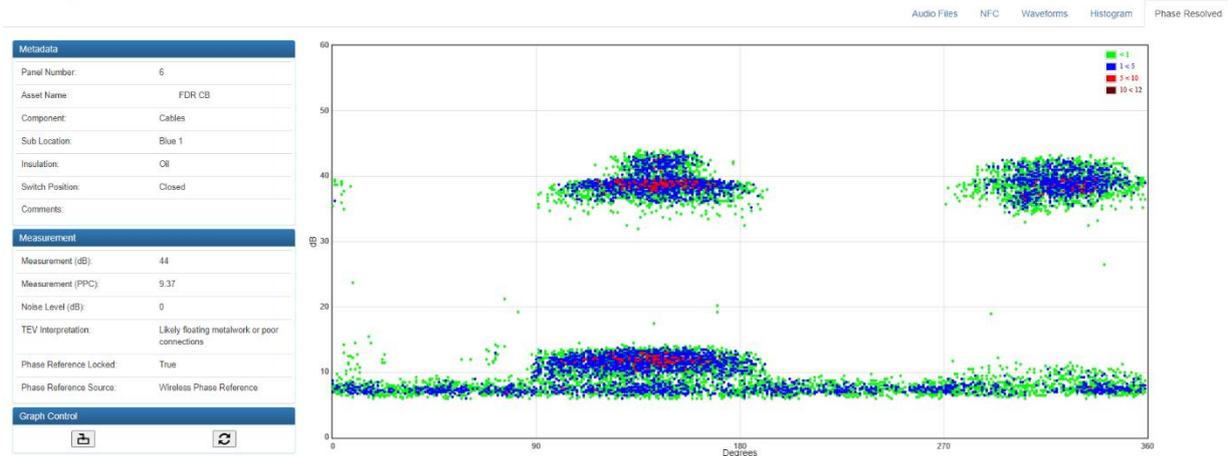
Figure 6 TEV PRPD Plot Blue Phase of No. 6 FDR CB

Now looking at the PRPD plot on the Blue phase of the final OCB in Figure 7, again a similar pattern is seen but this time with lower amplitude. This all points towards a source of activity associated with No.6 FDR CB.

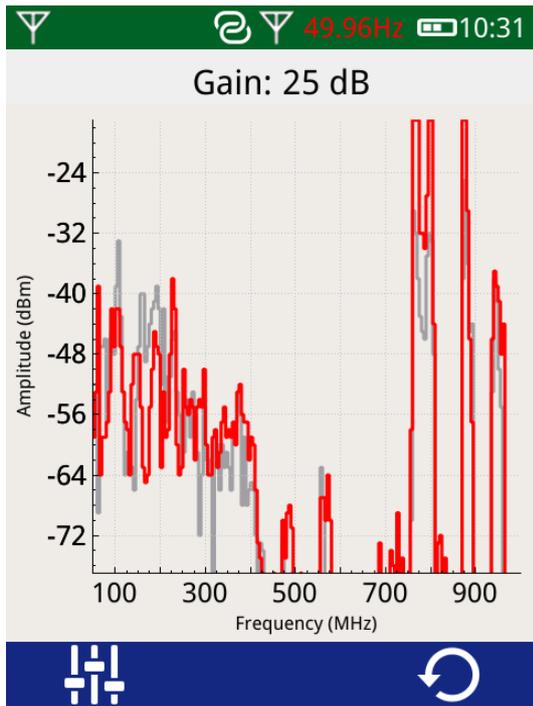
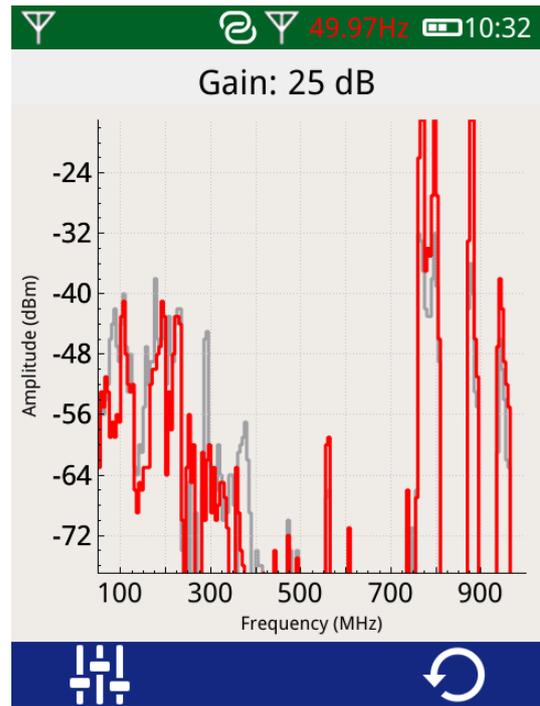
For the following circuit breakers no deviation of any note was seen between the background and asset sweeps:

- No. 1 FDR CB
- No. 2 FDR CB
- No. 3 FDR CB
- No. 4 FDR CB
- No. 5 FDR CB
- No. 7 FDR CB

Representative traces for two of the circuit breakers are shown in Figure 8 and Figure 9. In both traces, the background sweep is the grey line and the asset sweep the red line.

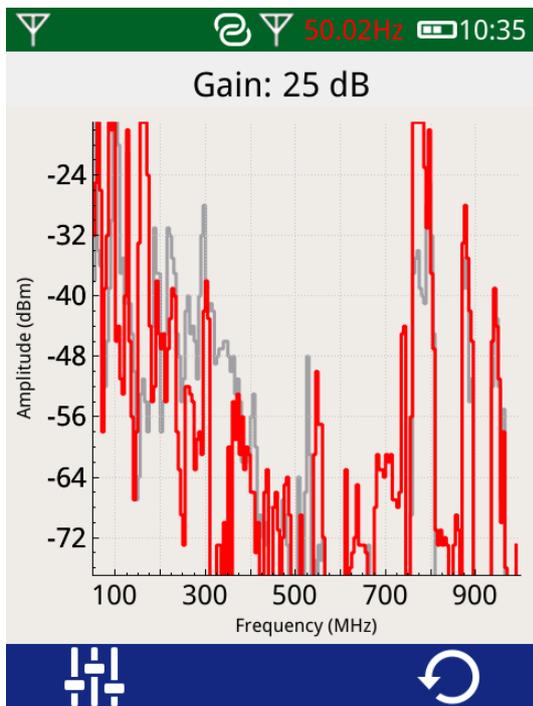
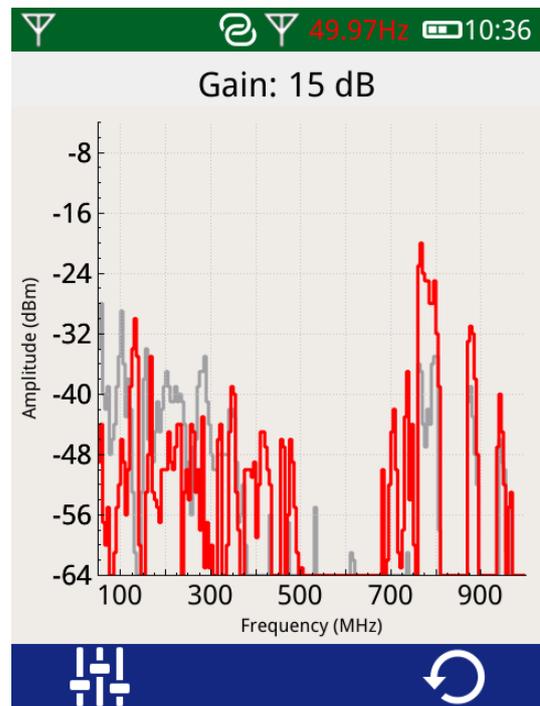
When surveying the circuit breaker No.6 FDR CB however, a marked and noticeable difference was apparent. The overall amplitude was also significantly higher (particularly around the VHF / TEV frequencies), so much so that a second sweep with the gain reduced to 10dB was also taken. These traces are shown in Figure 10 and Error! Reference source not found. where once again the grey trace denotes background and the red the asset sweep.

Looking at these traces, a very noticeable difference could be seen at the 700MHz frequency and this was also a very quiet part of the background spectrum. The antenna was therefore tuned to 700MHz and a PRPD trace captured when pointing toward No. 6 FDR CB which is shown in Figure 12.

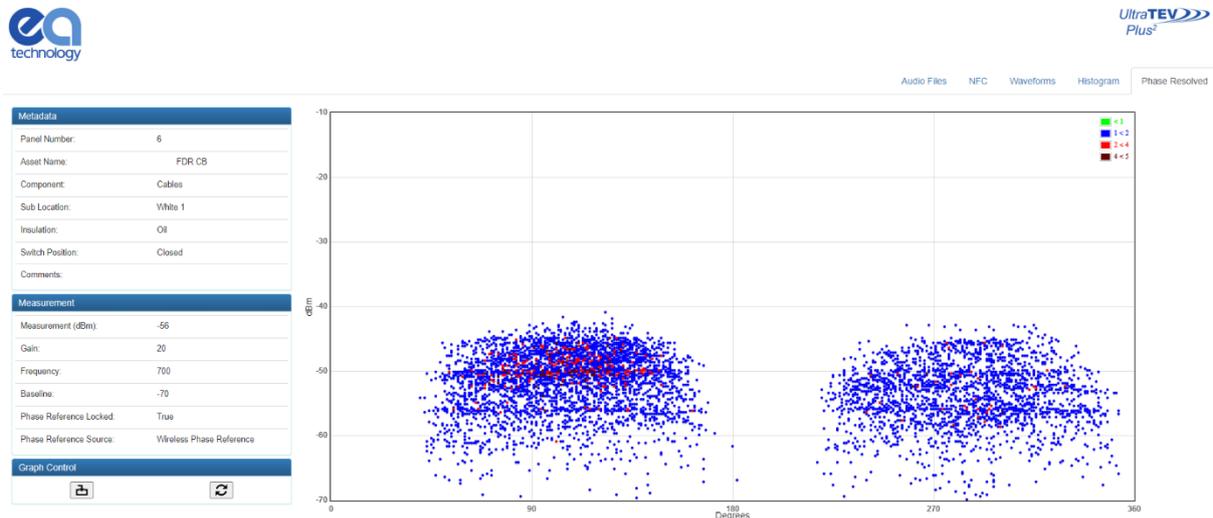
Figure 12 UHF PRPD Plot of No. 6 FDR CB

The UHF PRPD trace was consistent with the TEV traces in showing a single-phase partial discharge pattern associated with No. 6 FDR CB. The use of the UHF technique localised the signals and provided additional confirmation that this was indeed the source of the PD activity seen in the 66kV switchyard.

The TEV trace of Figure 14 and the UHF trace of Figure 12 show patterns with characteristics of both PD across a gap and PD within oil. Therefore, one potential cause could be with a contact issue in one of the oil tanks with White phase being most suspect.

- R2. An outage and inspection / maintenance of the circuit breaker is recommended to remove the source of PD from the network and reduce the level of risk.

- R2.1 DGA testing of the oil may help confirm the presence and location of the PD source.
- R2.2 Particular attention should be paid to the contacts and any components where gap type discharge could occur.

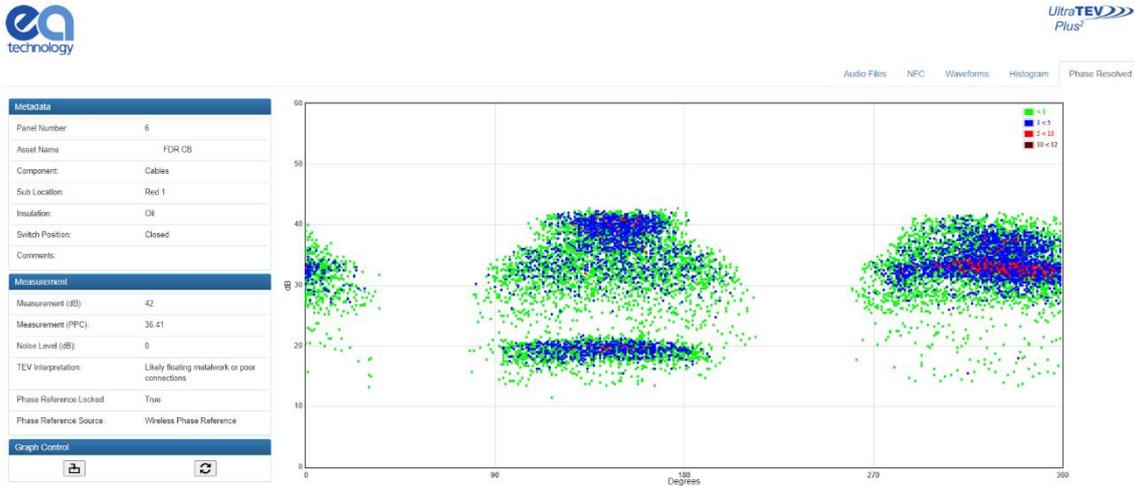
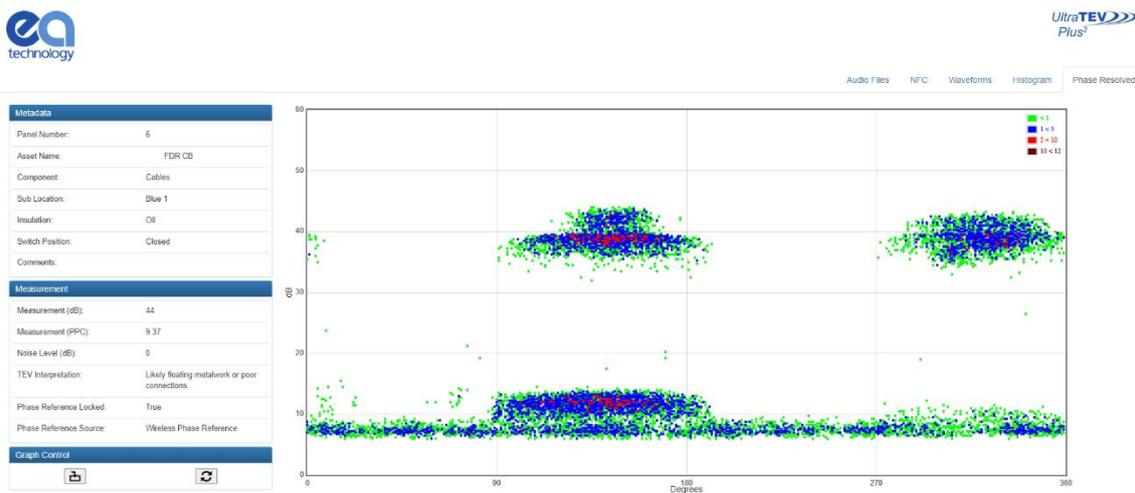
The circuit breaker No. 6 FDR CB was found to be exhibiting PD activity. The dual probe location technique was applied using the UltraTEV Locator accessory and whilst this also helped further confirm the source of the activity to this asset, it was not possible to conclusively indicate to which phase the issue was associated. Comparing the traces on each tank shown in Figure 13 to Figure 15, the White phase trace has a higher amplitude (44dB) and higher pulse per cycle reading and this would be the most likely suspect and place to start with any investigation. However, it is also true that that any inspection or remedial work would involve the complete circuit breaker so identification of exact phase non-intrusively is probably not the most important issue. The main aim is to identify PD and suspect circuit breakers which has been achieved.

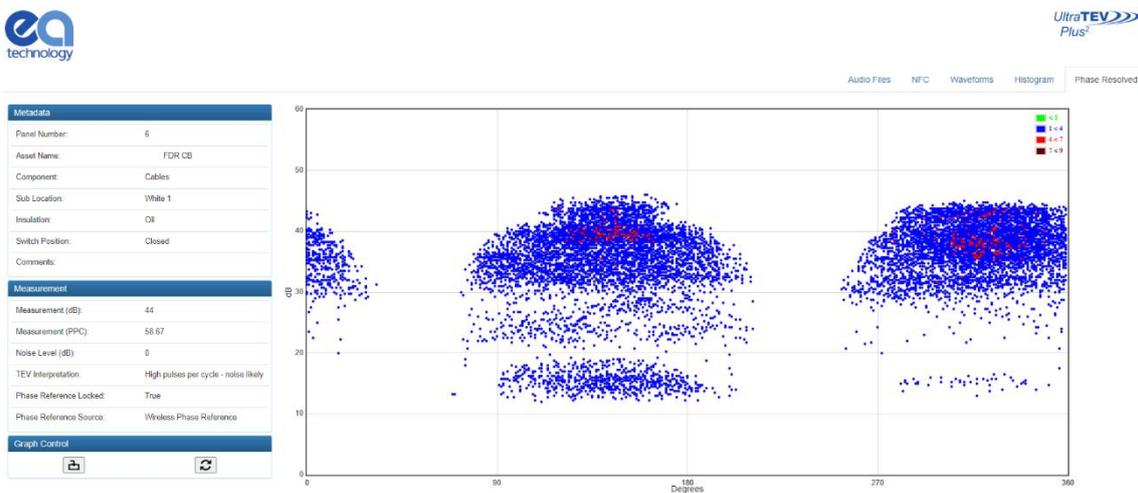
Figure 14 TEV PRPD Plot White Phase of No. 6 FDR CB

With respect to the severity of the PD, a TEV amplitude of 44dB is a high level large source of PD and warrants further investigation in the short term. This is particularly true when we compare the results to a previous series of tests undertaken by EA Technology at the same Terminal Station on 7th December 2023.

- R2.3 The highest level of activity was on the white phase and this would be the most obvious phase to closely look at first. It should be noted that due to the construction of switchgear and nature of the high frequency electromagnetic pulses and their propagation, the highest amplitude may not always be associated with the source of activity.

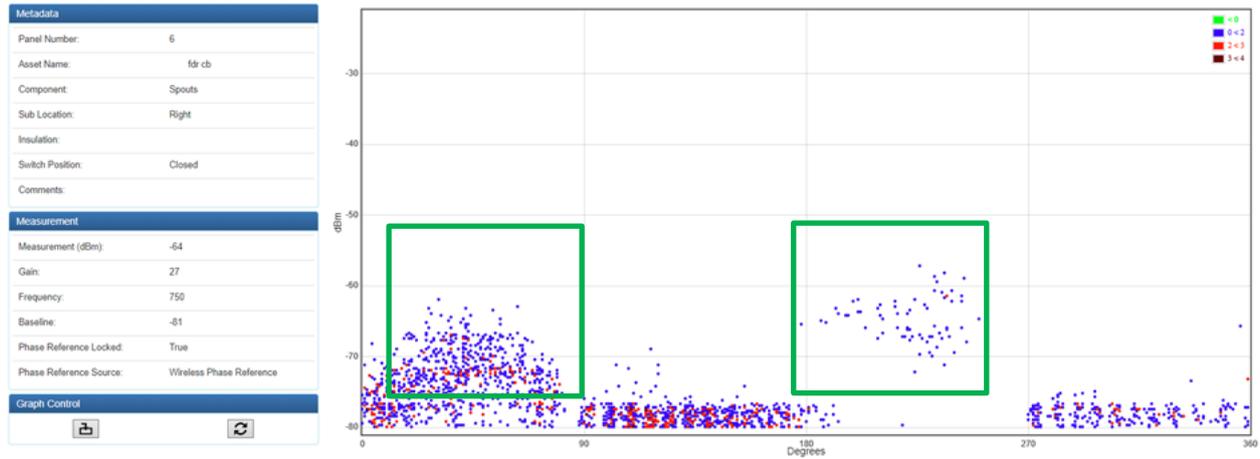
Figure 16 No. 6 FDR CB, UHF Phase Plot, Test 2

In that report, an intermittent source of PD activity was detected and noted on this circuit breaker. At the time, the activity was found to be active for only very short periods of time, making the testing difficult. In December, PD was only detected using the UHF method, but this may well have been due to the PD being inactive at the time of the TEV testing. Figure 16 taken from that report shows a much less conclusive trace of UHF activity and comparing this with Figure 12 we can see that the amplitude and rate of PD has substantially increased between these two measurements taken only 3 months apart.

Admittedly this is only based on only two samples of data, however, the PD source in the OCB appears to have substantially increased in severity over the intervening 3-month period.

In March the TEV and UHF measurements were very constant and the source was active for the whole period of testing and at a much higher amplitude and discharge rate.

- R1. Based on the findings of this report, and the increase in severity since the previous testing in December 2023, the PD source identified in No. 6 FDR CB has progressed to the point where further investigation in the short term is recommended.
