# The service that could have saved a DNO \$300,000+

## Background

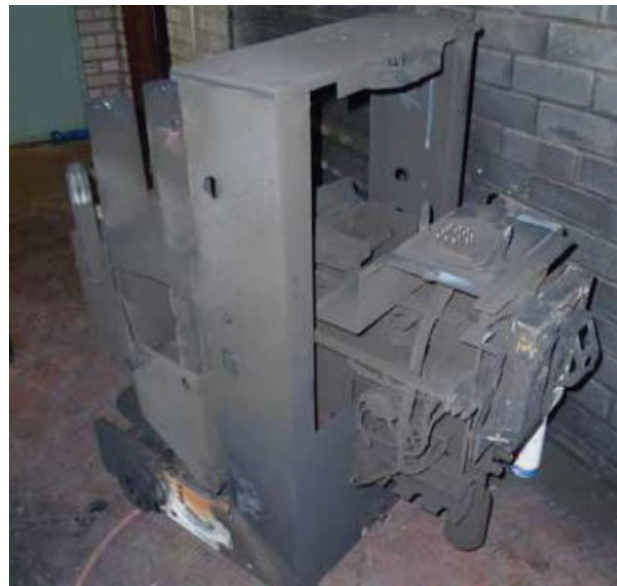
*Failed circuit breaker truck*

However, on 28 July 2015 – eight months after the monitor was installed – the DNO contacted **EA Technology** telling us the switchgear had blown, leaving a large part of the local city without power for eight hours. We went to investigate.

In the event, the DNO was oblivious to the impending fault, and the catastrophic failure was all but inevitable. It received fines of over \$300,000 for Customer Minutes Lost and Customer Interruption, and incurred further repair and replacement charges.

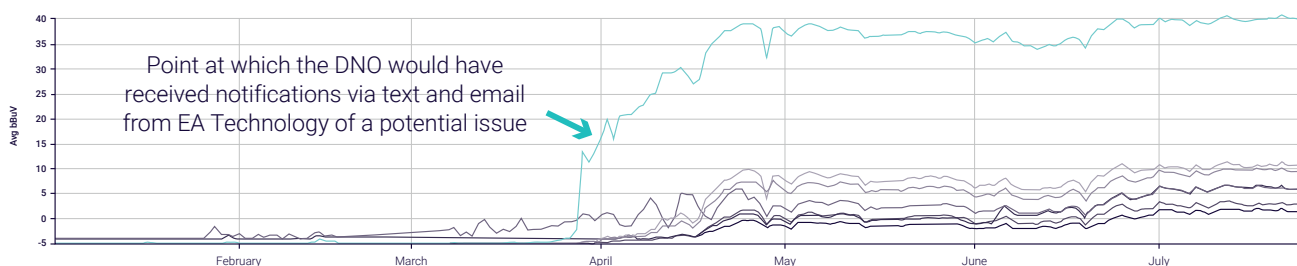
The graph below was retrieved and the findings were clear. The system was running normally for several months, but towards the end of March 2015, partial discharge

(PD) readings leapt. Had the **UltraTEV® Monitor** been communicating with **EA Technology**, we would have automatically alerted the DNO right then and they could have investigated. With faults detected, the DNO could have replaced or repaired the relevant components without interrupting the power flow to customers.

*The graph below shows the results recorded at the DNO's site*

As the graph illustrates, PD provides an early warning sign of problems to come they should not be ignored. That is why **EA Technology** often recommends that customers take the **Astute HV Monitoring™ Service**, which relays data to our offices 24/7 and triggers automatic alerts should certain criteria be met. We can also send monthly or quarterly reports for peace of mind or to identify trends.
