Addressing Noise Sources During Online PD Testing

Timothy Erwin

National Sales Manager, EA Technology LLC

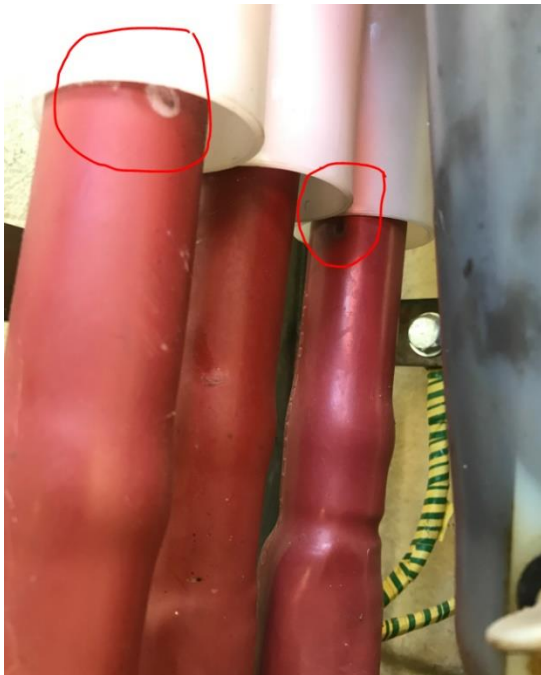
Surface PD – Flexible microphone

- 11kV HV Cable phases too close to insulated plastic boot
- Can be just heard with naked ear

Metadata	
Panel Number:	2
Asset Name:	
Component:	Cables
Sub Location:	Red 1
Insulation:	XLPE
Switch Position:	Closed
Comments:	White discharge seen on red heatshrink at base of white cover
Measurement	
Measurement (dBμV):	24
Ultrasonic Accessory:	Flexible Microphone
Ultrasonic Classification:	PD
Classification Certainty (%):	94
Phase Reference Locked:	True
Graph Control

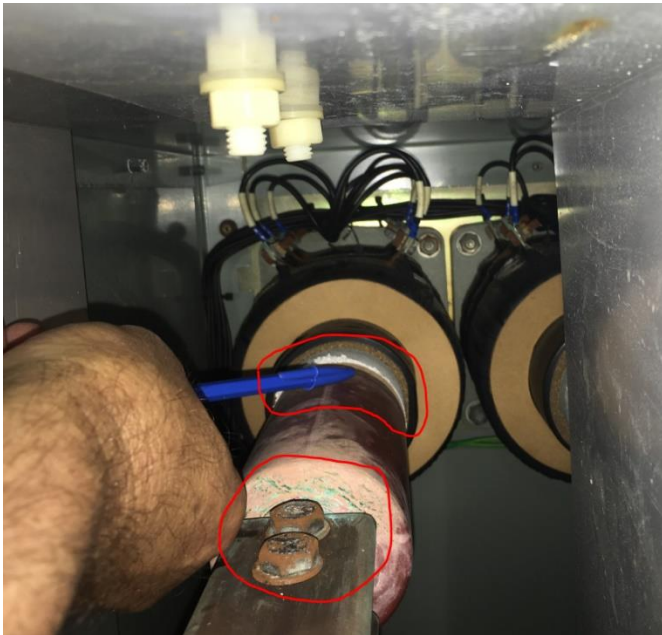
Corona / Surface PD – Flexible Microphone

- 11kV connection at rear of CB spouts, poor insulation interface
- Note white build up, also rust and green verdigris
- Corona with some surface PD – can be seen in phase resolved pattern
- Corona tends to have a 'deeper' sound

Metadata	
Panel Number:	1
Asset Name:	...
Component:	Cable Box
Sub Location:	Centre Left
Insulation:	Air
Switch Position:	
Comments:	
Measurement	
Measurement (dB μ V):	16
Ultrasonic Accessory:	Flexible Microphone
Ultrasonic Classification:	PD
Classification Certainty (%):	97
Phase Reference Locked:	True
Graph Control

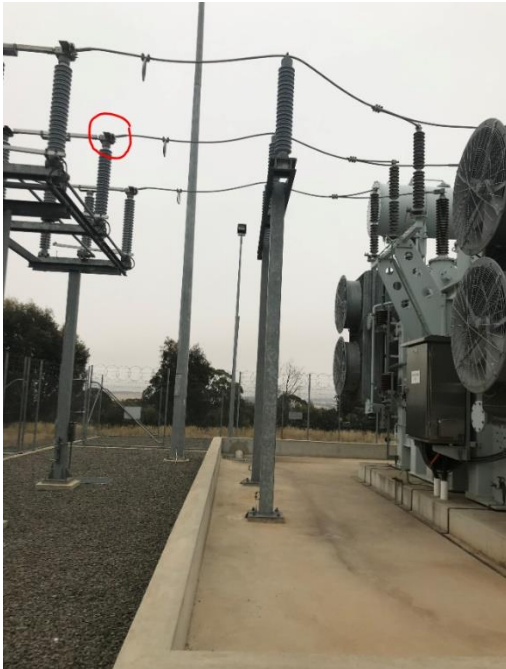
Corona, 132kV Isolator - Ultrasonic

- 132kV isolator, sharp point into air
- High ultrasonic
- Note one peak of activity on one half of sine wave

Metadata	
Panel Number:	2
Asset Name:	132kV Tx Isol
Component:	Upper Busbars
Sub Location:	
Insulation:	
Switch Position:	Closed
Comments:	White ph on Tx side corona
Measurement	
Measurement (dB μ V):	36
Ultrasonic Accessory:	UltraDish
Ultrasonic Classification:	PD
Classification Certainty (%):	64
Phase Reference Locked:	True
Phase Reference Source:	E Field

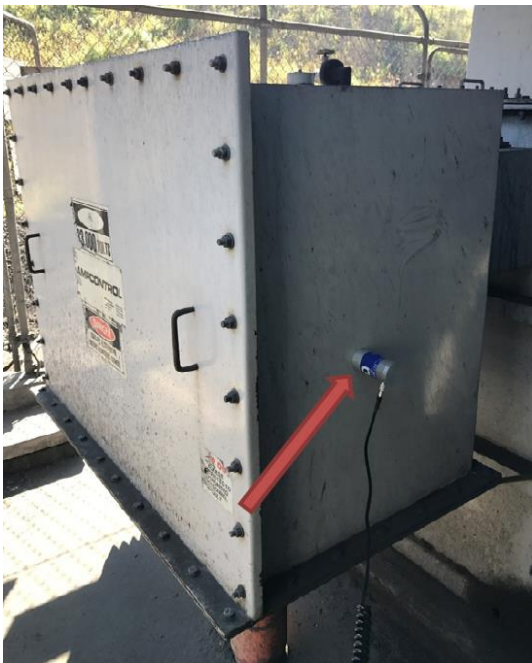
Magnetic Transformer Vibration, Contact Probe

- 11kV Transformer magnetic vibration noise detected with contact probe – no problem detected
- Sound goes away when metal plate is physically leant on – stops vibrating
- Note 4 clusters of activity in phase resolved plot, not indicative of PD

Metadata	
Panel Number:	1
Asset Name:	Tx
Component:	Cable Box
Sub Location:	Centre Right
Insulation:	Air
Switch Position:	
Comments:	Possible vibration, goes away when touching metal with hand
Measurement	
Measurement (dBV):	2
Ultrasonic Accessory:	Contact Probe
Ultrasonic Classification:	PD
Classification Certainty (%):	74
Phase Reference Locked:	True
Phase Reference Source:	Manual
Graph Control

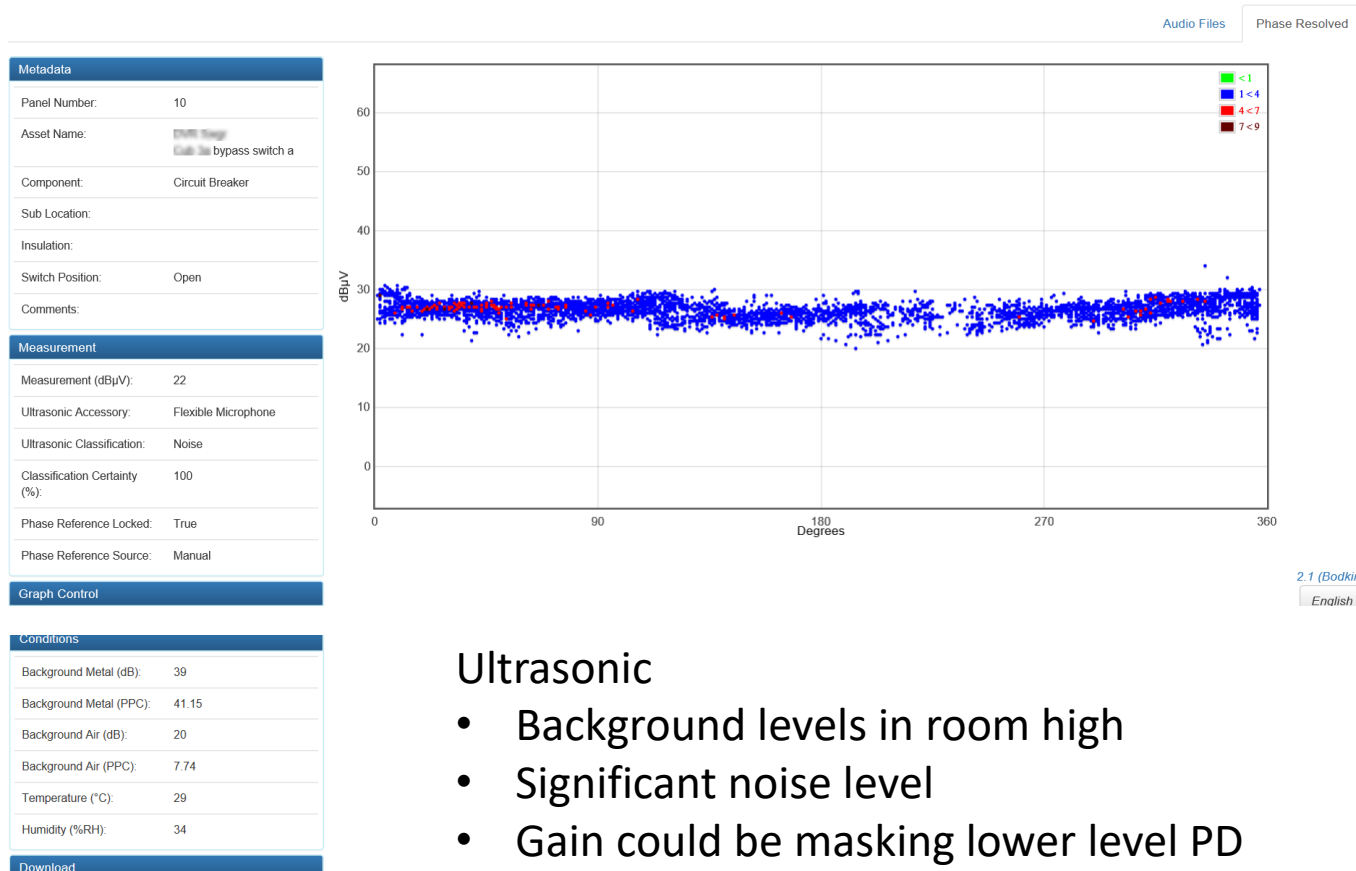
Example 1: Scientific manufacturing facility in room with switching inverters

Ultrasonic

- Background levels in room high
- Significant noise level
- Gain could be masking lower level PD

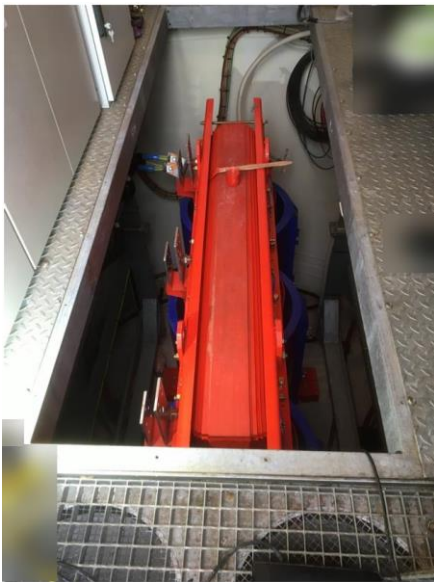
Example 2: Wind Turbine with known PD in basement mounted transformer

- Transformer had been tested with off-line equipment and it was determined that there was PD on at least one winding
- Testing with multiple online technologies was performed including
 - TEV
 - Ultrasonic
 - RFCT on transformer incoming, tail and chassis ground straps
 - Radiometric (RF) PD Detector
- Different test equipment was used for the TEV and Ultrasonic, RFCT on cable straps and the RF PD detector.
- Tests were run with the turbines generating and with them off and transformer back fed from the 33Kv side. This allowed a comparison of the affect of the inverters when generating.

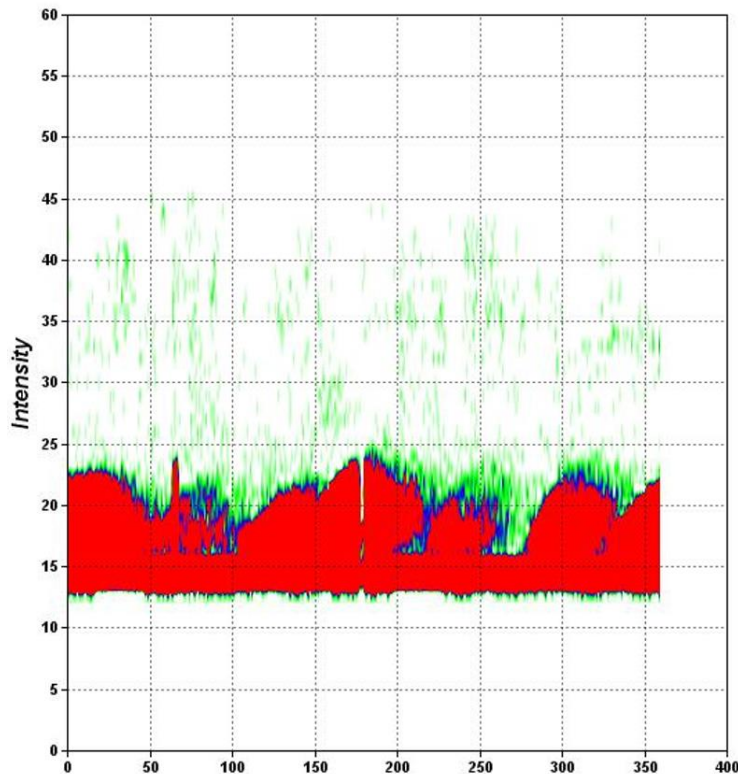
TEV: Phase resolved plot- Probe on transformer panel.

- Measurements with inverters operating will not allow TEV detection
- But with inverters stopped the PRP shows PD.

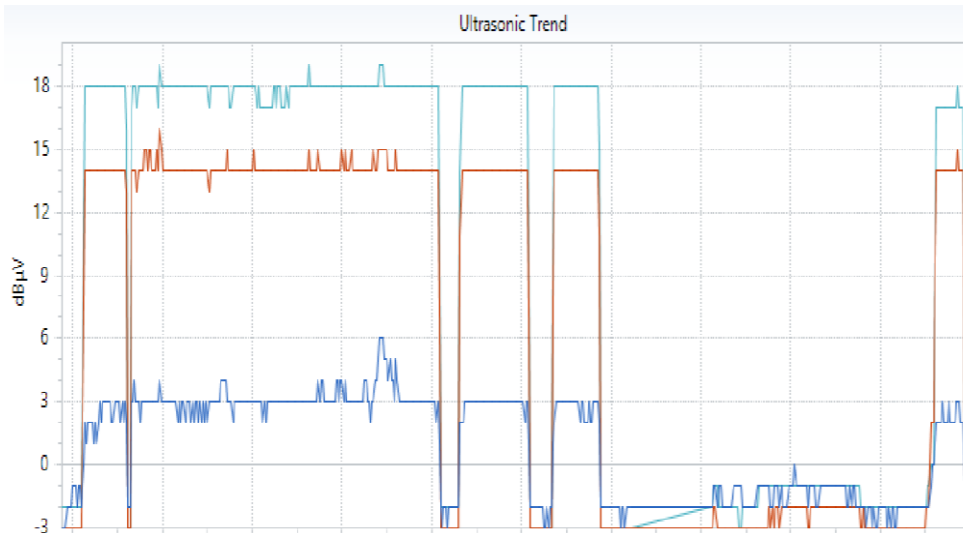
Ultrasonic: Average amplitude over same 24 hours as TEV

- Similar trend as TEV
- Low levels of U.S. activity when inverter was off suggest it is not possible to use U.S. as a method of PD detection in transformers

Because the transformers have solid resin insulation there is no airpath out, so ultrasonic internal PD detection is not possible with airborne sensors.

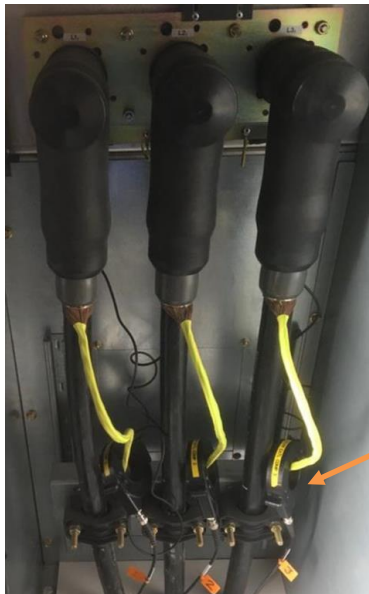
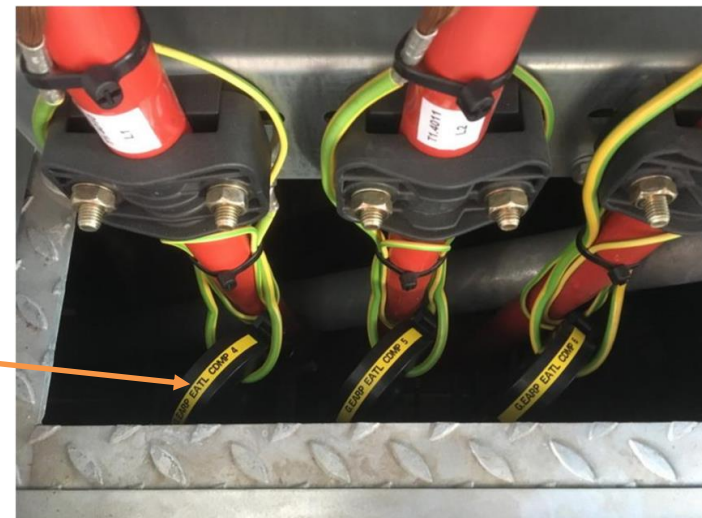
Cable testing- RFCT

RFCT

Incoming 33 kv
interconnect cables

Transformer Tails

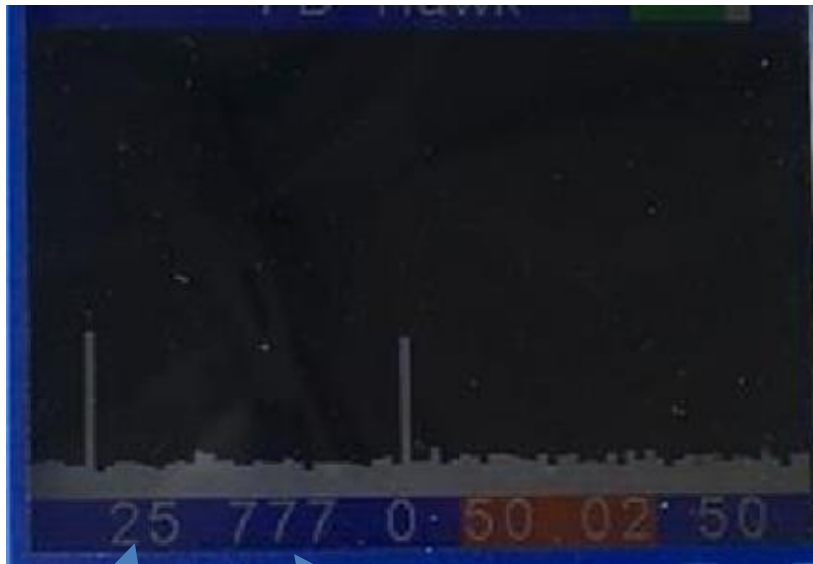
UHF (RF) Test – Turbine generating

Gain

Center Freq

- Center Freq 777 MHz
- Inverter operating freq. usually 10's to 100's kHz
- Not effected by inverter noise
