Review of Medium- Voltage Asset Failure Investigations

William Higinbotham, EA Technology LLC

2/26/2018

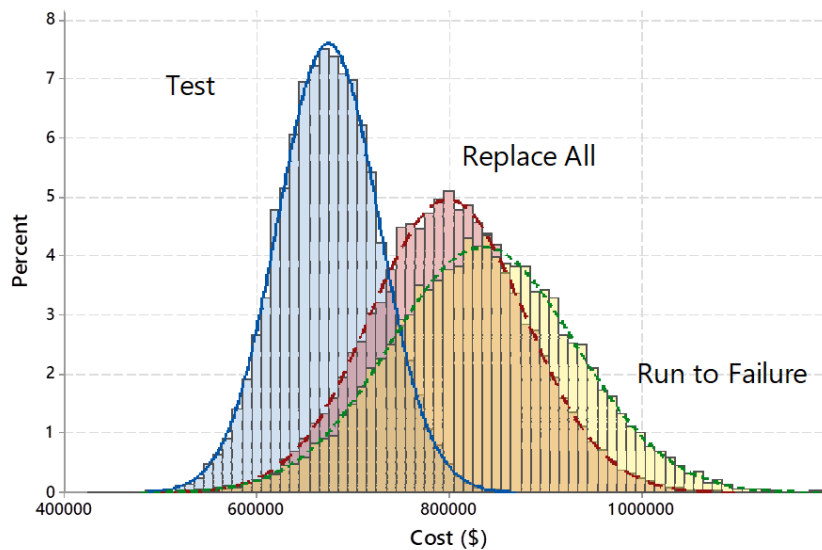
Figure 1: Comparison between Cost Options

Extruded cables offer many advantages over older designs, but are similarly prone to failure. One of the greatest problems facing the power industry is cable failures. Since cables often are sealed systems, it is hard to do continual assessment, and often failures occur without warning or preparation. In Figure 1, provided by NEETRAC, the costs of testing equipment, replacing all equipment regularly, and running

equipment to failure is compared. Each cost is shown as a standard distribution to represent the uncertainty associated with failure costs. It is evident from this figure that the costs of testing are significantly lower and have much less uncertainty than the costs associated with running equipment to failure or wholesale replacement prior to failure.

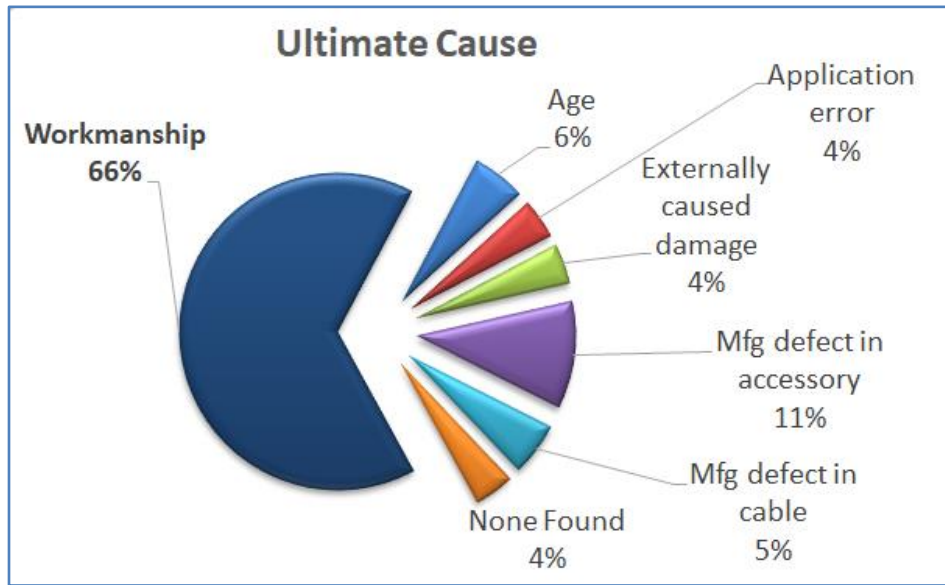
Figure 9: Ultimate Causes of Failure

What is missing from this picture is the detail of what is causing these failures. Proximate cause provides insight into what happened but often is lacking the complexity of the full reasoning behind a fault. By looking at the ultimate causes of the sampling, we see that the vast majority of faults can be attributed to workmanship errors. These would include any errors in jointing due to negligence or inexperience, as well as any sloppy work and lack of care. 6% of failures were due to age which is lower than expected based on the correlation to the Weibull distribution discussed earlier. Manufacturing defects presented about 11% of all ultimate causes which is higher than expected. These range from contaminants in the insulation to conductor spacing requirements being violated in the brand new cables. Only in 4% of cases was no ultimate cause found, which suggests steps can be taken to address the vast majority of cable failures.

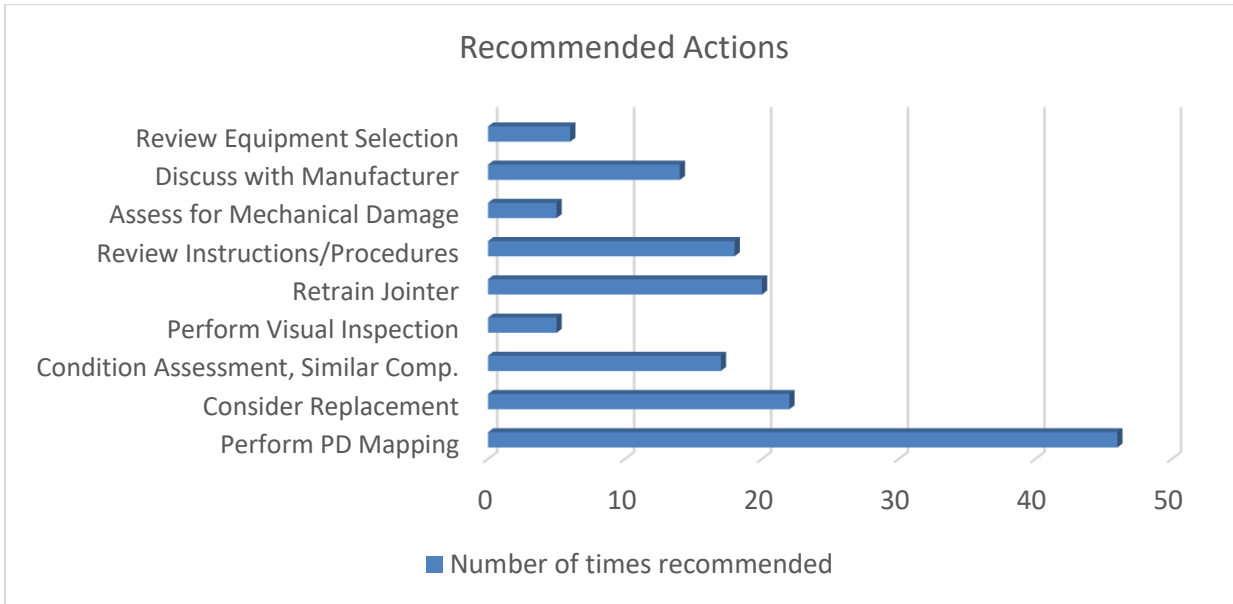
Figure 10: Recommendation Actions for Existing Equipment

Based on the ultimate and proximal causes of failure, there are several standard recommendations that would help prevent future failures. The most commonly recommended action was to perform Partial Discharge mapping regularly. Partial discharge is a flashover of part of the insulation system due to a localized electric field greater than the dielectric withstand capability of that part where the overall insulation system remains capable of withstanding the applied electric fields. Partial discharge is commonly found surrounding voids in the insulation and produces a variety of detectable byproducts such as heat, light, sound, scent, electromagnetic waves, and a high frequency electric current. Since the prevalence of partial discharge can indicate issues with insulation quality, a routine of partial discharge mapping can help clients plan for outages to address issues before they escalate. Cable PD testing can provide data about how aging and conditions have affected installed cable, and help prioritize replacement and repair.

Replacement is a commonly recommended action, yet overall it is regarded as only one of many options. The prevalence of PD mapping and condition assessment recommendations suggests that proper asset management techniques can help prevent untimely replacement of working equipment by providing additional information about its operating condition. Discussing the fault with the manufacturer was

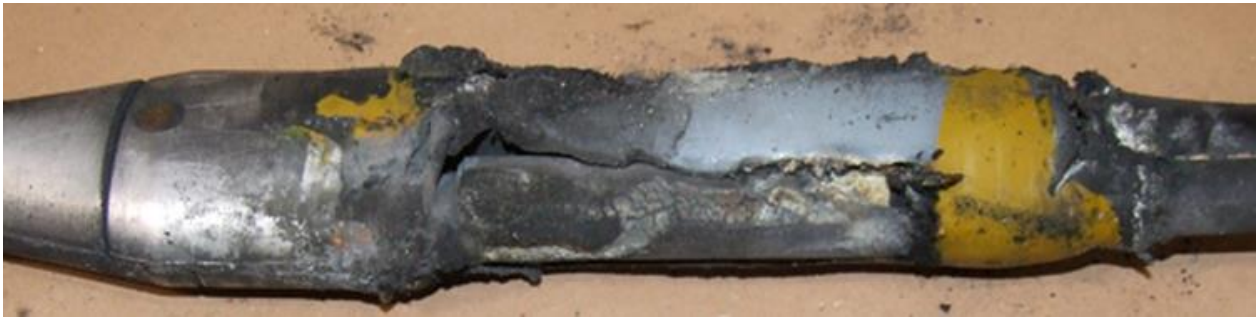
Figure 12: XLPE/PICAS Joint

The first example explored is an 11 KV PICAS to XLPE Branch adapter that failed one hour after installation. After investigation, the proximate cause was determined to be an incorrect positioning of the adapter tubes. Alternately, workmanship errors were determined to be the ultimate cause of failure. Throughout the investigation, many quality issues were found. Shear bolts were misaligned, there was no putty in the shear bolts, the tubing was poorly cut and there were gaps in the insulation throughout the sample. Recommendations common for these conclusions include retraining the jointers and assessing the

components done as a part of this project. This example highlights that finding and fixing the one proximate cause of the failure is not adequate. There were several mistakes that all would have led to failure had the first cause not been present. By addressing the ultimate cause of jointer training, all of the workmanship issues and potential failure points would be addressed.

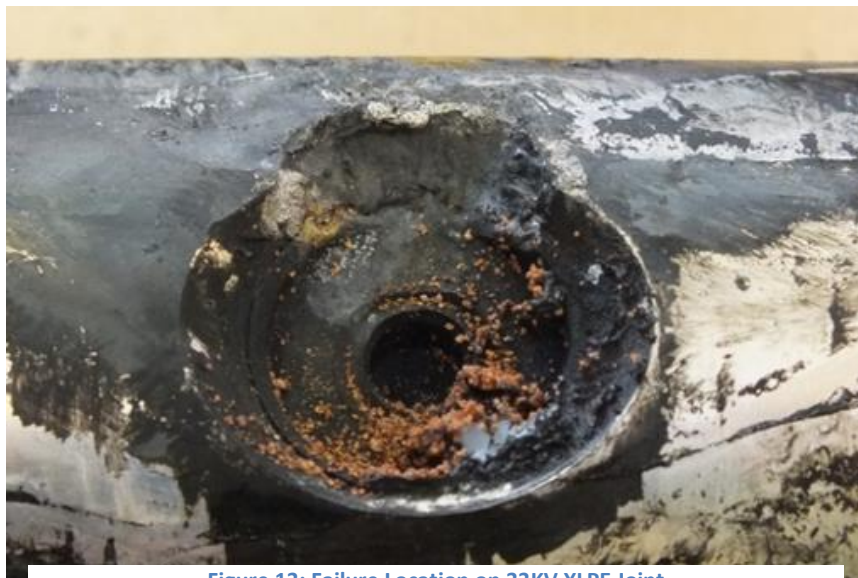
Figure 13: Failure Location on 33KV XLPE Joint

The next example explored was a 33KV XLPE joint that failed after 18 months in service. The fault hole is visible through the insulation in the figure below. The failure occurred because a connector was not

properly deburred by the jointer. The sharp edge caused mechanical damage and created a concentration of electric fields in the damaged insulation. The takeaway for this failure was that poor understanding of instructions, lack of attention to detail, and lack of training all contributes to the failure of this joint.

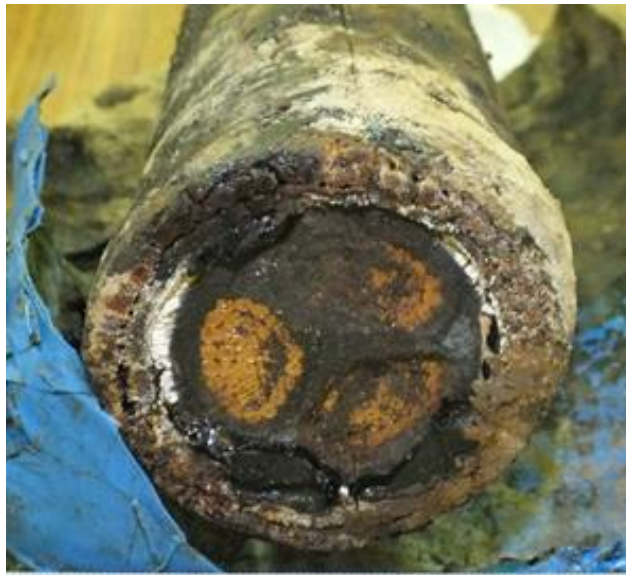
Figure 14: Failed PILC cable

The final example explored is a PILC cable that failed after 47 years of service. The 11KV cable experienced a mid-cable failure as seen in figure 14. This failure is a result of age related partial discharge. Although this cable was in service for an appropriate life span, this is an example of how partial discharge mapping could have prevented an unplanned failure. Catching the partial discharge earlier would have allowed the client to plan an outage to address the issues.
