**MC // Monitoring**

**How electrical test companies can adapt to meet customers' evolving needs**

# **Always-On Electrical Assets Require Continuous Monitoring**

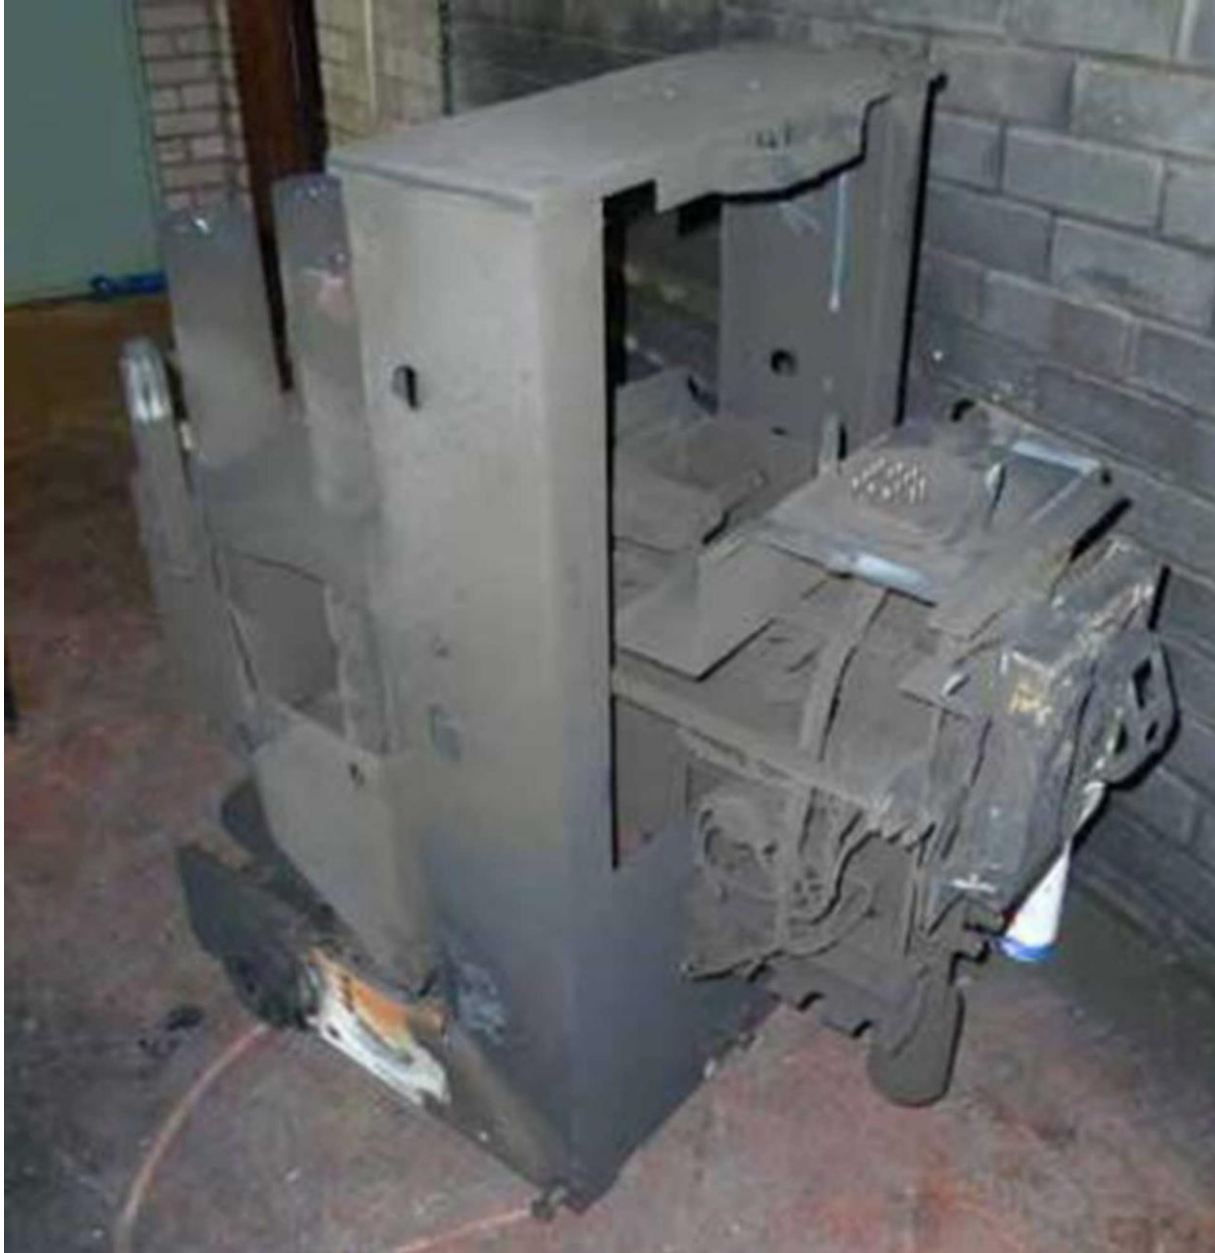
**FIGURE 1: As a result of inaction, the switchgear at a U.K. utility experienced a catastrophic failure.**

**In November 2014, this U.K. utility installed an ultrasonic and Transient Earth Voltage (TEV) monitor at one of its high-risk substations. The site was deemed high risk due to its location near a river's edge combined with the type of switchgear operated at the location. Tragically, there was no remote communication channel available, and the system data was not being reviewed during the testing period. On July 28, 2015, the switchgear failed catastrophically (see Figure 1).**

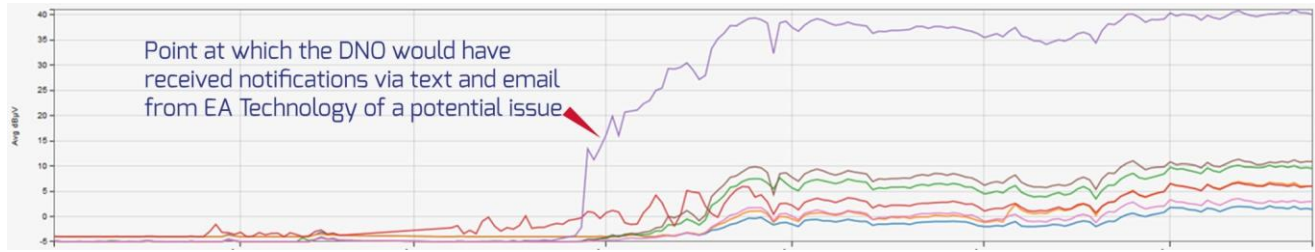
**FIGURE 2: Over a weeklong period, PD levels rose to a level that would have triggered an alarm had one been installed.**

Experts reviewed the recorded data and found the substation had been reading little to no activity from installation in November 2014 until March 2015. From March 2015 on, however, there was a marked increase in PD activity. Over a week-long period, PD levels rose to a level that would have triggered an alarm had one been installed (see Figure 2). This spike continued to exist until the failure occurred. As a direct result of downtime, the utility received customer minutes lost (CML) and customer interruption (CI) fines totaling \$700,000.

A periodic survey done in early March would have found no issues, but a catastrophic failure still occurred four months later. This would have been easily caught with continuous monitoring.

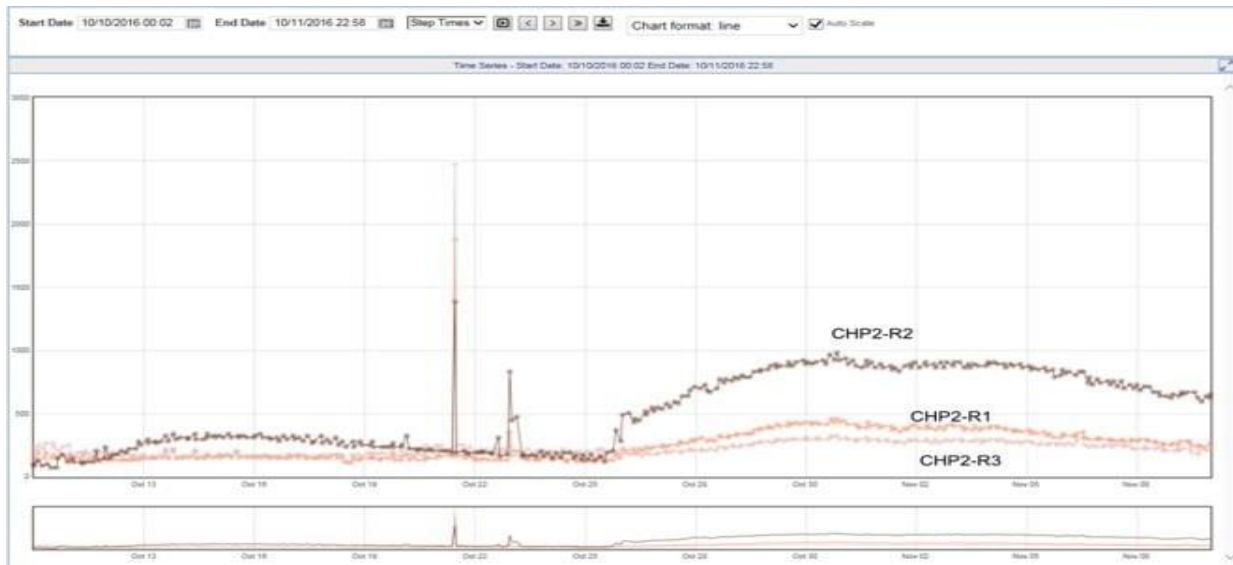
**FIGURE 3: The onset of PD can be seen for cable CHP2-R2 over a one-month period, when levels rose from 100 to 1,000 pC.**

The onset of PD can be seen in Figure 3 for cable CHP2-R2 over a one-month period, when levels rose from 100 to 1,000 pC. Figure 4 shows the very clean pulse that enabled the location of PD. This highlights the benefit of continuous monitoring, whereby trends in activity can be seen that would have been missed with spot measurements alone.

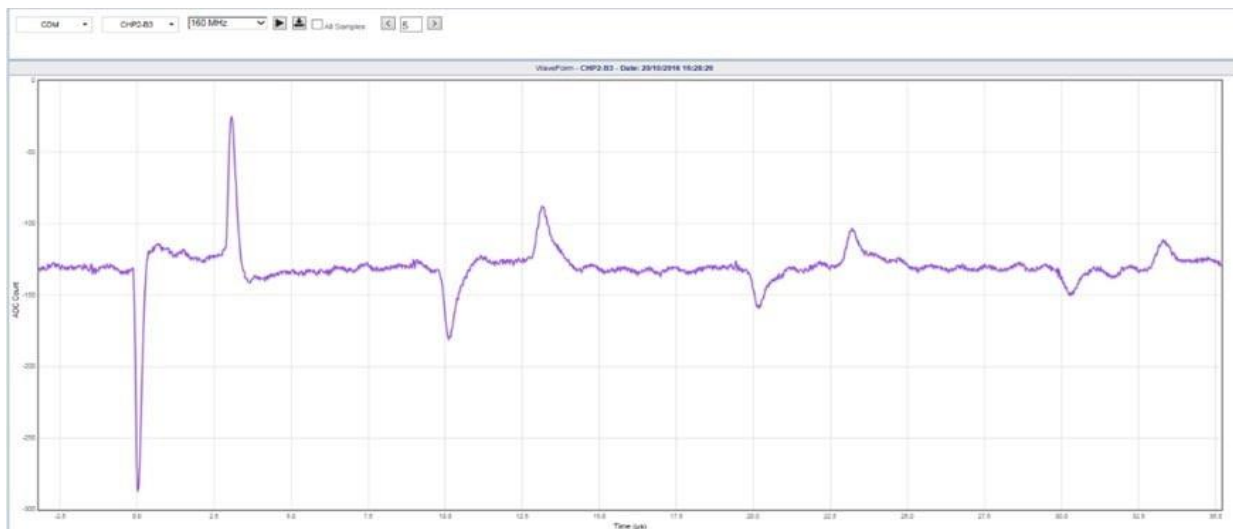
**FIGURE 4: This image shows the current PD pulse recorded on CHP2-R2.**

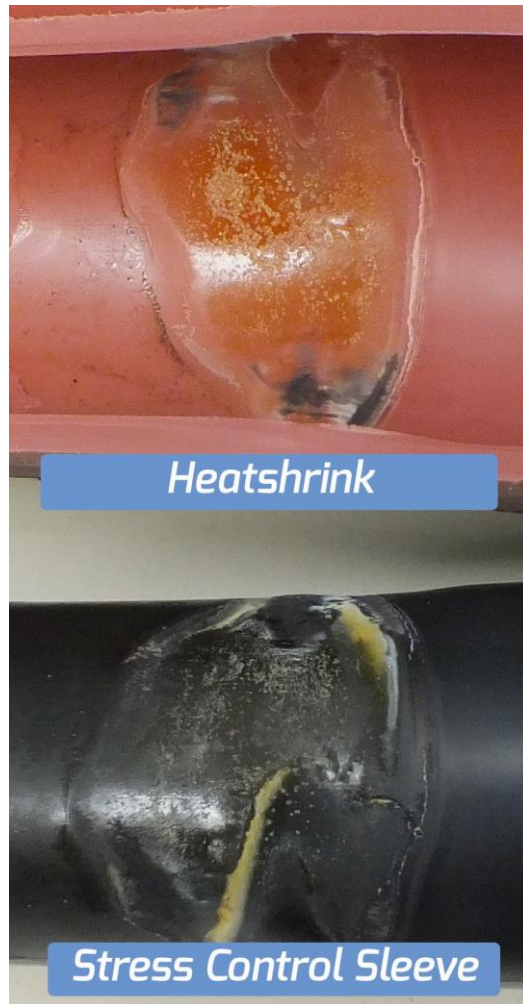
**FIGURE 5:** The root cause was identified to be an incorrect gap between the XLPE insulation and the connector being only 1 mm instead of the recommended 5 mm, preventing the yellow mastic from filling the gap properly and leaving a void that led to the elevated electrical stress responsible for the detected PD.

During the forensic investigation, evidence of PD was found in one joint of the joint pairs when the outer heat shrink cover was removed from the cable stress control sleeve. The root cause was identified to be an incorrect gap between the XLPE insulation and the connector being only 1 mm instead of the recommended 5 mm, preventing the yellow mastic from filling the gap properly and leaving a void that led to the elevated electrical stress responsible for the detected PD.

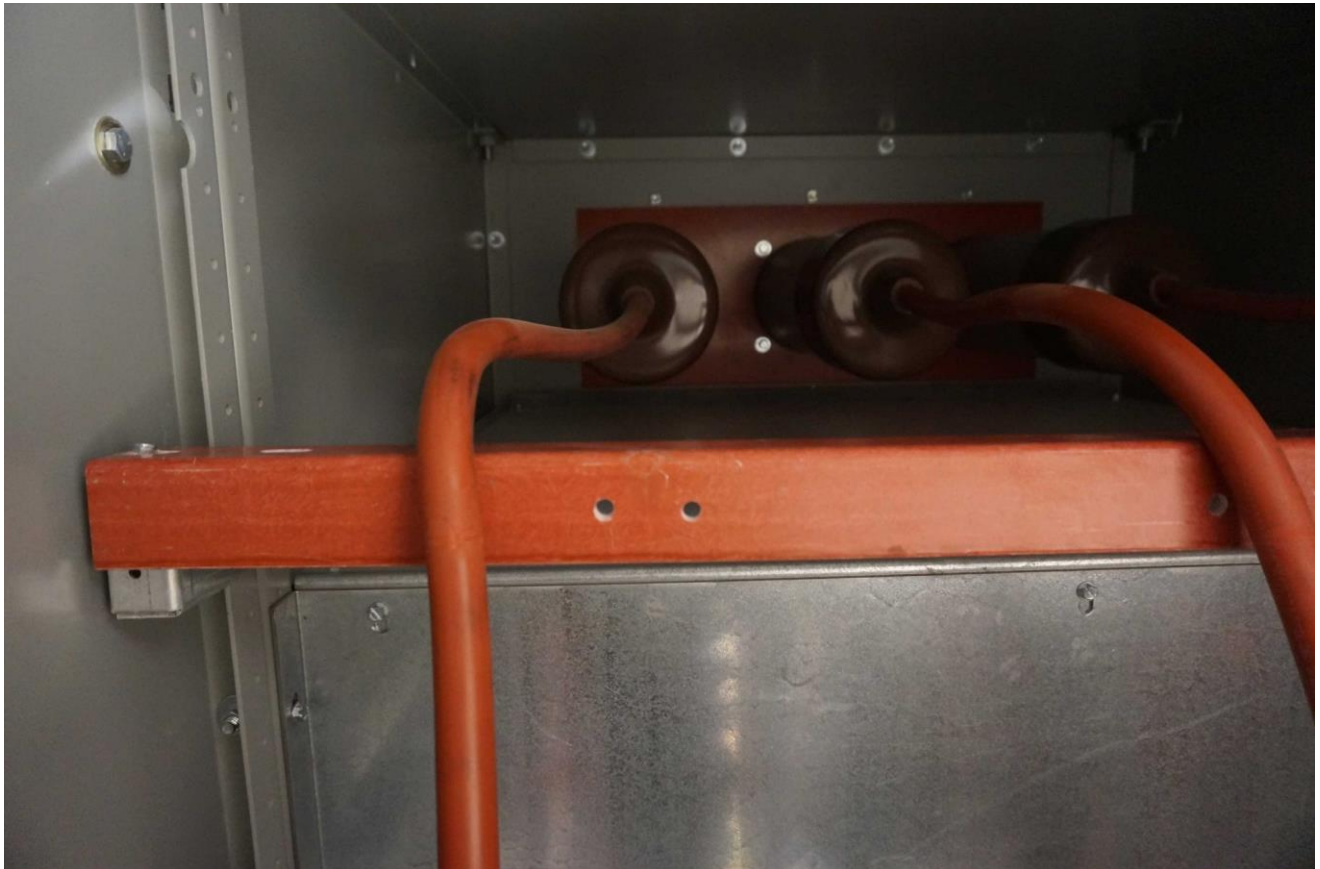
**FIGURE 6: Improperly installed PT cables.**

**A large office building had full-time PD monitoring installed due to the critical nature of its operations. Ultrasonic and TEV detection were provided for all cable termination compartments. An installation mistake common to all of the potential transformer cables (see Figure 6) caused partial discharge to be present almost immediately upon energizing.**

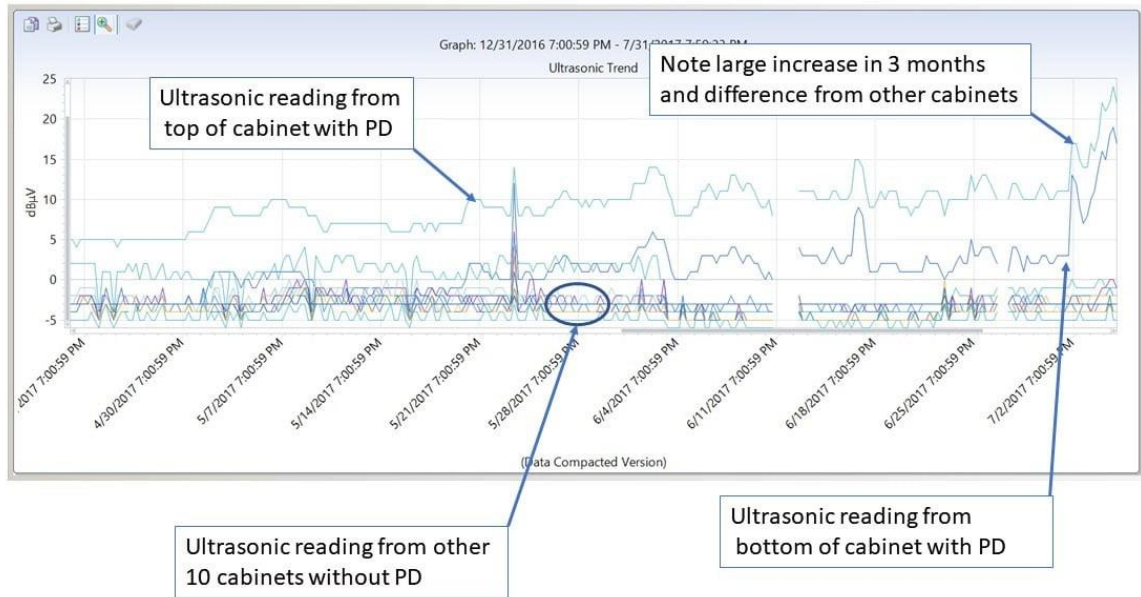
**FIGURE 7: This graph shows the marked increase in PD signature.**

**As can be seen in the graph in Figure 7, the cable was energized in March 2017, and, within a month, the ultrasonic level was already four times higher than other identical cabinets where the problem was previously corrected. Over the course of the next three months, the level increased to more than 100 times that of the good cabinets.**

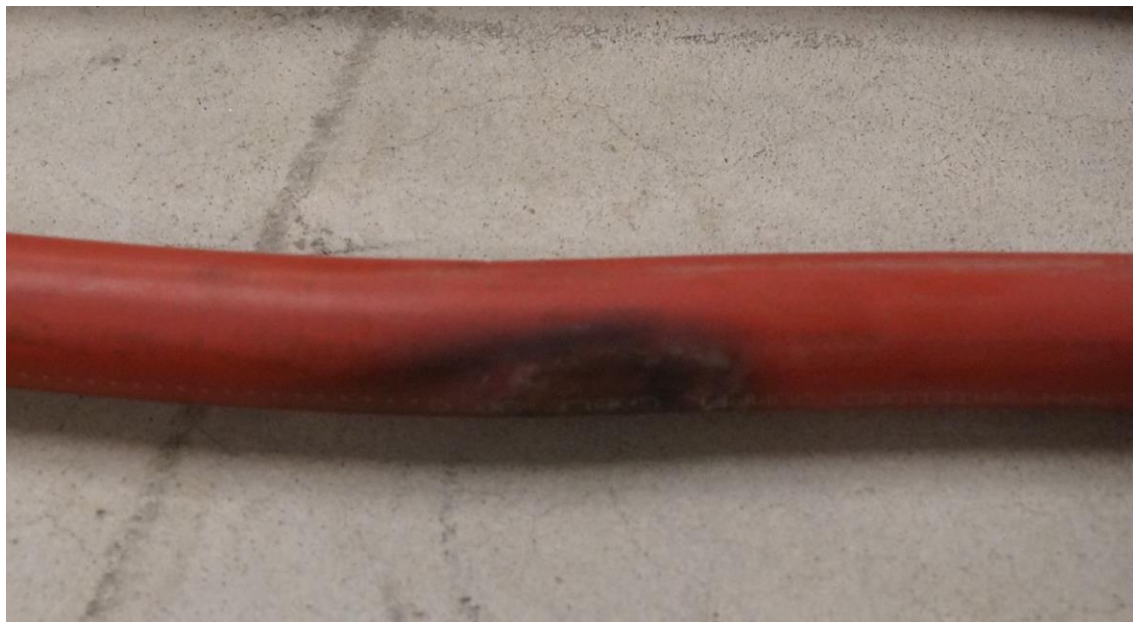
**FIGURE 8: PD damage to a PT cable.**

The cable was deenergized after a few months, and the damage was similar to a previously replaced cable shown in Figure 8.
