### Partial Discharge in MV Cables

#### IEEE Insulated Conductor Committee Meeting Hollywood FL, October 2017

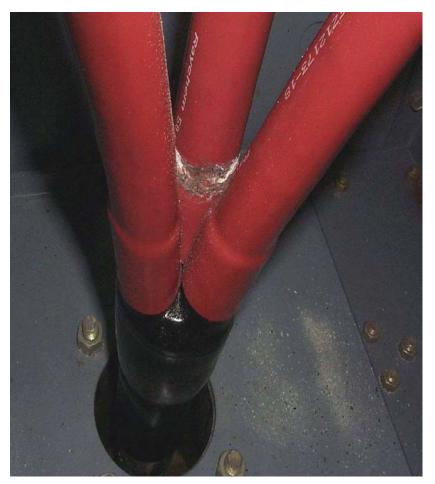
### Cables & Terminations - Surface Discharge Activity

- Discharge across surface of insulation towards earth or phase to phase discharge
- Often characterised by low amplitude but very high discharge rate
- Visible signs include white powder (Nitric Oxide)

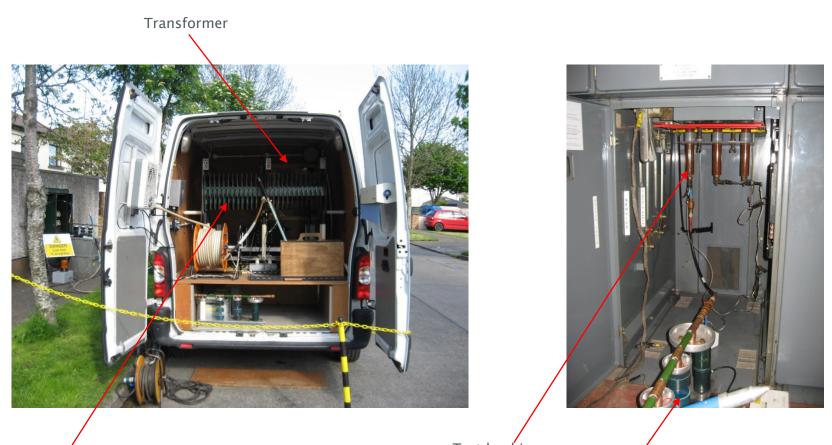
#### Offline Test Equipment - Test Van

Test bushings

VLF generator

Detector filter (allows LV detection lead to be connected to HV Supply and filters Hz)

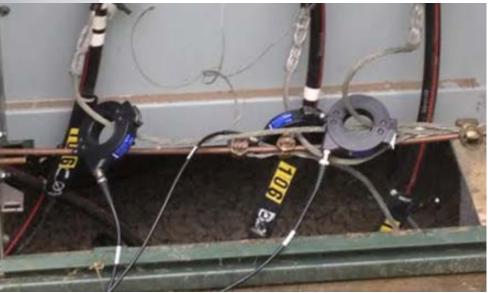
#### RFCT Installed on Ground Straps

ground strap
