CableData Monitor™ detects and locates Partial Discharge on cable joints within a petrochemical complex's critical supply cables

Client

- INEOS' Olefins & Polymers (O&P UK) business, which is based at Grangemouth and is one of INEOS' largest manufacturing sites. It is also home to one of Petroineos' oil refineries and oil and gas processing facilities owned by INEOS FPS.

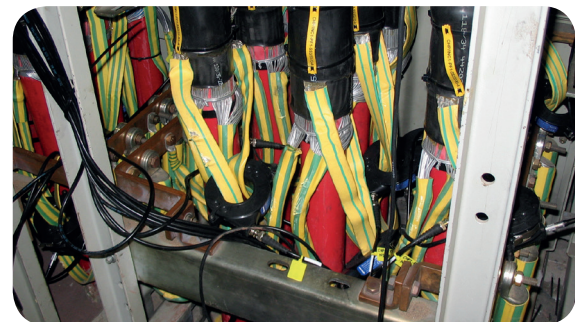
- EA Technology's CDM provides 24/7 condition monitoring of the critical cables using Radio Frequency Current Transformers (RFCTs) clipped non-intrusively around the earth strap on each of the individual cable terminations within the substation (Figure 2).
- Following installation, the PD activity identified during the VLF testing was confirmed in all three cables using the CDM system and located to the vicinity of the suspect joint-pairs.
- This removed the need to have to take the CHP plant off-line again to perform further periodic VLF testing to determine the severity of the problem.
- Avoiding just a single CHP outage in this way saved considerably more money in terms of lost production than the entire cost of the CDM installation.

Figure 2
RFCT Installation

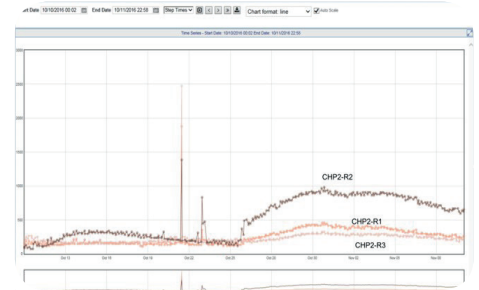
- The case of cable CHP2-R2 is described here by way of example, but similar results were obtained for the other two cables.
- The onset of PD can be seen in Figure 3 for cable CHP2-R2 over a one-month period when levels rose from 100pC to 1,000pC.
- This highlights the benefit of continuous monitoring whereby trends in activity can be seen that would have been missed with spot measurements alone.
- Precautionary measures were also put in place to ensure that human resources and materials were readily available should there be a sudden unexpected failure.
- All three cables where PD was identified were successfully managed until their joint-pairs were replaced during the planned outage 10 months later.
- The suspect joint-pairs were sent for forensic examination to EA Technology.

Figure 3
Event Amplitude Mean for cable CHP2-R2

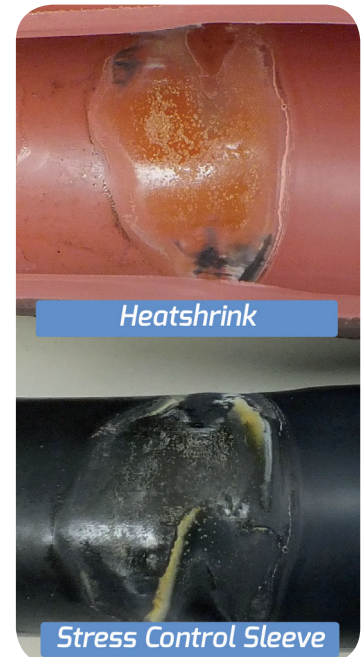
- Evidence of PD was found in one joint of the joint-pair when the outer heat shrink cover was removed from the cable stress control sleeve (Figure 4).
- The root cause was identified to be due to an incorrect gap between the XLPE insulation and the connector (only 1 mm instead of the recommended 5mm). This prevented the yellow mastic from filling the gap properly, leaving a void that led to the elevated electrical stress responsible for the detected PD.

Figure 4
Evidence of PD activity

- If left unattended, this defect would eventually have led to the failure of the joint.
- When the CHP cables were re-energised following the joint replacement, the CDM showed that the PD was no longer present, confirming the successful implementation of the remedial works.
- The CDM system has resulted in considerable financial saving by alleviating CHP plant downtime and is continuing to provide confidence in the integrity of the critical HV cables supplying the site.
- This study has shown how INEOS' pro active approach to managing PD on its critical HV cables has helped to save money, whilst at the same time, enhance the reliability of its electricity distribution network at its site at Grangemouth.
- The system has since been expanded to monitor all 120 cables in the primary substation.
