Application and Commissioning of Online Partial Discharge Technology for Medium Voltage Switchgear

American Electrical Testing Company, Inc.

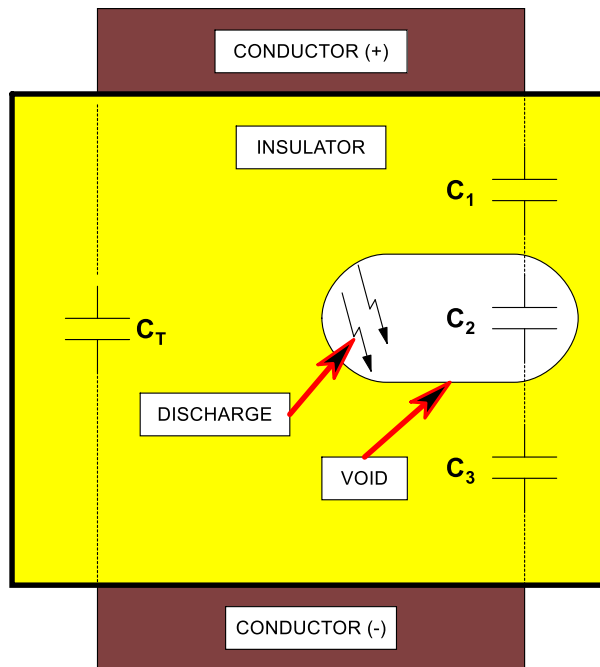
Figure 1: Partial Discharge in Solid Insulation

As illustrated in figure 1, when a discharge occurs, a small current flows in the conductors and is attenuated by the capacitive voltage divider network C_1 , C_2 , C_3 in parallel with C_T (total or bulk capacitance).

PD in insulating materials usually initiates within gas-filled voids in the dielectric. The dielectric constant of the void is much less than the encompassing dielectric so the electric field across the void is substantially greater than across an equivalent distance of the dielectric. When voltage stress across the void exceeds corona inception voltage (CIV), for the gas in the void, PD activity is initiated.

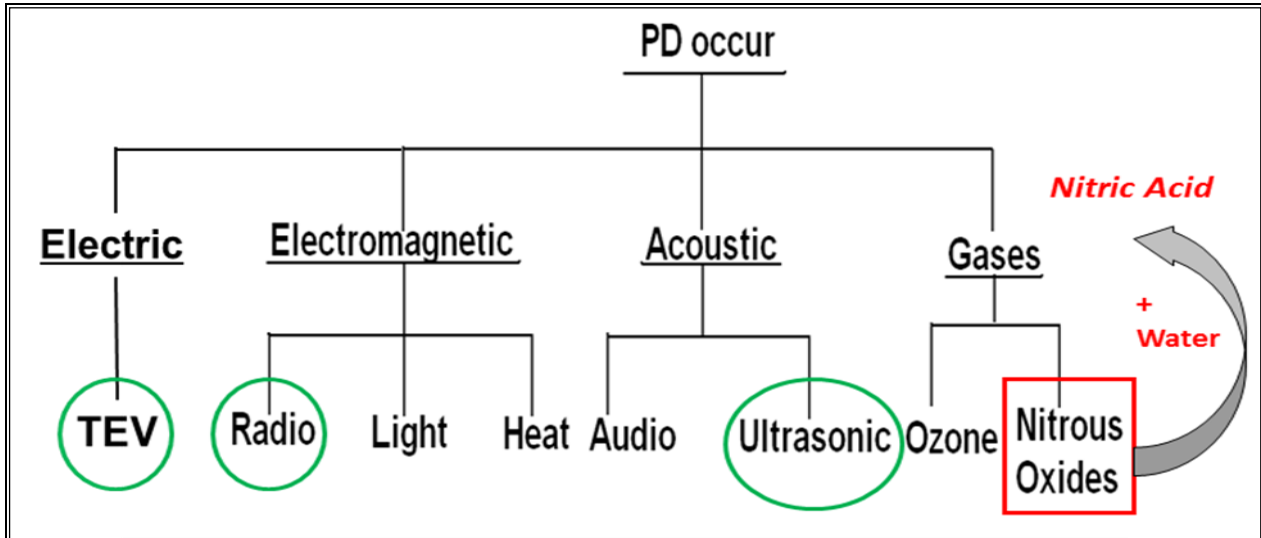
Figure 3: Selected Sensors (Metal Clad - Vacuum / Air Insulated)

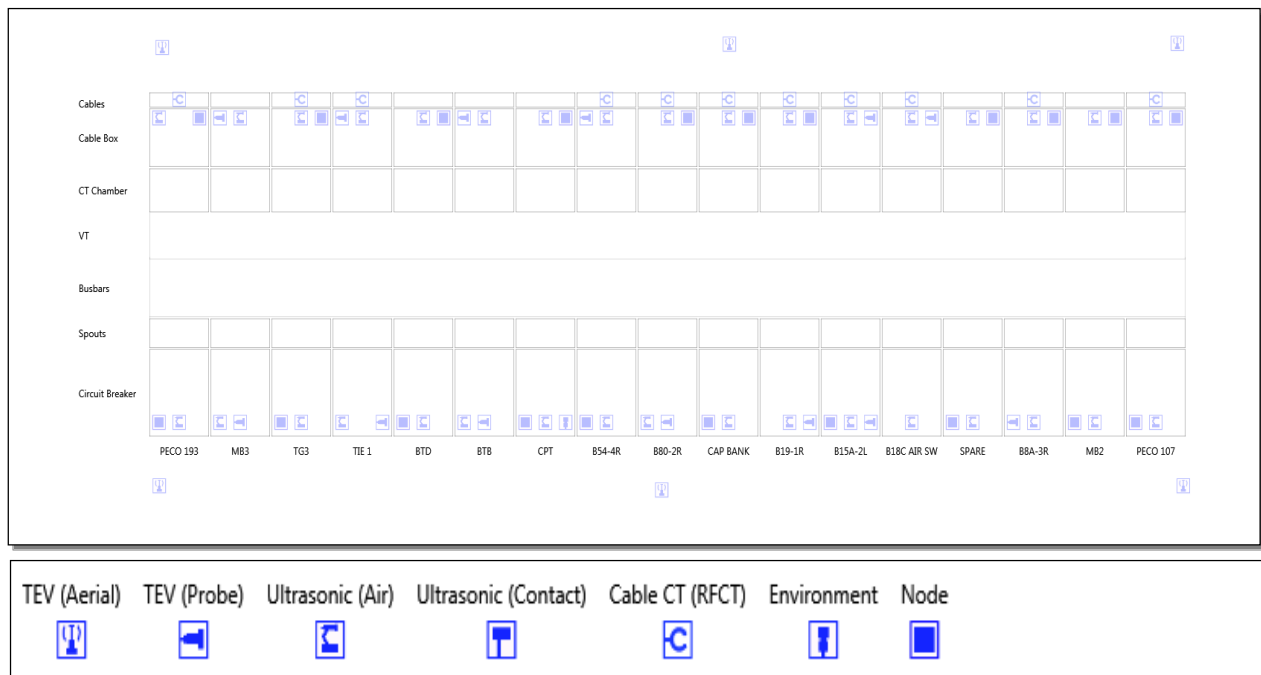
Figure 5: PD Monitoring System - Indoor Switchgear Layout

For the larger indoor switchgear installation the nodes were mounted on the front of the circuit breaker cubicles. Cables for sensors located in rear cable compartments needed to be brought to the front of the switchgear for connection to the node. The manufacturer supplied all the hardware, including interconnecting hardware (cables). Because there were so many cubicles to monitor and cable design is constrained to thirty (30) meters the system required two (2) hubs. The cable limitation is due to attenuation of the small signals to avoid data or system errors. Each hub is also limited to a polling capability of (22) nodes.

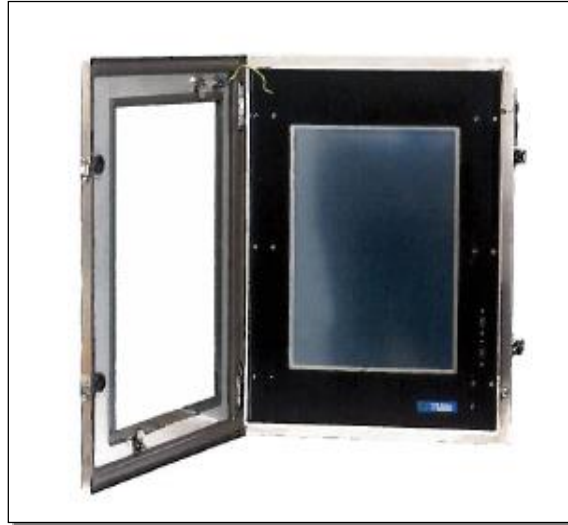
Figure 7: Hub

Since the manufacturer provides all interconnecting cables preliminary system design layout is critical. The system has to be designed and laid out so cable lengths can be identified before ordering equipment. This requires locations for the sensors, nodes and hubs to be identified early. The hub needed to be located within a (30) meter cable run. The hub also requires a reliable 115 VAC external power source. In order to ensure continuously reliable power a small stand-alone UPS was installed.

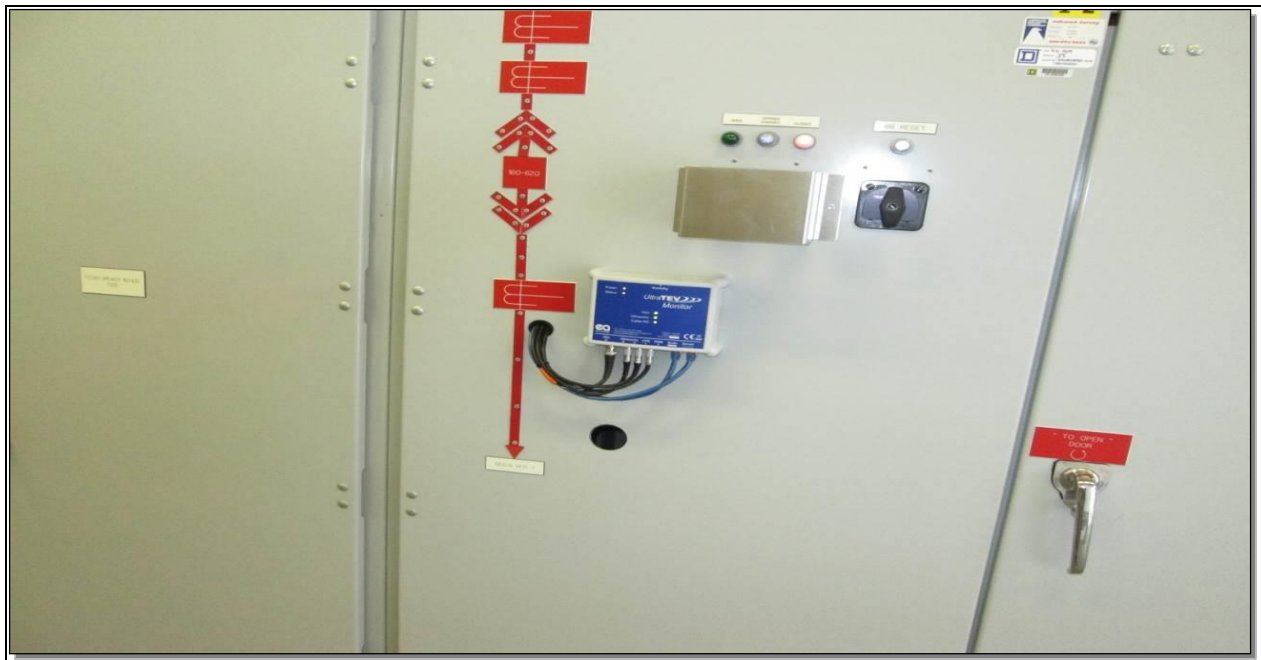
Photo 1: Node Installed on Exterior Cubicle Door

Once the location of the sensors, nodes and hubs were identified, a methodology needed to be developed to route all the cables. The manufacturer's literature depicted nodes on the front door of the circuit breaker compartment with cables draped in front of cubicle doors from node to node. The manufacturer indicated on systems with such a design, when the circuit breaker doors needed to be opened the associated node and cables would be disconnected. This is not acceptable for many customers. It is not desirable to disturb the system to perform inspection or operation of the circuit breaker cubicle. To address this issue, holes were drilled in the doors and grommets were used to route interconnecting cables between cubicles. This allowed doors to be easily opened to avoid system disruption for operating or maintenance.

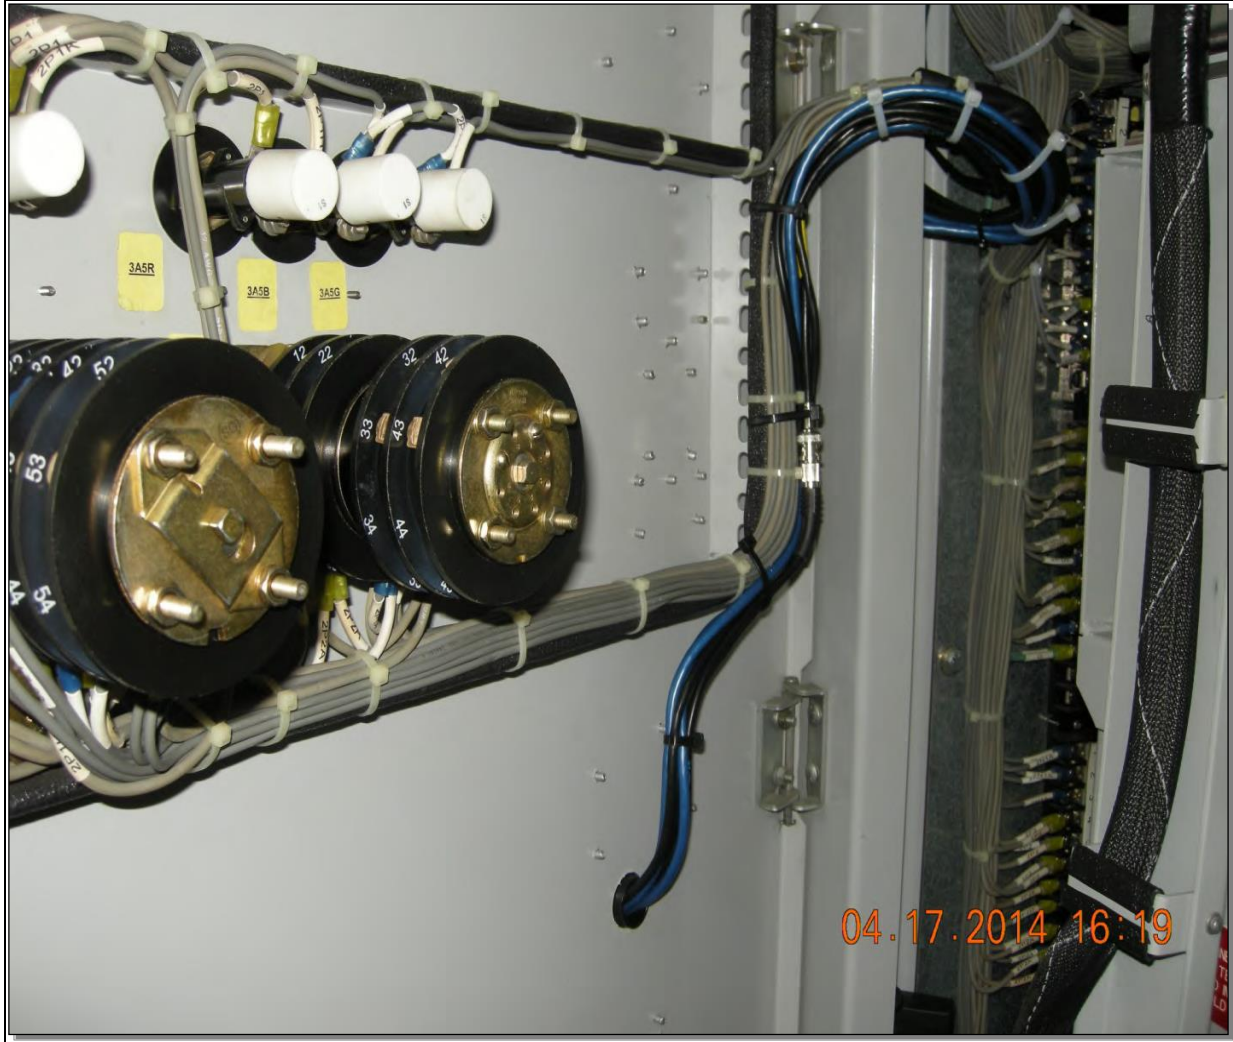
Photo 2: Cable Routing to Node through the Door

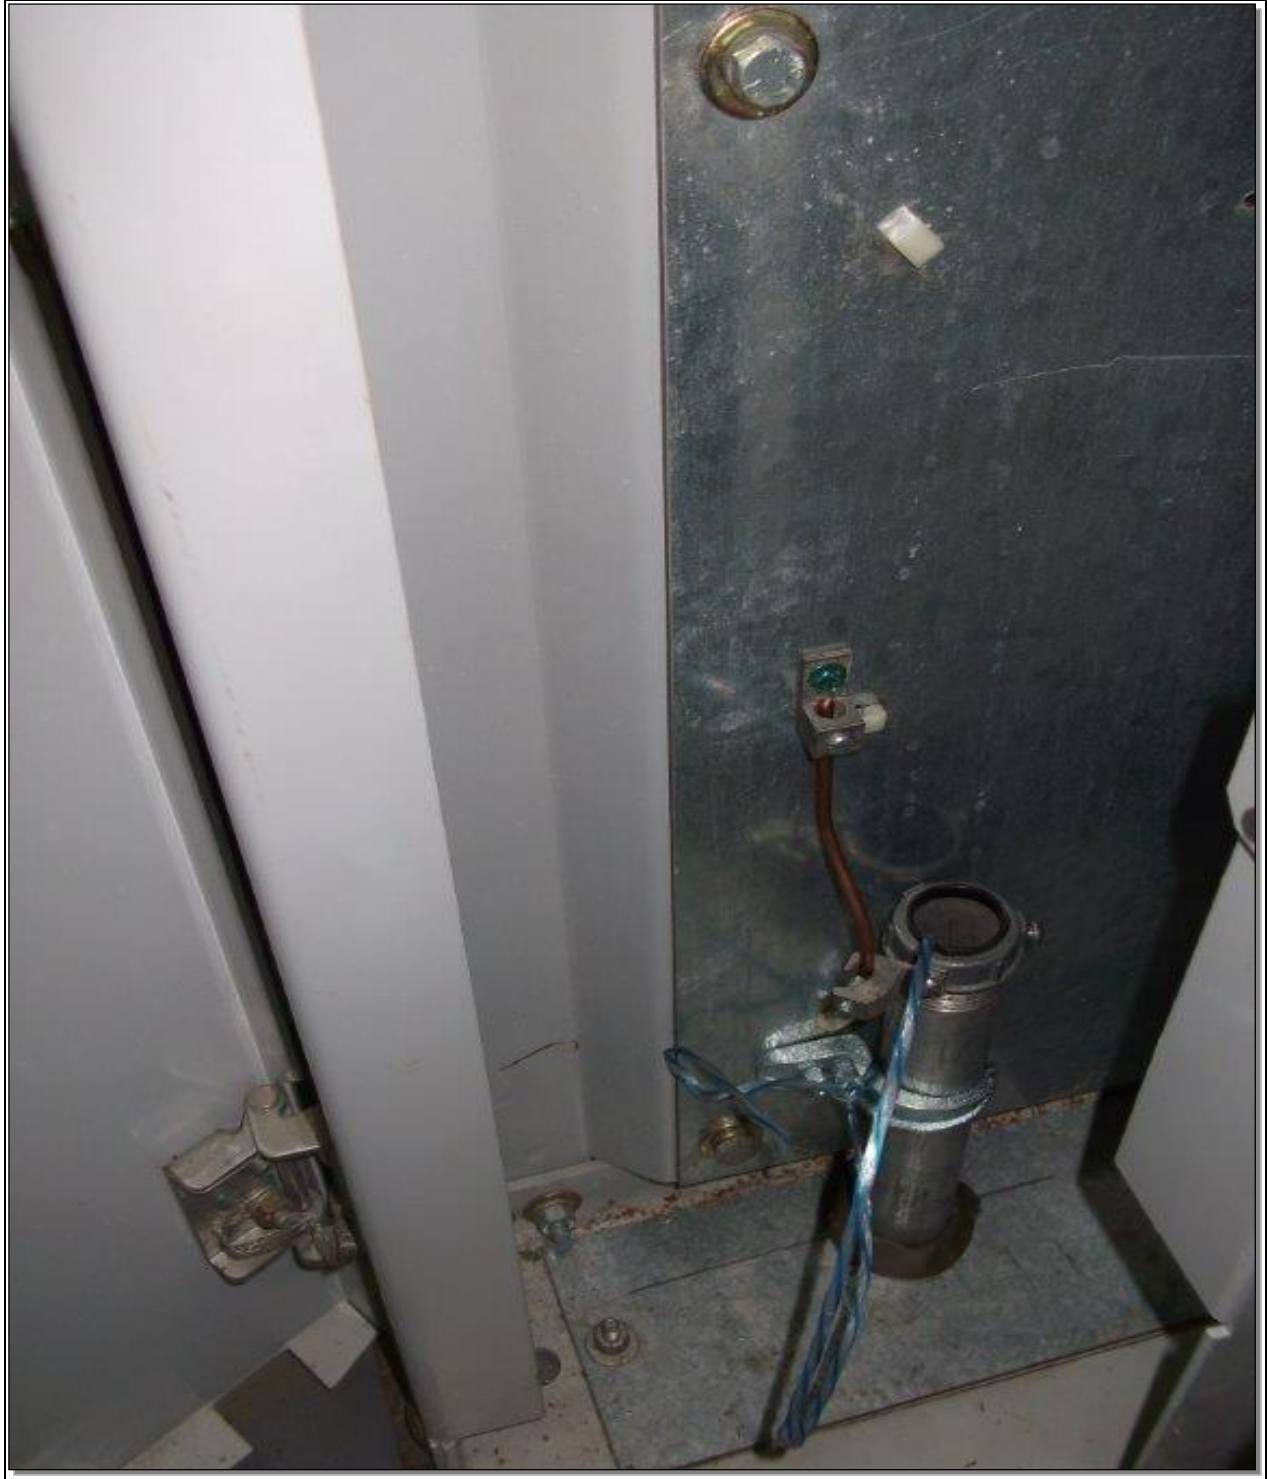
Photo 3: Conduit Penetration - Under Floor

For the outdoor switchgear, routing up and over the switchgear and through the roof or up and around the switchgear were not feasible since the cable length constraint could not be met. Routing cable through the switchgear was not safe since the line bus and line side stationary breaker stabs were energized. That only feasible option was to route under the switchgear. The switchgear is an outdoor, walk-in enclosure. The entire assembly sits on an I-Beam frame on a concrete foundation. When the switchgear was installed, the I-Beam frame was elevated two (2) inches above the concrete pad. This provided a gap that accommodated a 1-1/2 inch conduit. The conduit was fished under the structure between the rear cable compartment and the front circuit breaker compartment. This allowed sensor cables to be routed rear to front to the nodes.

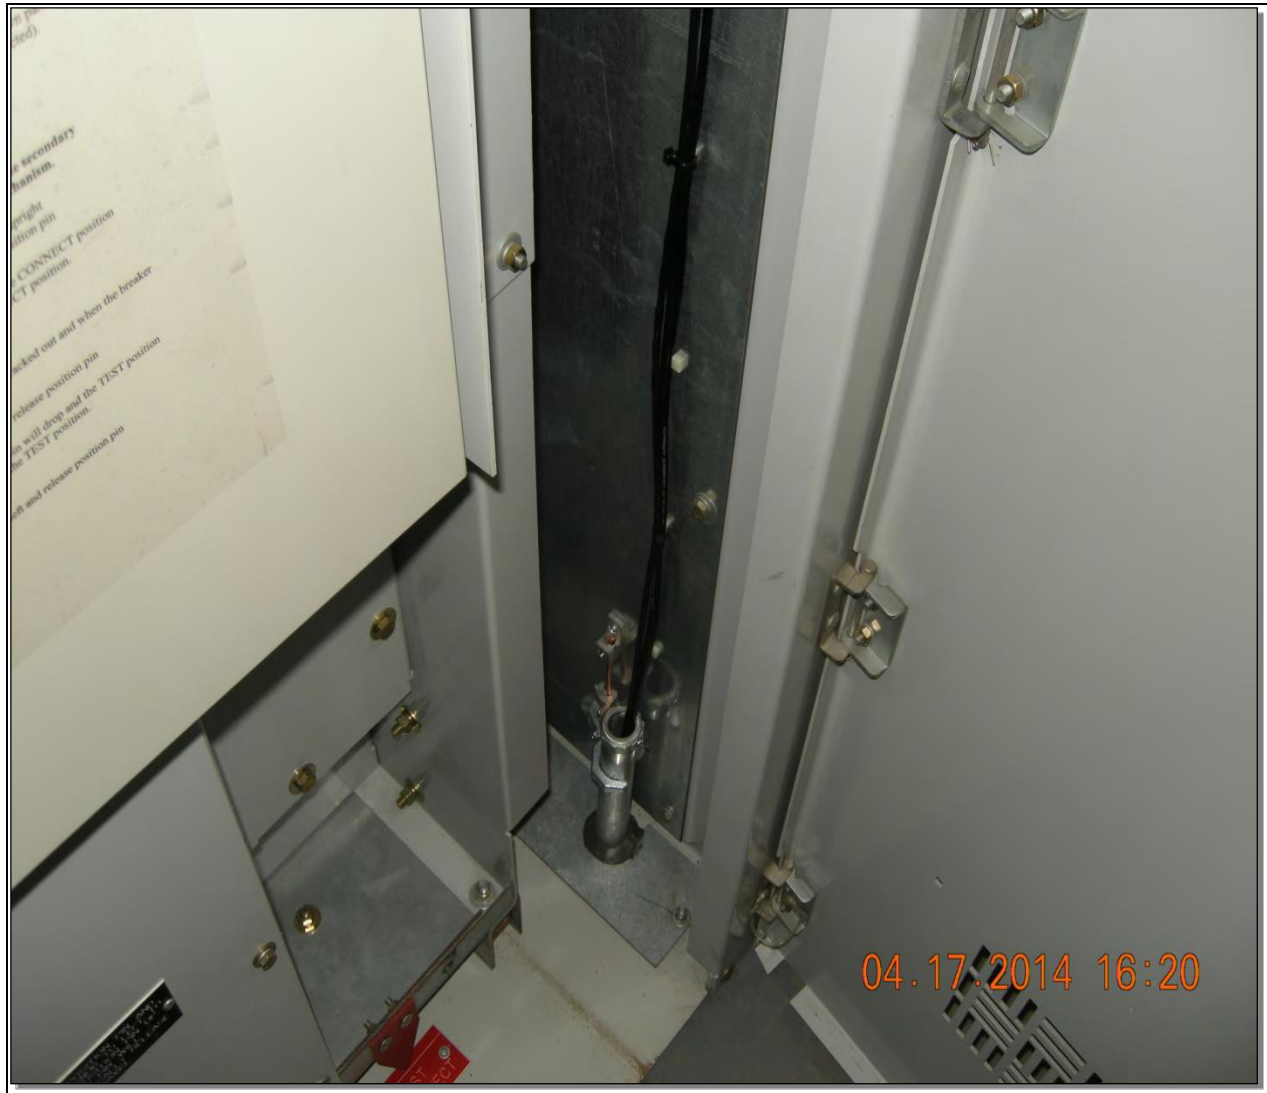
Photo 4: Cable Pulled In Underfloor Conduit

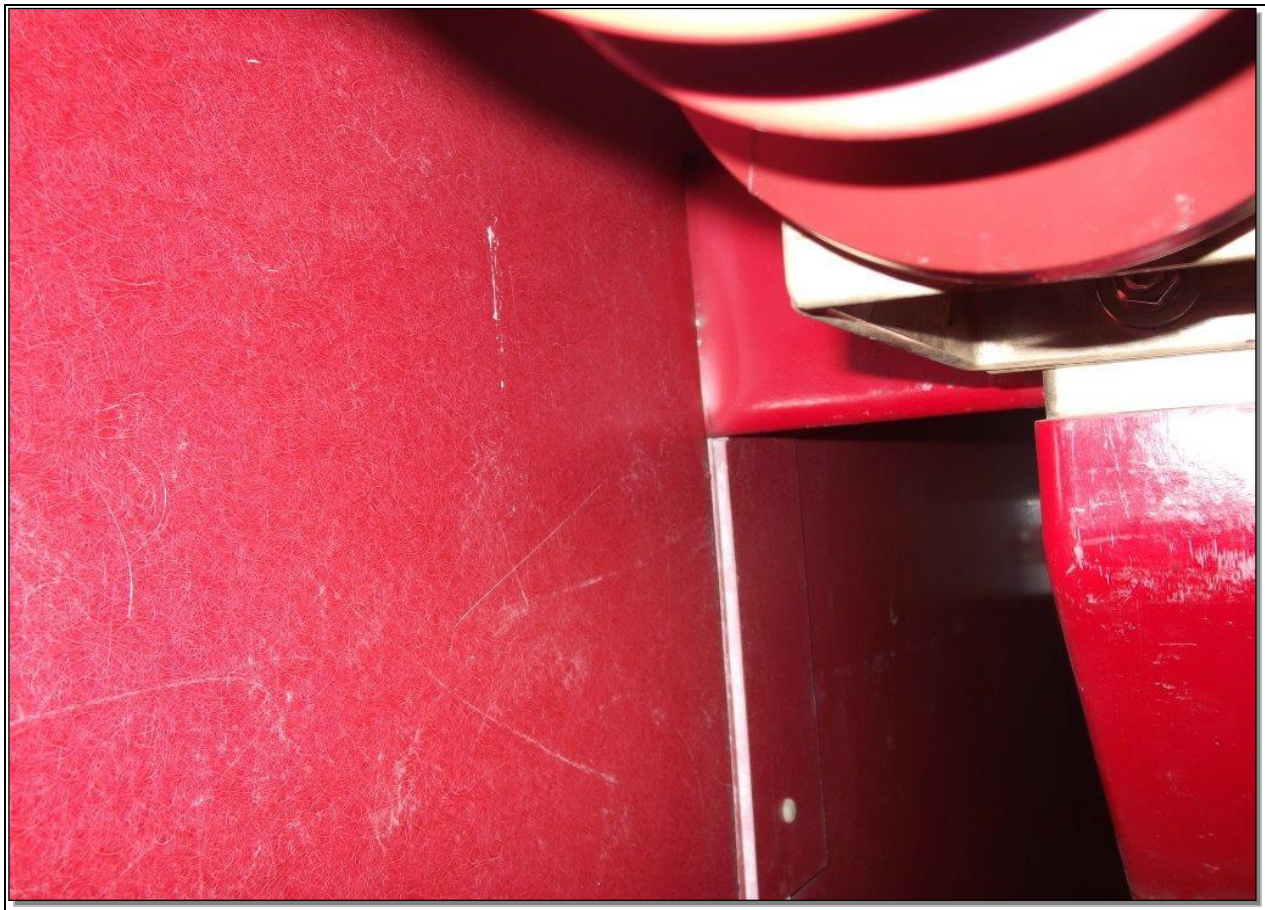
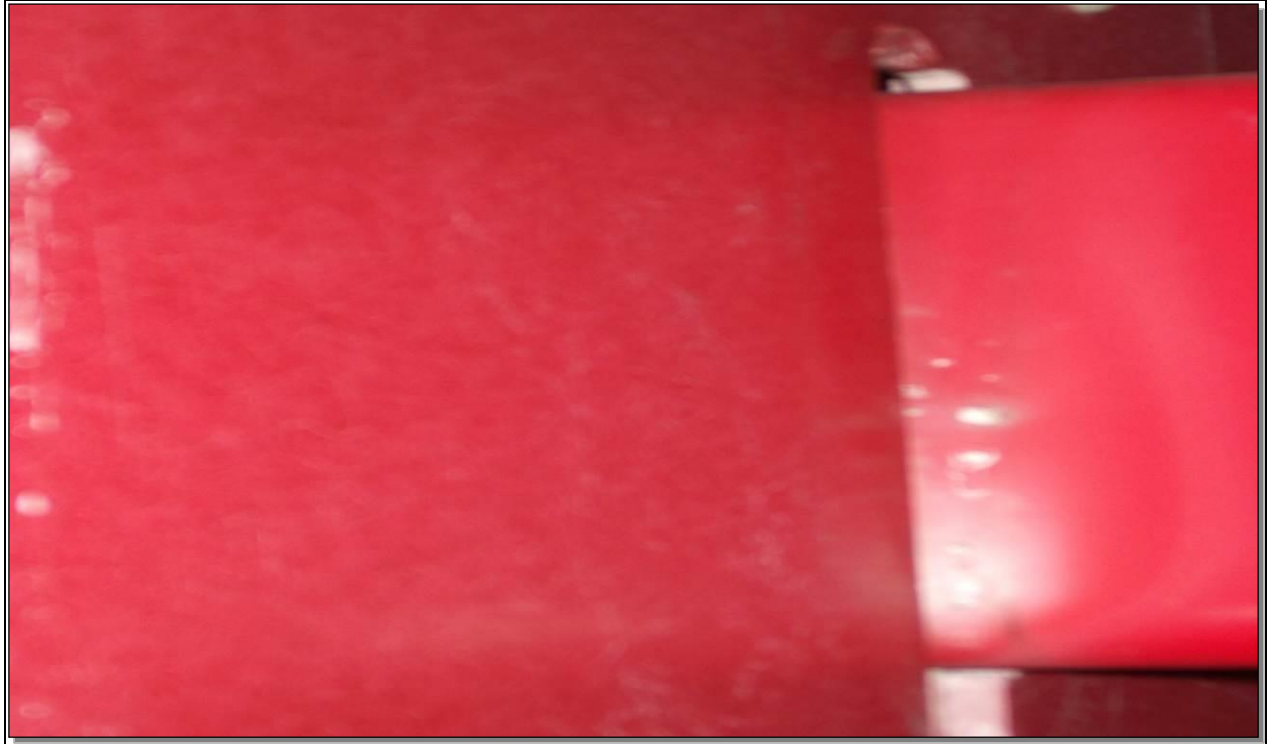
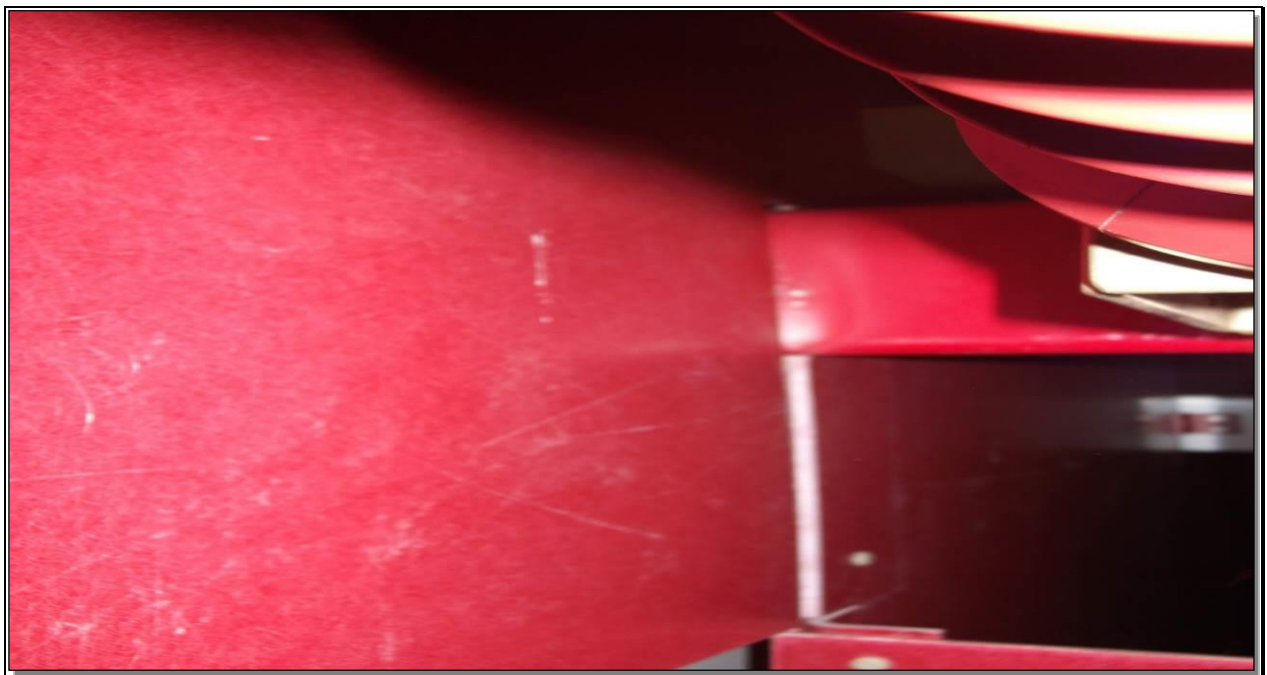
Photo 5: Insulation Emitting PD

Photo 6: Insulation Emitting PD

Photo 7: Insualtion Emitting PD

During a periodic review of stored data, after one of the systems had been installed for several months, one (1) ultrasonic detector reading had increased above the other sensors. However, this sensor was below the alarm point (Figure 8). Looking at the data it appeared to be impacted by humidity. The user was notified of the potential situation. However, because the system was relatively new, the user was reluctant to remove the equipment from service just on this increased sensor reading. Separate ultrasonic readings were performed using a hand held instrument, which confirmed electrical activity. The feeder was removed from service and an inspection performed. An insulating barrier board was found rubbing against a 33 kV insulated conductor, causing corona to be emitted. Photos 5-7 show the inspection findings. The barrier board was removed, modified, cleaned and re-installed.

Maintenance testing was performed on the cubicle and it was returned to service. Upon return to service the ultrasonic readings returned to normal levels consistent with other cubicles. Without this PD system, it may have been years before this activity might have been detected, which could have ultimately led to an uncontrolled catastrophic in service failure.

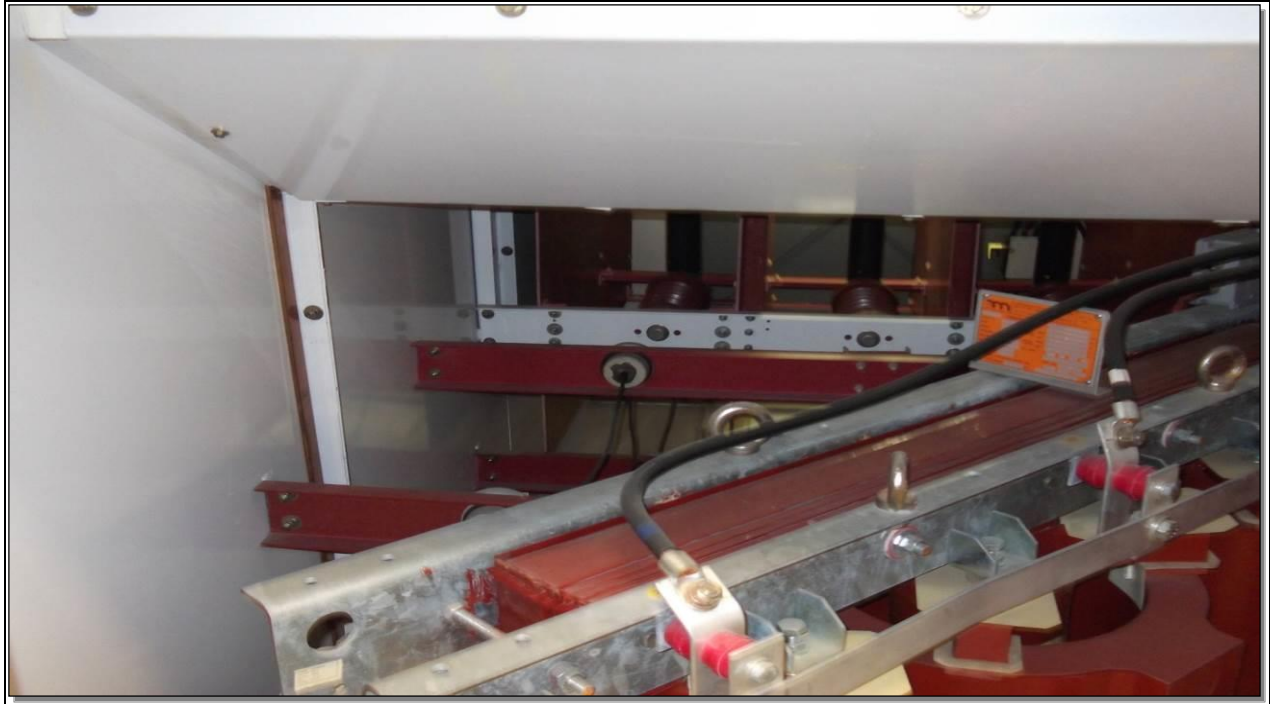
Photo 8: CPT (Top)

Photo 9: CPT

A subsequent alarm investigation identified that the system was reporting elevated ultrasonic levels on a CPT Transformer used for supplying station service light and power. The hand held ultrasonic instrument was used and it confirmed low levels of electrical activity. The hand held instrument allowed the activity to be pinpointed to a cable pass-through insulator. A bare conductor was used to connect the primary of the transformer to the load side of the fuse. Because the alternate CPT was out-of-service at the time this CPT could not be removed from service for repair. Three months later, smoke was seen coming from the CPT cubicle. It was immediately removed from service. The PD system was interrogated and it showed that the ultrasonic detectors had gone into alarm just prior to the smoke being reported. The trouble was tracked to a defective high side fuse that had operated single-phasing the transformer. The issue with the fuse is it was tracking on the inside of the tube (the tube was made of fiberglass). This event precipitated the owner's decision to install the remote access capability. Photos 8-9 show the CPT.
