## PARTIAL DISCHARGE ASSESSMENT WITH ULTRASOUND AND TEV (TRANSIENT EARTH VOLTAGE) IN MEDIUM VOLTAGE SUBSTATION FOR POWER DISTRIBUTION SYSTEMS RELIABILITY OF 18<sup>TH</sup> ASIAN GAMES 2018

### ABSTRACT

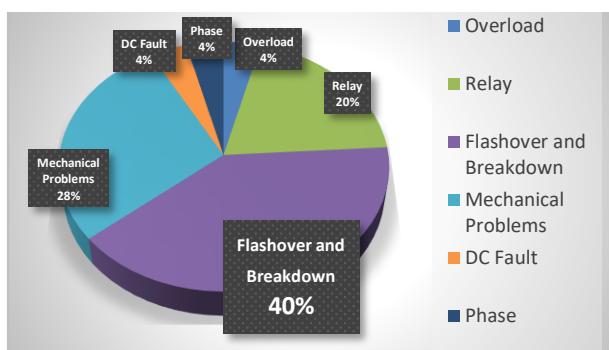
Fig.1. Identified Root Cause of Incoming 20 kV Transformer Trip

In Fig. 1, in 2017, 40% of incoming 20 kV transformer trip (unscheduled shutdown) were having medium voltage cubicle breakdown failure as its root cause. Incoming 20 kV transformer are connecting the secondary winding of the power transformer to the medium voltage busbar 20 kV which supplies the feeders in the substation. If the incoming 20 kV transformer trips, then the feeders that supply to the customer will experience power blackout.

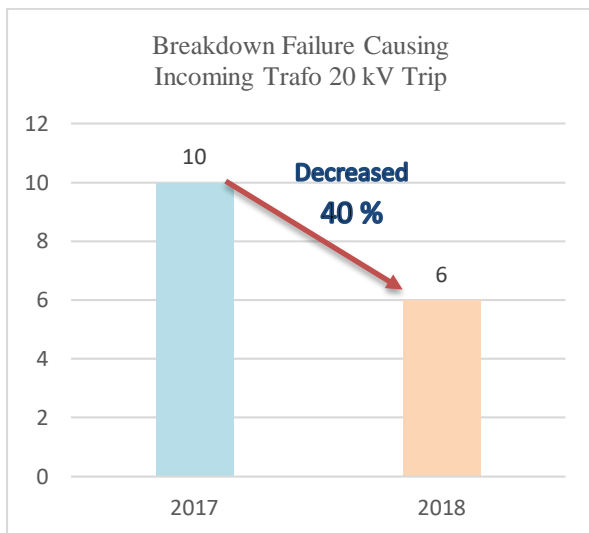
Fig.10. Breakdown Failure Causing Incoming 20 kV Transformer Trip

Having implemented partial discharge assessment started in semester 2 of 2018, breakdown failure (causing incoming 20 kV transformer trip) has lowered 40% compared with previous year achievement.
