Online Partial Discharge Testing of HV Cable: Single Test Vs Feeder Mapping

By Thomas Whyte - EA Technology

CASE STUDY: 22KV FEEDER ANALYSIS

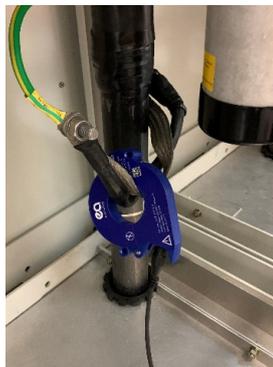
Figure 1 HFCT around earth sheath

Once a PD event has occurred through the electrical insulation of a cable, a set of radio frequency current pulses both equal in magnitude but opposite in polarity are seen on the line conductors and the earth conductor. On-line PD detection utilises this effect by measuring these pulses using High Frequency Current Transformers (HFCT's) placed on the earth sheath of the cable.

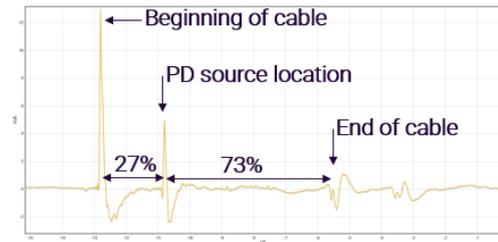
Figure 2 PD Waveform Analysis on HV Cable

Waveform analysis employs similar analysis methods as time domain reflectometry (TDR) testing. The partial discharge current pulses are known to reflect off high impedance points in the HV network, such as cable terminations. This results in the initial partial discharge pulse being reflected, enabling analysis to pinpoint the origin of these signals. An example of this is shown in Figure 2.

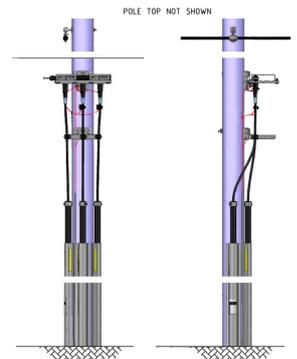
Figure 3 Hybrid style Pole top terminations

The spur of the feeder that is being analysed for this study comprised of 14 sections of 22kV XLPE cables, spanning over 5km. The XLPE cables terminated into hybrid style pole top terminations, shown in Figure 3.

Each run of cables was tested for partial -discharge using HFCT's from both ends of the cable and each pole top termination was tested using the TEV, ultrasonic and UHF test techniques. This method of testing ensures that all partial discharge sources would be identified and localised.

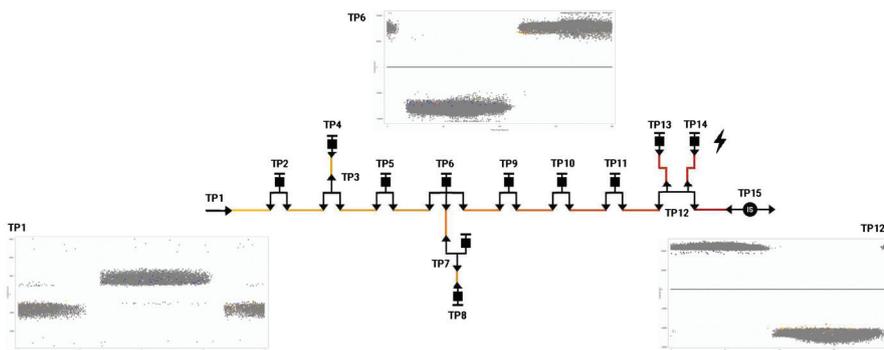
Figure 4 Test Point 10 - Waveform analysis

Figure 4 below shows a heat map of the feeder spur indicating the origin of the PD source as well as the PD signals identified on each HV cable as well as at each cable termination.

It was found that at test point 1 no local PD was identified. However clear indications of partial discharge could be seen on the HV cable. This trend continued along the feeder, with amplitude slowly increasing as the test points move closer to the origin of the PD signals.

However, the single PD defect was identified during the local testing at test point 14. TEV testing of the HV pole at test point 14 identified very high-level TEV signals, time of flight location was used to verify that these signals originated at the top of the HV pole. This was further confirmed by using UHF testing. Ultrasonic testing was able to localise the PD source to the red phase termination. Due to the construction of the termination and the PD signals identified it was concluded that these sources were likely caused by a poor HV connection in the termination.

Analysing the PRPD plots shows how far the partial discharge signals can travel across the full feeder. Partial discharge signals were identified on all test points using PRPD analysis and waveform analysis revealed significant reflections at five separate test points.
